Architectural Salvage Assessment

**Contributing Buildings
Oakland Army Base Historic District
Oakland, California**

**Prepared by:
Woodruff Minor
Consulting Architectural Historian**

December 7, 2006

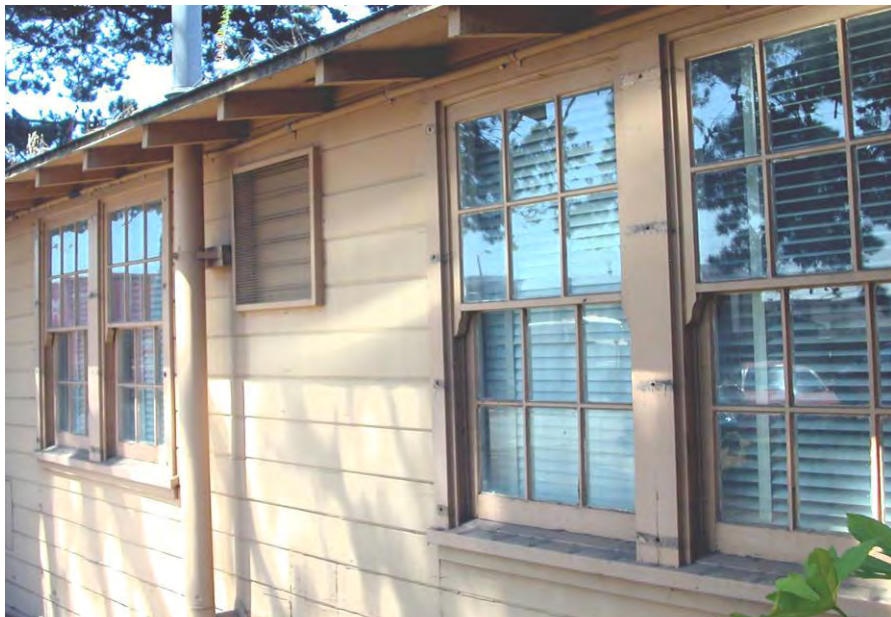
Figure 3.16. Similar six-over-six double-hung windows can be found on Building 90, though most windows on this building have been replaced with aluminum sash.

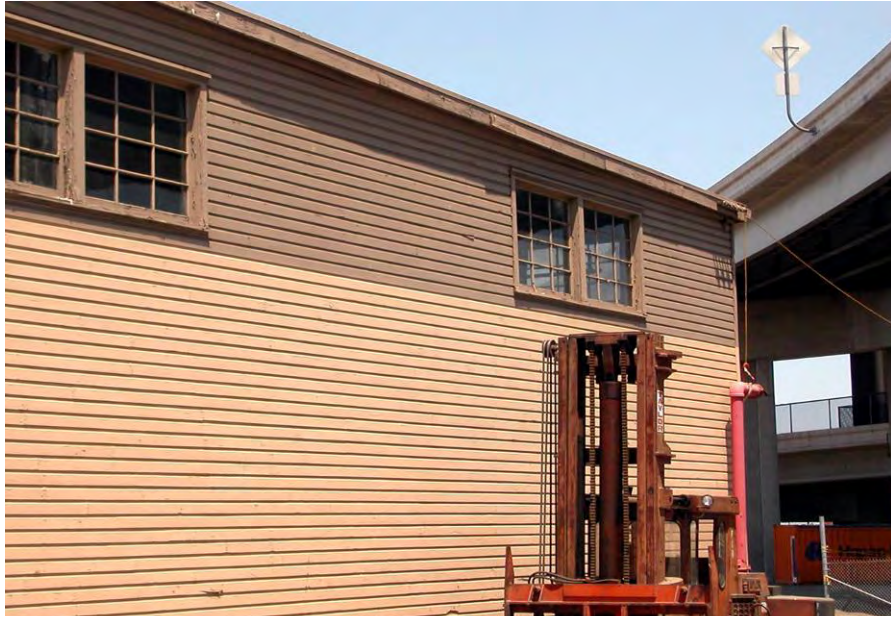
Figure 3.17. Building 808, east end detail. Multi-light, fixed-pane, wood-sash windows are set into the walls at each end of the “800 series” warehouses as well as in rows above the canopies and along the monitors. This view also shows the generally good condition of the exterior wood siding on these buildings.

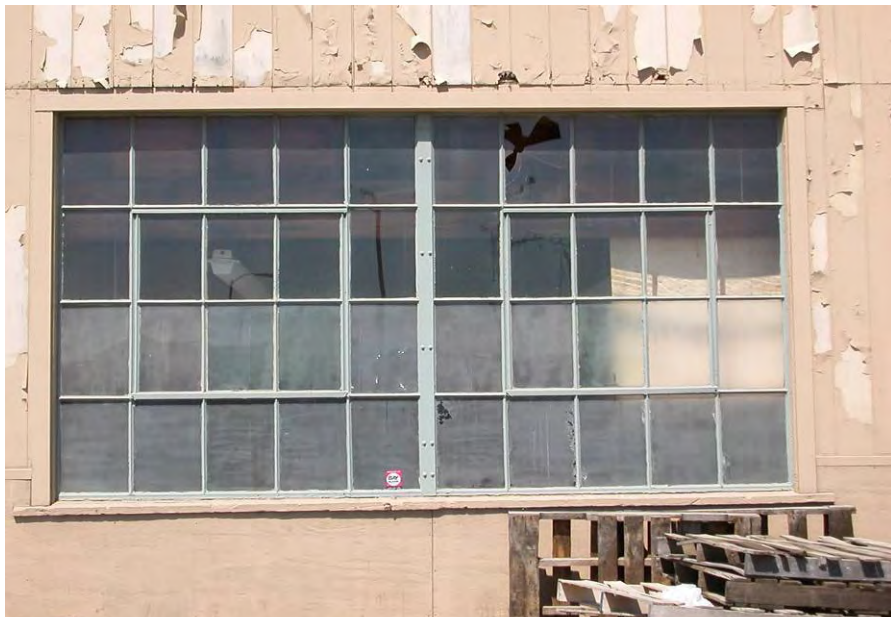
Figure 3.18. Steel-sash window, Building 88. The Port of Oakland’s reconstruction of this World War I-era building probably included the addition of steel-sash windows, although they may form part of the original structure. Because of restrictions on the use of steel, all World War II-era buildings on the base have wood-sash windows.

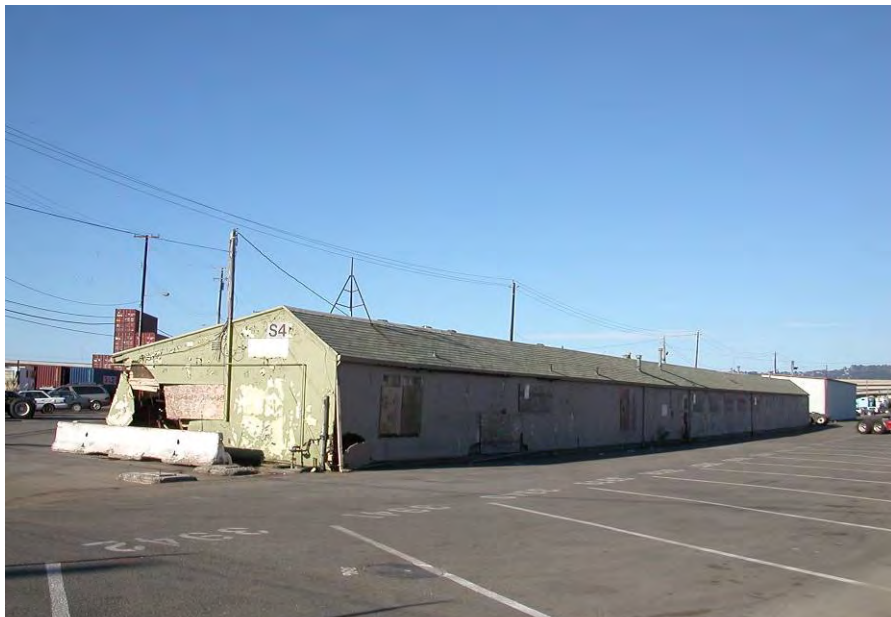
Currently vacant and in poor condition, the shed was substantially altered in 1961, when it was converted into a vehicle inspection station. At that time, a concrete slab was added, the south wall was enclosed, the parking stalls were rebuilt as offices, exterior walls were covered with stucco, and a drive-through canopy was added to the north side of the building.

Figure 4.2. Now in poor condition, the vacant building has been altered by the enclosure of the parking stalls and the application of stucco to the walls.

No features or components recommended for salvage.

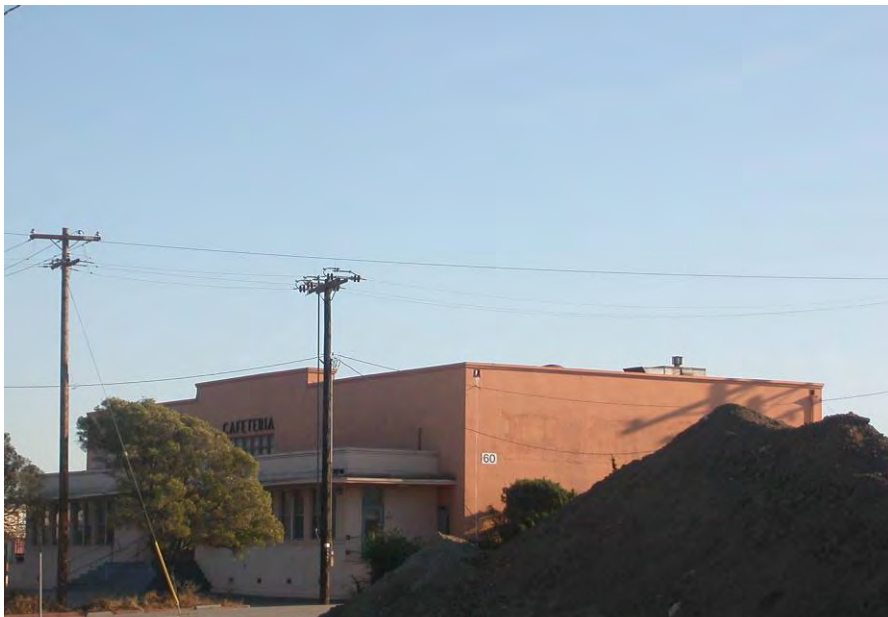
Figure 4.4. The building as it appears today, vacant and fenced off. The view is to the south. Windows at the front and sides have been enclosed, and the interior is substantially altered.

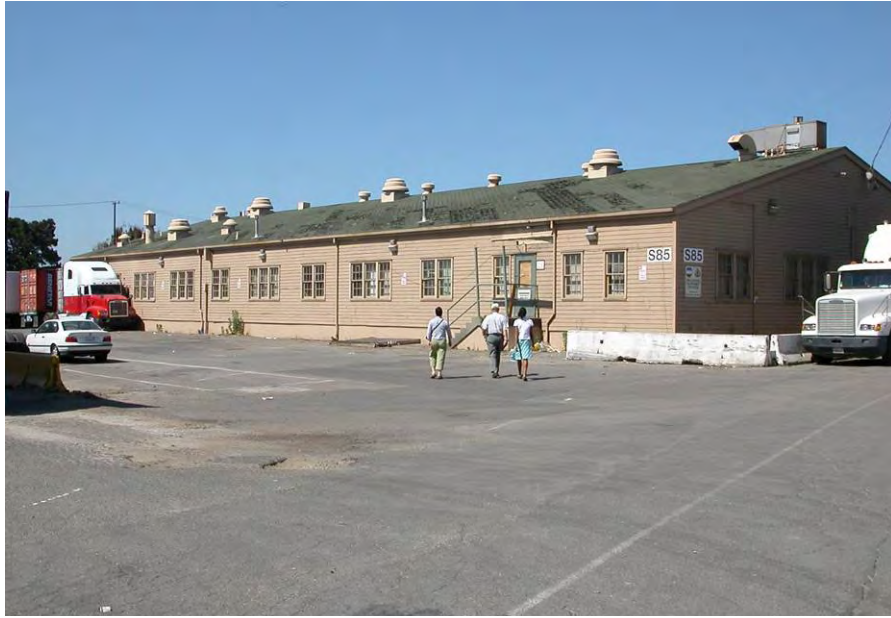
Figure 4.5. Erected in 1942 as a storehouse, Building 85 was later converted into a printing plant, and is currently vacant. The view looks west.

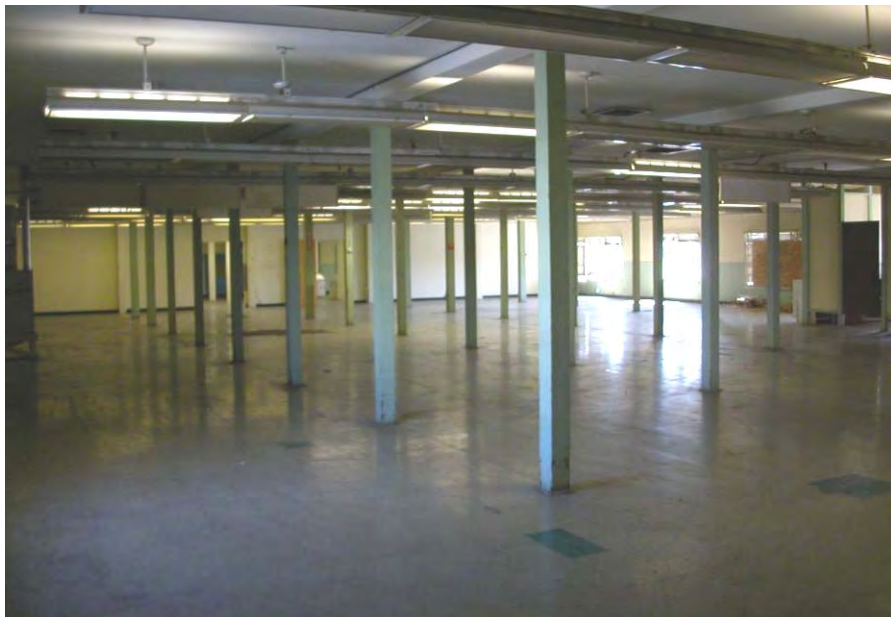
Figure 4.6. Alterations to the interior of Building 85 include linoleum flooring, plasterboard walls, a dropped ceiling, and modern light fixtures. The timber posts are original.

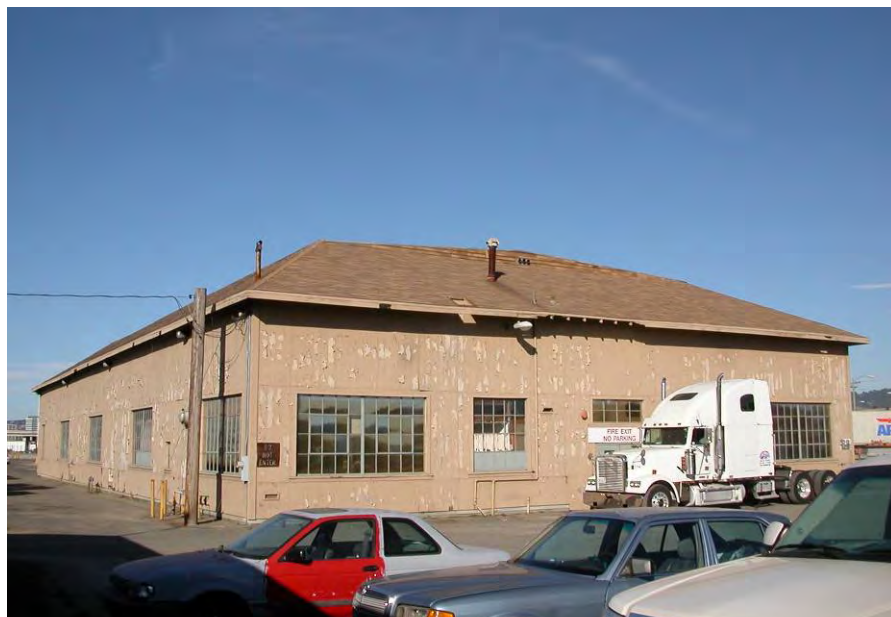
Figure 4.8. This view looking northeast shows the veneer of vertical wood paneling that has been applied over the original horizontal wood siding of Building 88, as well as the steel-sash windows dating from World War I or the 1930s. The original doorway at south end of the building has been enclosed; the doorway at the north end is intact.

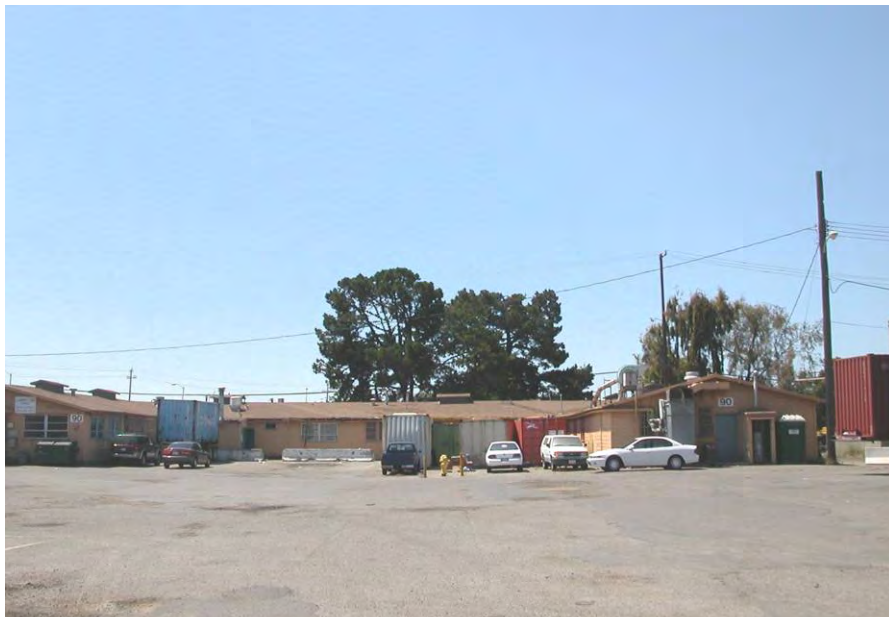
Figure 4.12. Rear view of Building 90, looking southwest. The exterior is intact except for the replacement of most windows with aluminum sash. Interior finish and fixtures have been largely altered.

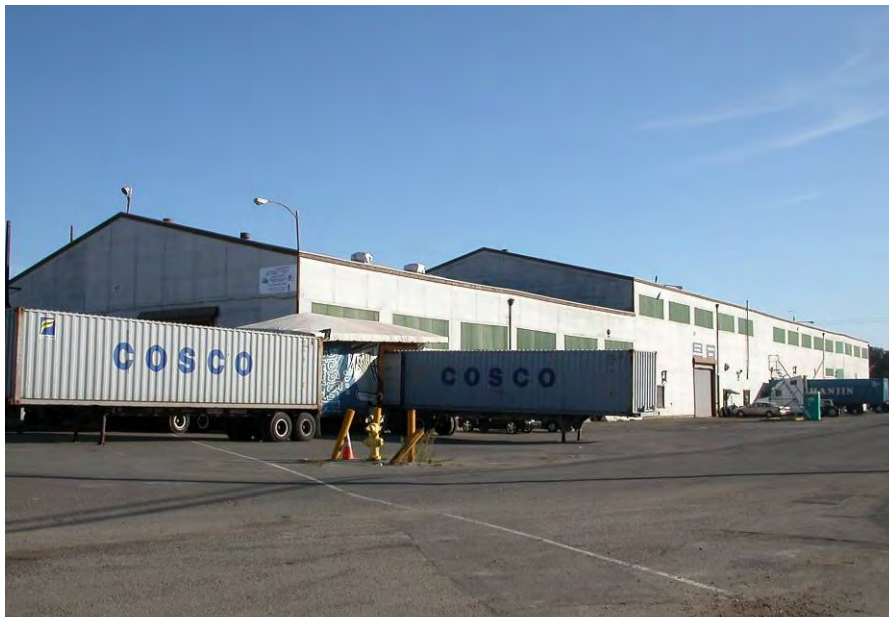
Figure 4.14. Building 99, looking southwest. This view clearly shows the scale and the stepped, gabled massing of the structure. The exterior has been altered by the application of asbestos-cement panels over the original horizontal wood siding and the enclosure of windows with translucent plastic panels.

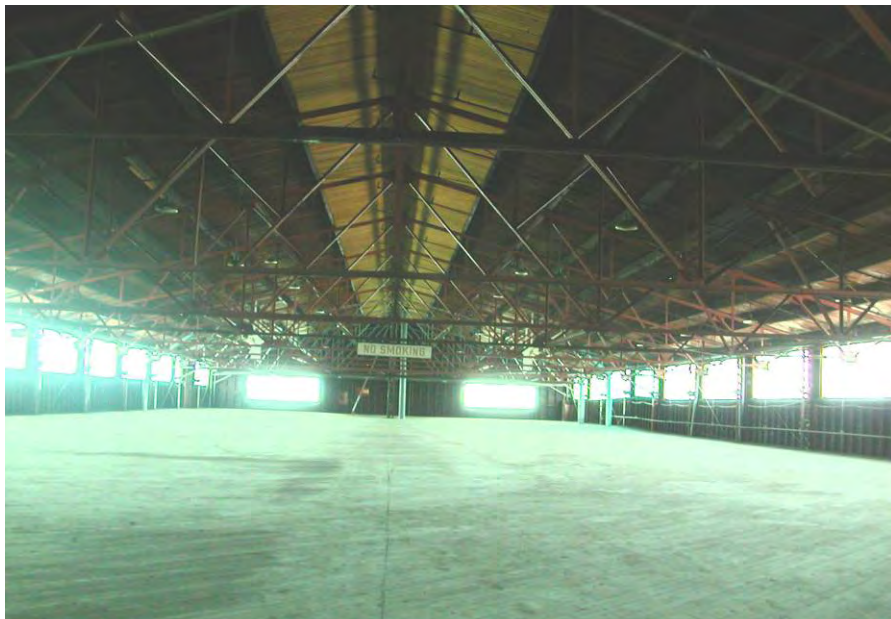
Figure 4.15. Former mold loft, Building 99. Spanned by steel trusses, this spacious room is encompassed by windows and capped by a skylight, now covered with translucent plastic. The floor is laid with diagonal boards.

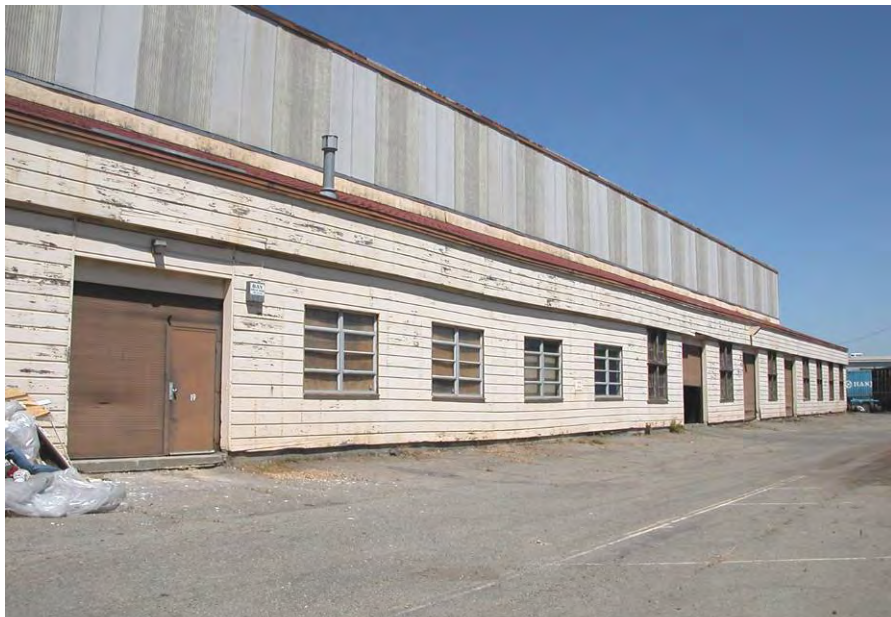
Figure 4.26. Building 812, south side. Most windows have been replaced with aluminum sash, and sliding wood doors have been replaced with roll-up metal doors. Walls retain the original horizontal wood siding.
