**Feasibility Study for Adaptive Reuse
of the Existing Oakland Army Base Warehouses**

RE: Feasibility Study of Potential Reuse of Existing Warehouses

Seismic Retrofit and Rehabilitation Report
Oakland Army Base Warehouse Buildings
Oakland, CA

Appendix A
Building Photos

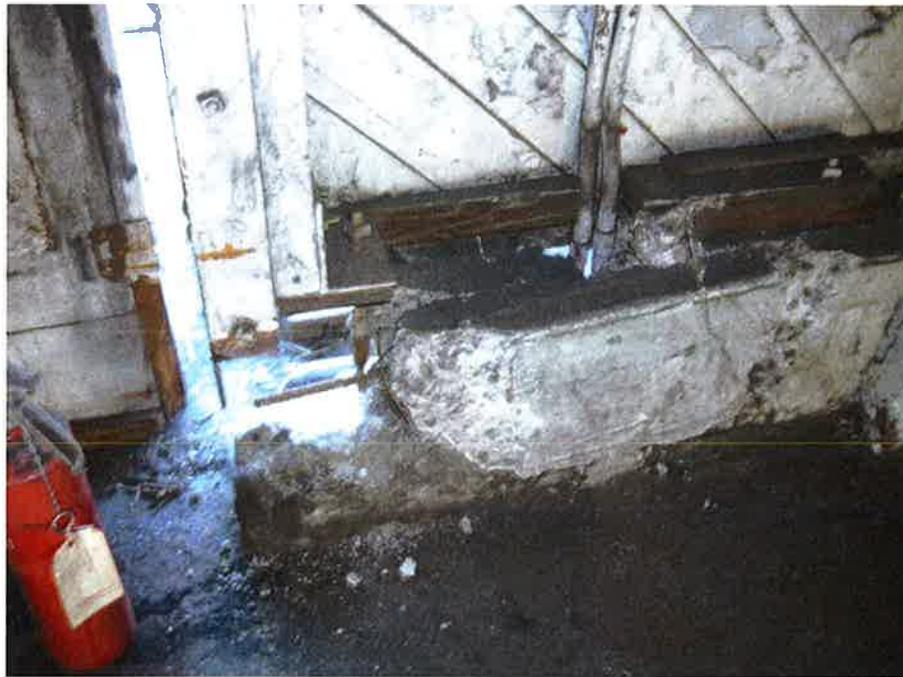
Some cracking of the exterior strip footings/retaining walls was observed (approximately 10 locations), indicating that some minor differential settlement has occurred. Additionally, several of the stem walls adjacent to the loading doors (at approximately 40% of the doors) are damaged. This may have occurred from impact and/or differential settlement. In general the foundation system appears to be carrying existing loads with no significant deficiencies; however we recommend epoxy injection of the cracks and repair of the damaged stem walls noted above.

Photo 7: Damaged Stem Wall at Door

- Epoxy inject cracks at the exterior concrete stem walls (approximately 10 locations observed at this structure).
- Repair damaged concrete stem walls near the loading doors (Observed at approximately 40% of loading doors).
- Repair or replace split interior posts (Approximately 20% of posts).
- Replace damaged windows and building finishes, and weatherproof the structure.
- Repair and/or replace exterior doors.

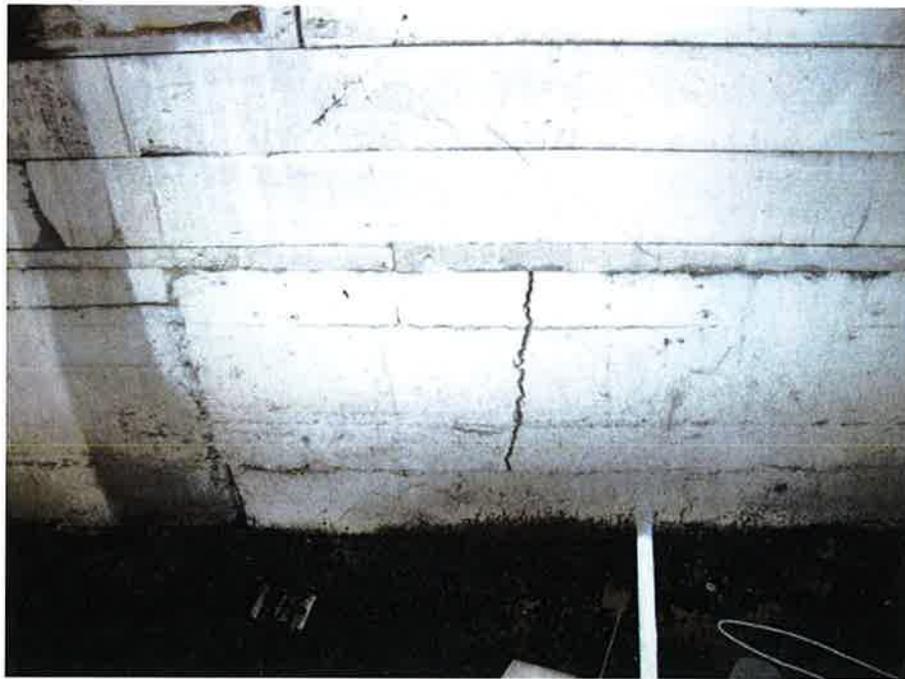
Photo 9: Cracking at Stem Wall (Interior)

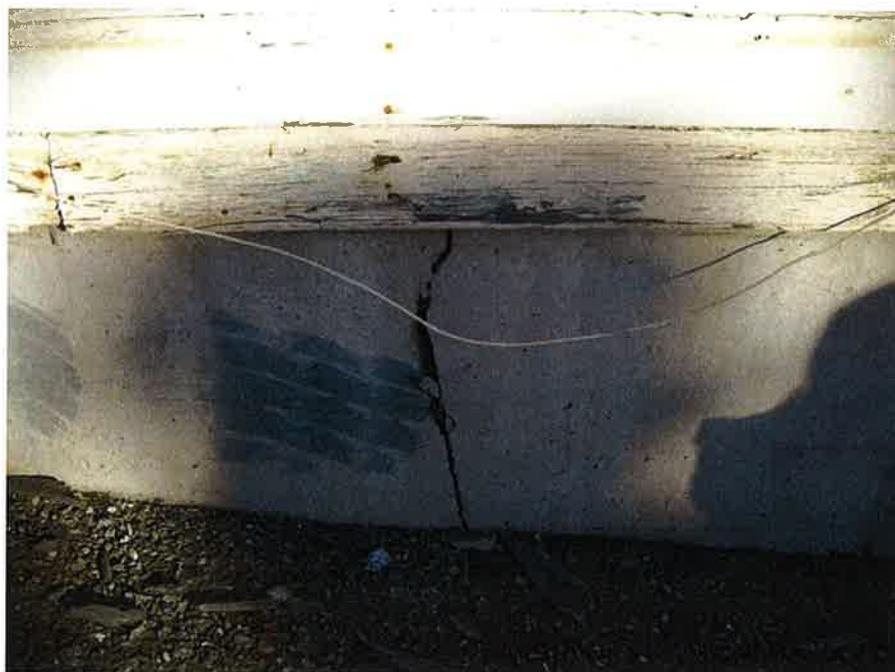
Photo 10: Cracking at Stem Wall (Exterior)

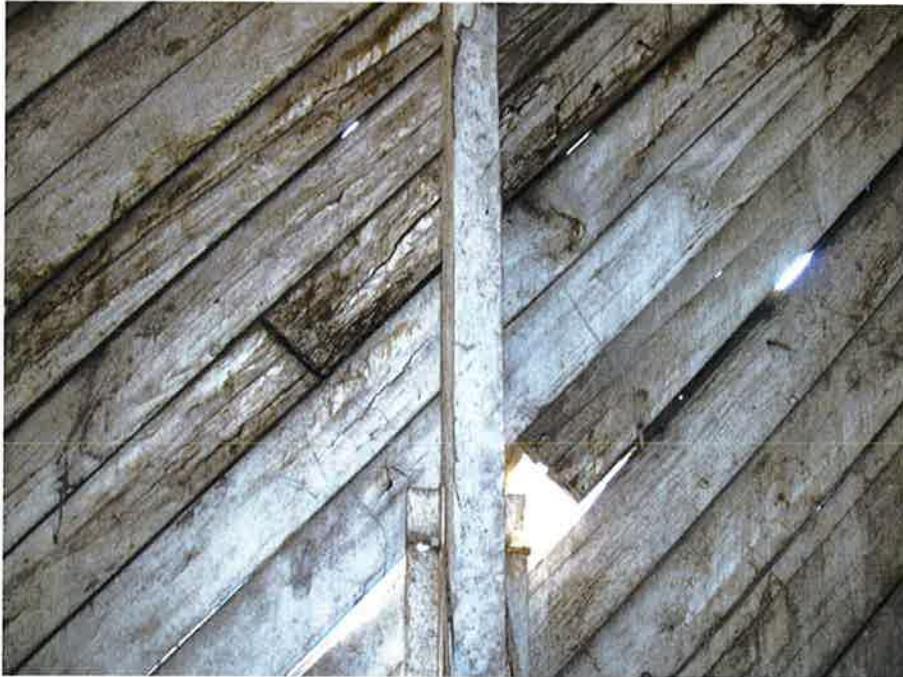
Some leaks were observed in the roof and exterior walls. At one location in the building observed, the leaking roof has caused significant deterioration of the diagonal sheathing at the exterior wall. There are also damaged windows that allow rain inside the building. The painted exterior horizontal siding is showing some signs of wear and deterioration, especially at unprotected end walls. The exterior finishes on the entire structure should be inspected and repaired. If no waterproofing exists under the exterior horizontal siding, consideration should be given to removing the siding, repairing the diagonal sheathing, adding building paper, and replacing the horizontal siding.

Photo 11: Water Damaged Sheathing

- Consider replacing the AC pavement at the finish floor with concrete for improved performance.
- Replace roofing.
- Repair horizontal siding.
- Consider the need for adding building paper underneath horizontal siding.
- Repair diagonal sheathing at exterior walls.

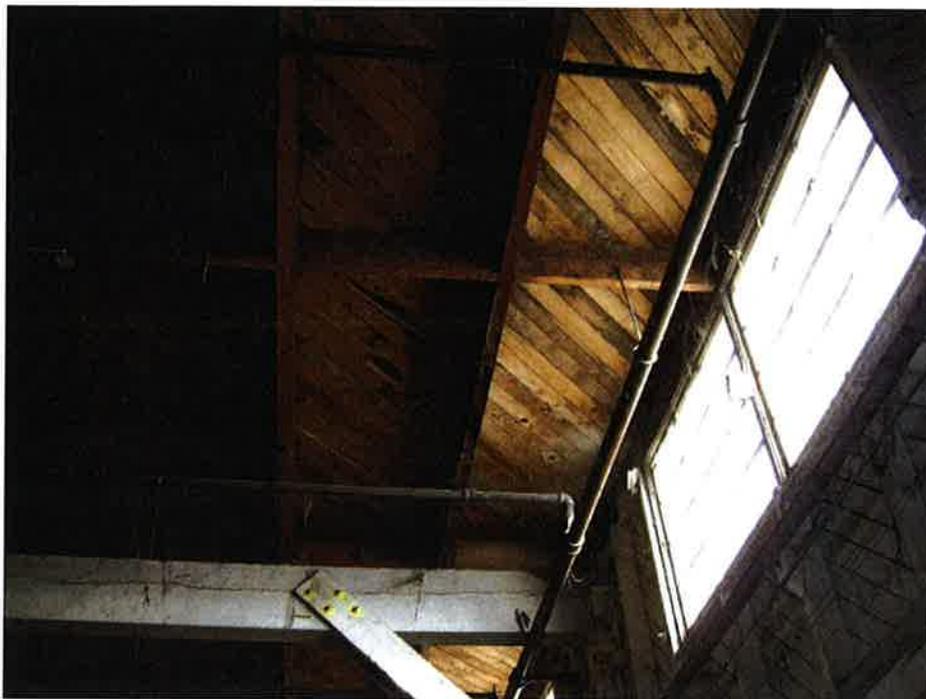
Photo 12: Leak at Roof

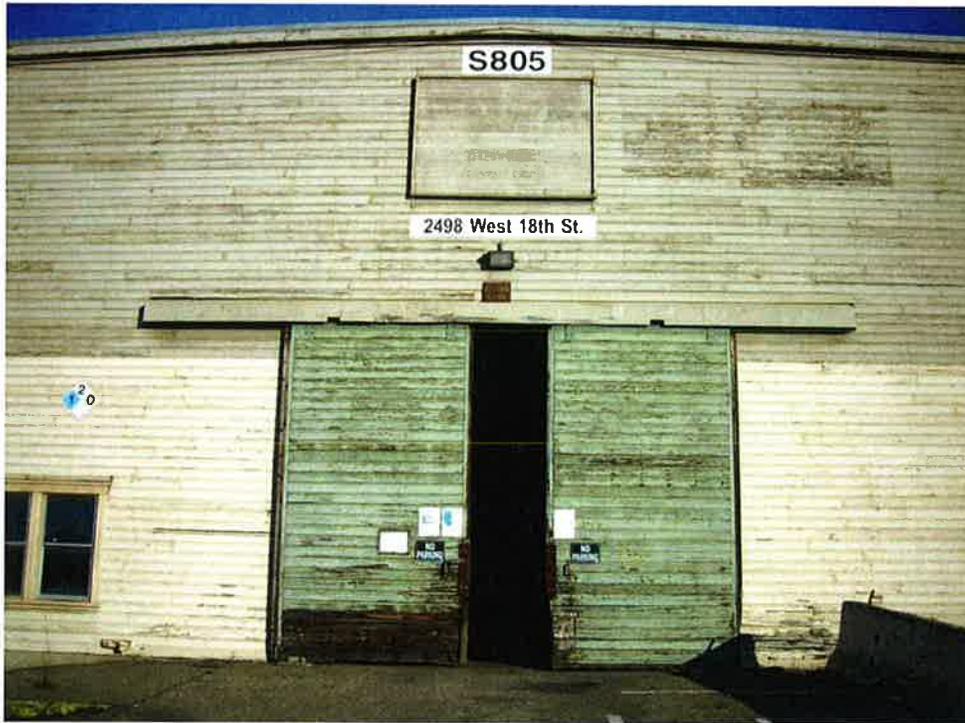
Photo 13: Weathered Siding

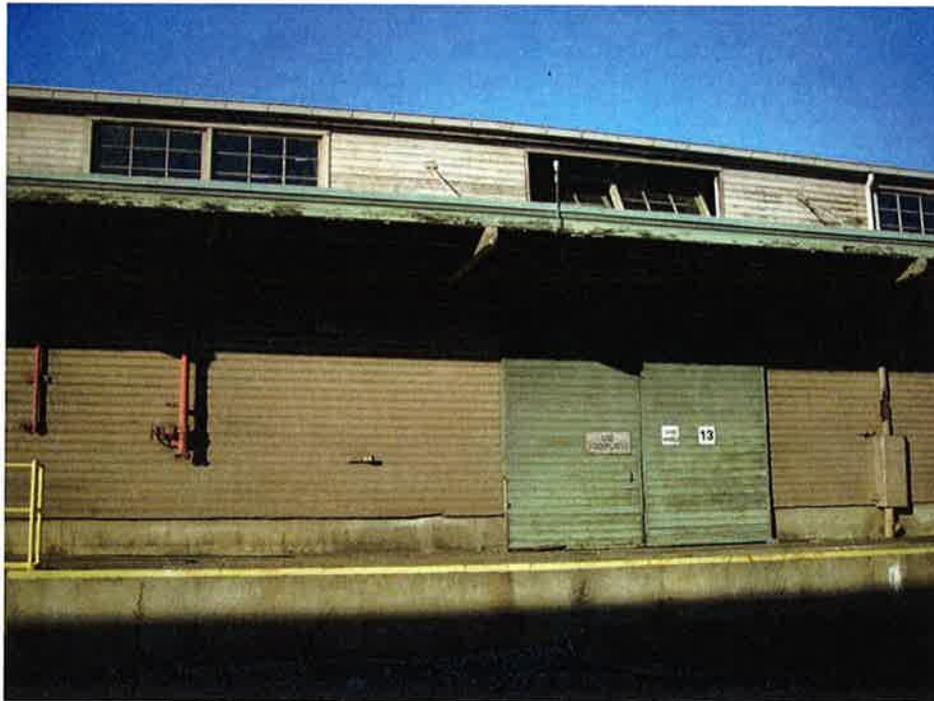
Photo 14: Damaged Window

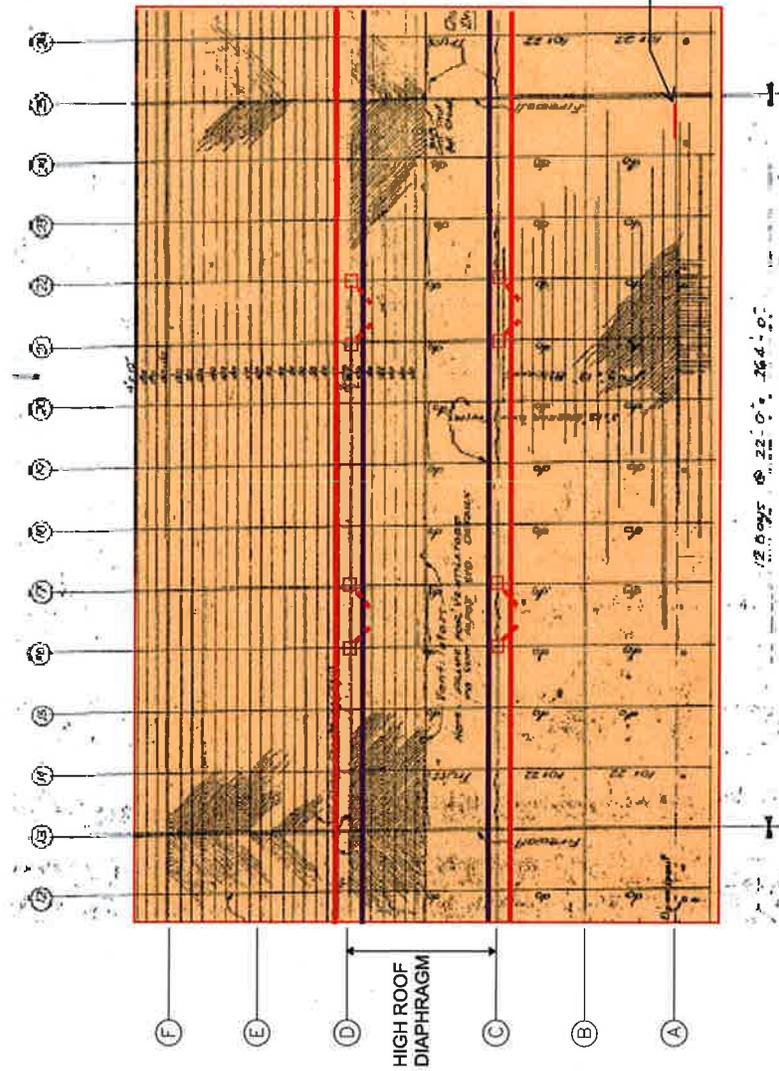
PARTIAL ROOF FRAMING PLAN
NO SCALE

Roof Diaphragms and Continuity: Similar to the stress in the shear walls, the diagonally sheathed diaphragms are overstressed due to the increase in seismic demands since the original design, and the long spans between supports. Furthermore, the discontinuity between the low and high roof, with no continuous roof chord or collectors creates a potential for damage and partial collapse at this location.

It is recommended that the roof diaphragms be strengthened with an overlay of structural plywood to resist the demands associated with the large spans between shear walls. Note that this will require removal and replacement of the entire roofing system.

SIMPSON A35 CLIPS AT 12" OC BTWN 4x PURLIN AND TOP PLATE, TYP

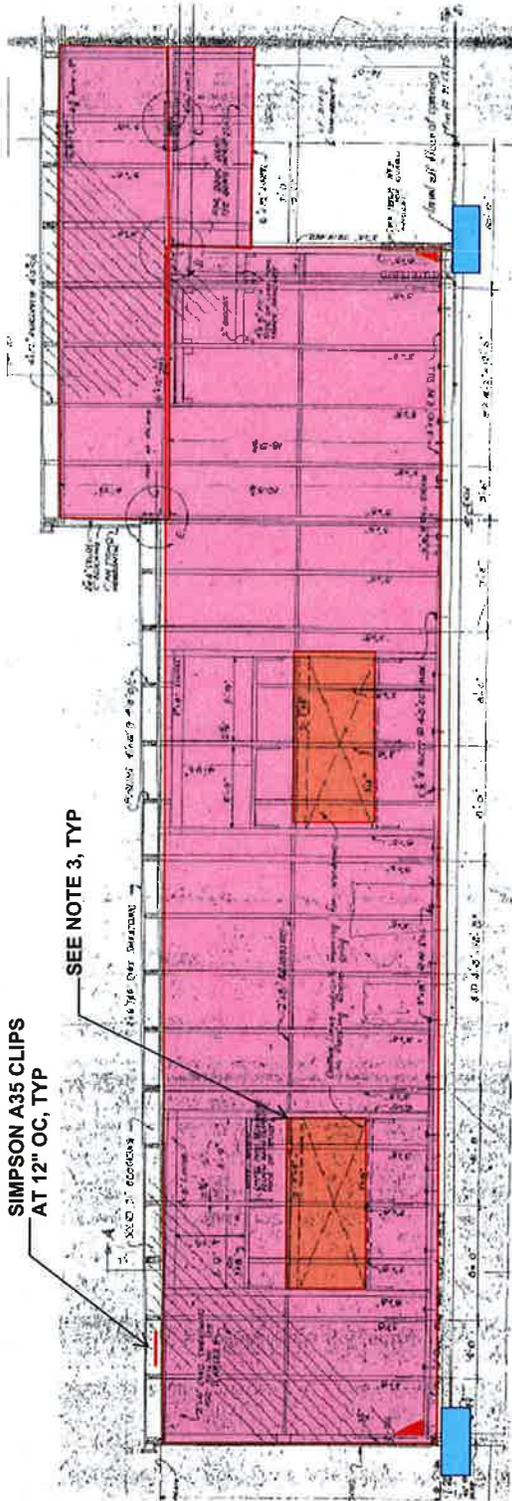
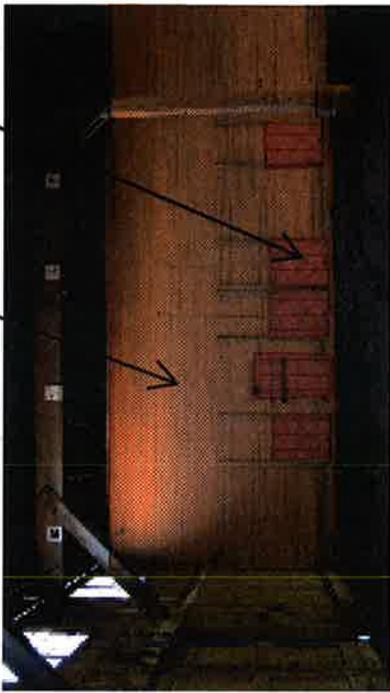
TYPICAL PARTIAL INTERIOR WALL ELEVATION

Shear Walls: The building has significant overstress in both the longitudinal and transverse shear walls. The diagonally sheathed walls were designed for a much lower seismic coefficient when compared to today's standards and the large openings result in high stress in the walls. Water damage to some areas of the existing diagonal sheathing from the leaking roof and walls has also reduced the wall capacity. The soil supporting strip footings under the transverse walls is also overstressed, and additional footing width is required to resist compression loading from the ends of the shear walls.

Additional shear walls are needed at both the exterior walls and interior partition walls in the transverse direction. For these walls to be effective in resisting the seismic demands, additional wall studs will be needed to create a maximum stud spacing of 24". Layers of structural panel sheathing are recommended as shown on the Conceptual Retrofit Details provided in Appendix B to this report. Any damaged diagonal sheathing should also be replaced. Interior shear walls will also need hold down anchors and additional concrete footings at wall ends.
