Landmarks Preservation Advisory Board

STAFF REPORT

Case File Number ER15-004

Project Name and Location:	Oak Knoll Mixed Use Community Plan Project The project is located on the former Oak Knoll Naval Medical Center Property at 8750 Mountain Boulevard and is bounded by Keller Avenue and Mountain Boulevard. APNs: 043A-4675-003-21, 043A-4712-001 (portion), 043A-4675-003-19, 043A-4675-003-16, 043A4678-003-17 {roadway easement}, 043A-4675-003- 30 (roadway easement) 048-6865-002-01, and 043A-4675-74-01.
Proposal:	Conduct an informational briefing on the current status of the Project and its updated proposal to salvage and relocate the historic Club Knoll building as a community center for the Project, rather than demolition of the building as had been previously proposed.
Applicant:	Oak Knoll Venture Acquisitions, LLC (previously SunCal Oak Knoll, LLC), c/o Sam Veltri
Phone Number:	Sam Veltri, at (949)705-8786
Owners:	Oak Knoll Venture Acquisitions, LLC and the City of Oakland

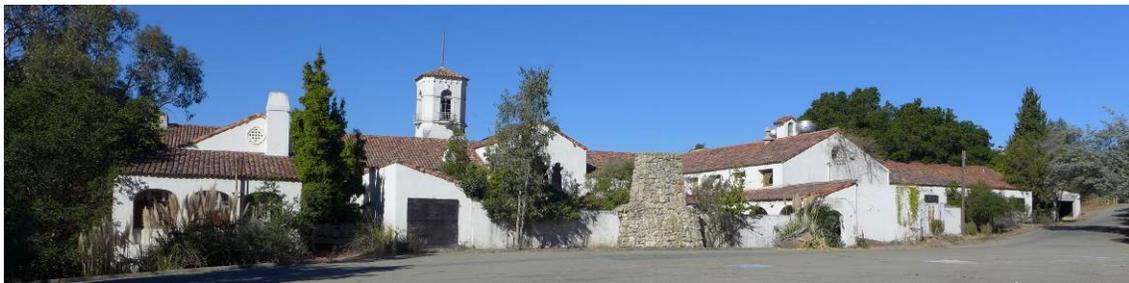
Figure 1. East elevation, 2013. Refer to Photograph Key in the Appendix for photograph locations.

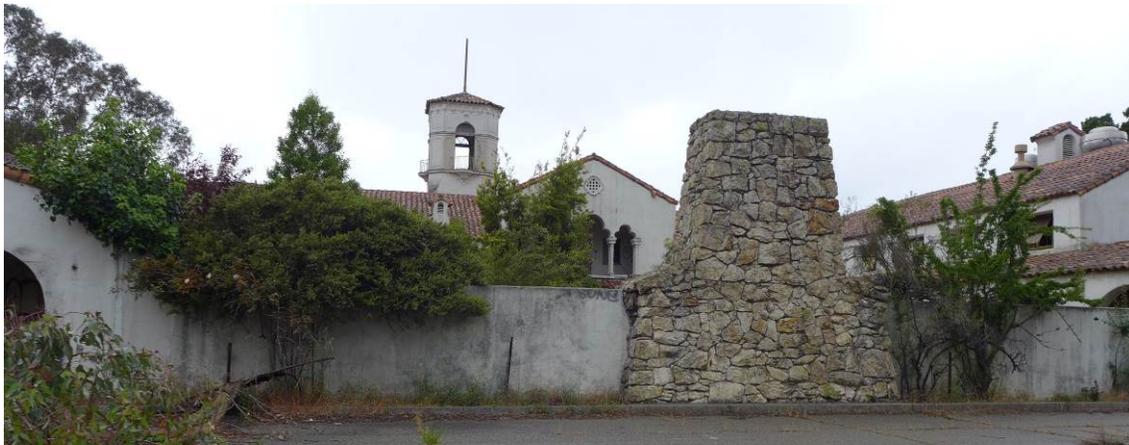
Figure 2. East elevation, 2015.

The east elevation features a stucco clad wall which encloses the courtyard. The large rock chimney is centrally located along the wall. Across from the chimney, in the courtyard, is the main entrance to the building. A cross gable projection marks this entrance. A bell tower raises above the main roofline several stories accentuating the entry. Paneled wood doors, topped by a single glass lite and an intricate metal grille, identify the entrance. Directly above the main entrance, on the second level is a balcony which is accessed by a paneled wood door. A trilobe detail tops the arches at the balcony. Balcony columns have elaborate plaster detailing, as does the bell tower. Below the gable ridge is a decorative vent. Windows along the arcade vary and are either multi-lite metal casement or multi-lite wood casement. Second story windows are metal multi-lite awning. Arched topped multi-lite wood windows are also visible on the east elevation. A variety of doors can also be found along the arcade – wood paneled doors with arched tops, three paneled glass lite doors with transoms and simple wood paneled doors. The north wing features similar door and window types. A stucco wall with an arched opening creates a small courtyard off the east elevation of the north wing. The vents at the gable ends on this elevation have plaster detailing or lack plaster detailing but are adorned with a metal grille. All window and door openings are recessed deep into thick walls. Viewed from the east the building appears to be two stories as it was built into the hillside.

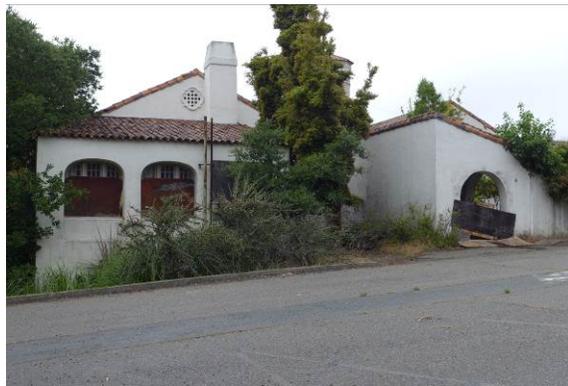
Figure 4: Gable end of at southern corner, 2015.

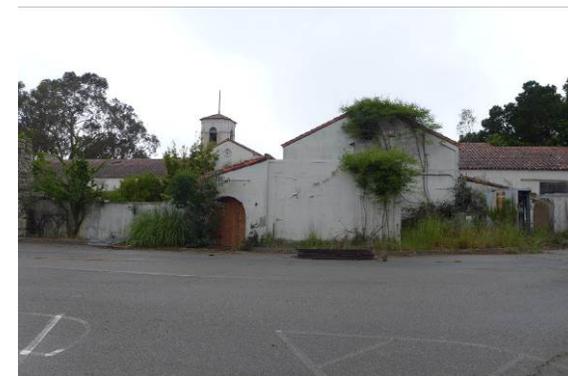
Figure 6: Gable end at kitchen, 2015.

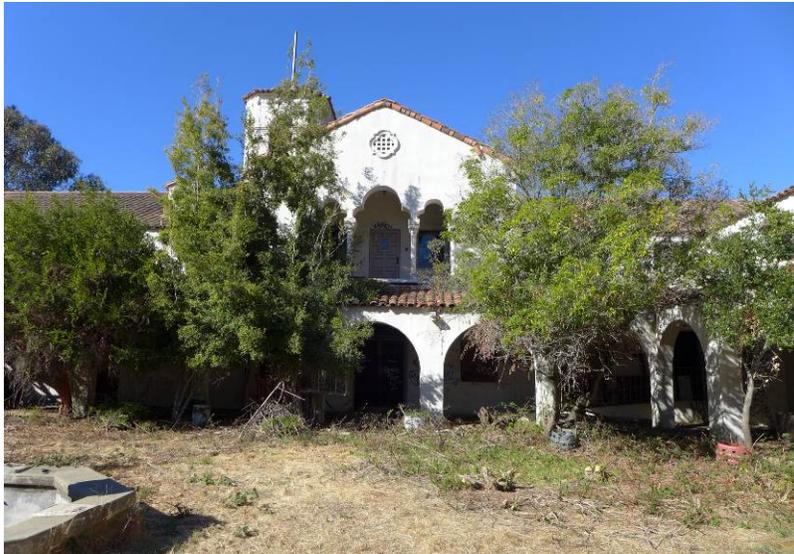
Figure 7: Cross gable projection at entry, 2013.

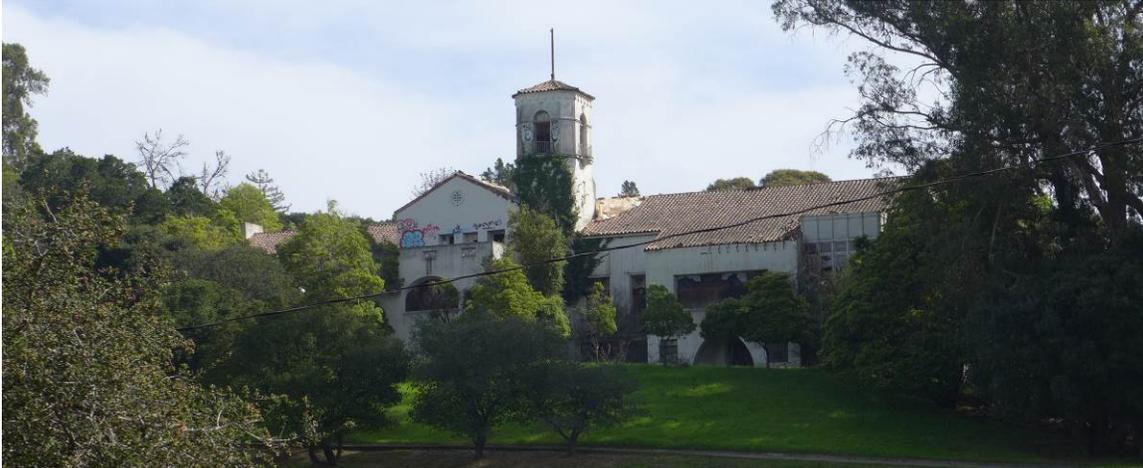
The west elevation is three-stories in height with the ground level of the building accessible from this side. This elevation once fronted the golf course and golfers could retire into the clubhouse through an arched entrance on the ground level toward the southern end of the structure, or enter via a staircase to the main level at the center of the building. South of the three-story cross gable portion of the building is the bell tower which has intricate plaster detailing and metal railings at the openings. At the cross gable section of the building on the second floor is a balcony which features a stucco wall with decorative vents. The dominant window type on the main floor is multi-lite arch topped wood casement. A variety of windows can be found on the other sections of this elevation. At the southwestern corner of the building is a flat roof projection which has large fixed windows with upper transoms. Plaster detailing surrounds these windows. Metal rain gutter brackets remain on this elevation.

Figure 11. West elevation viewed from former golf course, 2016.

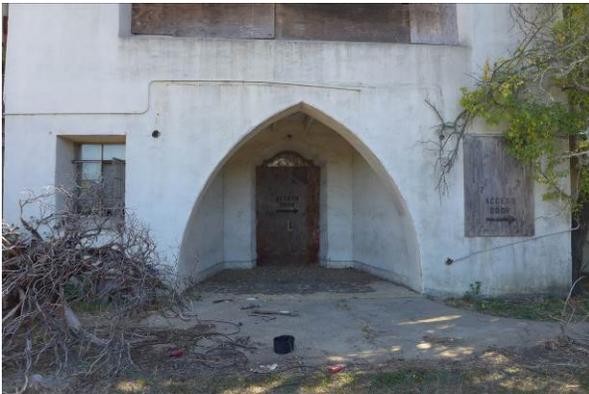
Figure 12: Ground floor entry, 2013.

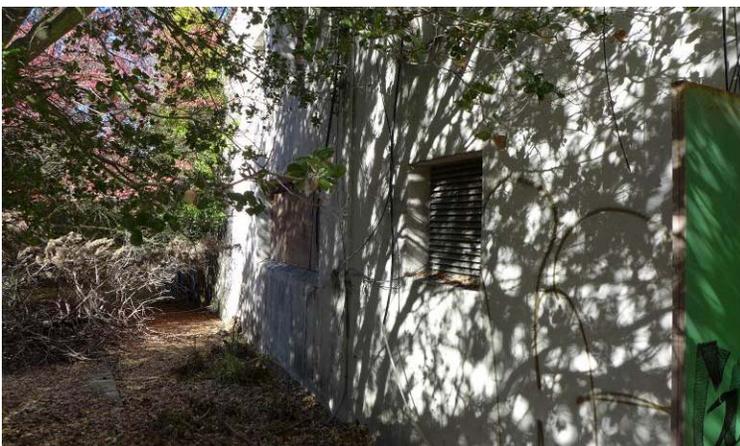
The south elevation is three-stories in height with the ground level accessible from this elevation. Along the ground level are metal vents, a metal door and metal multi-lite windows. The main floor once again features the typical varieties of wood and metal multi-lite windows. On the main portion of the building, a stucco clad chimney is centered on the two-story gable end. Accessed by paneled wood doors are two small wrought-iron balconies, which flank the large chimney.

Figure 15: Metal vents at ground level, 2013.

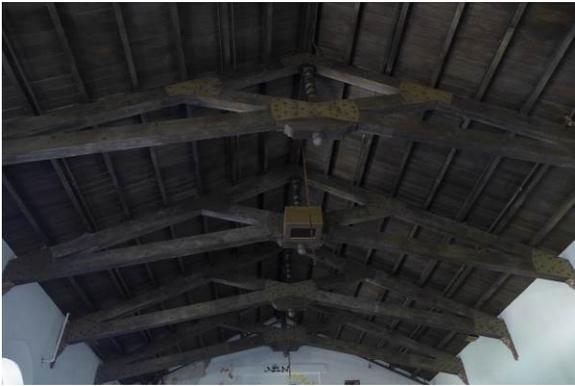
Figure 32: Scissor trusses, 2013.

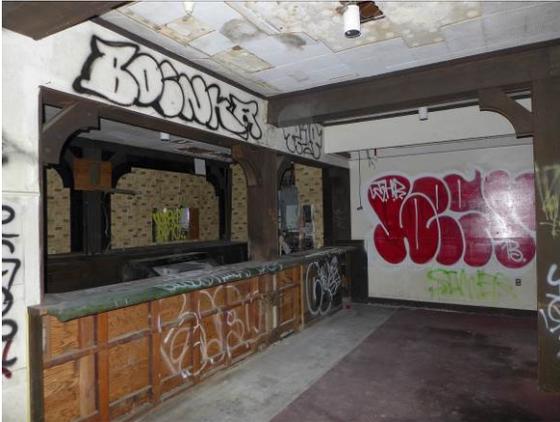
Figure 37: Basement bar, 2016.

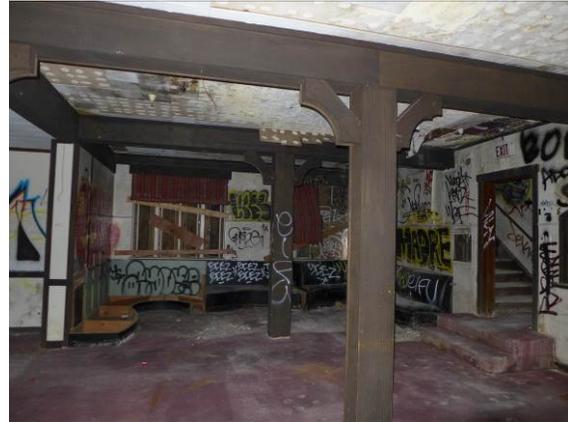
Figure 38: Basement – column and beam detail, 2016.

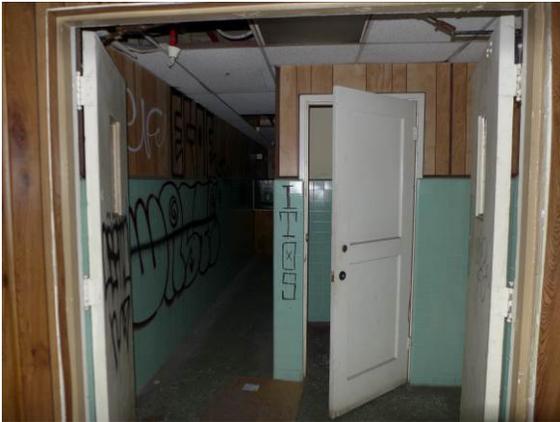
Figures 39, 40 and 41: Restroom with panel door (left), wood cabinet (middle) and door and transom (right), 2016.

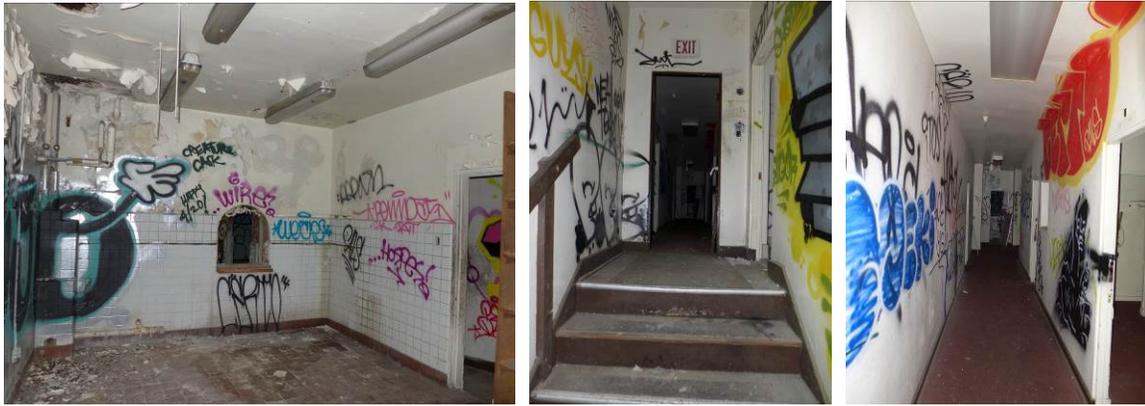
Projecting off the north elevation, the “third wing” is accessed via the kitchen. A long hallway, with a ramp and a small set of stairs, accesses the numerous small rooms of this wing. Several private bathrooms and shared restrooms are located in this wing. These rooms feature original floor tile, built-in medicine cabinets and older plumbing fixtures. Some original panel doors remain in this wing, although most of the hardware has been removed. A larger room, adjacent to the main kitchen, functioned as a secondary kitchen. Carpet and 9x9 tiles cover the floor of this wing. Simple wood trim adorns the base of the walls. The configuration of the “third wing” likely dates to the time of construction but, as in the basement, many of the finishes have been lost due to improvements completed by the Navy.

Figures 42, 43 and 44: Secondary kitchen area in the “third wing” (left), stair in hall of “third wing” (middle) and hall of “third wing”, 2016.

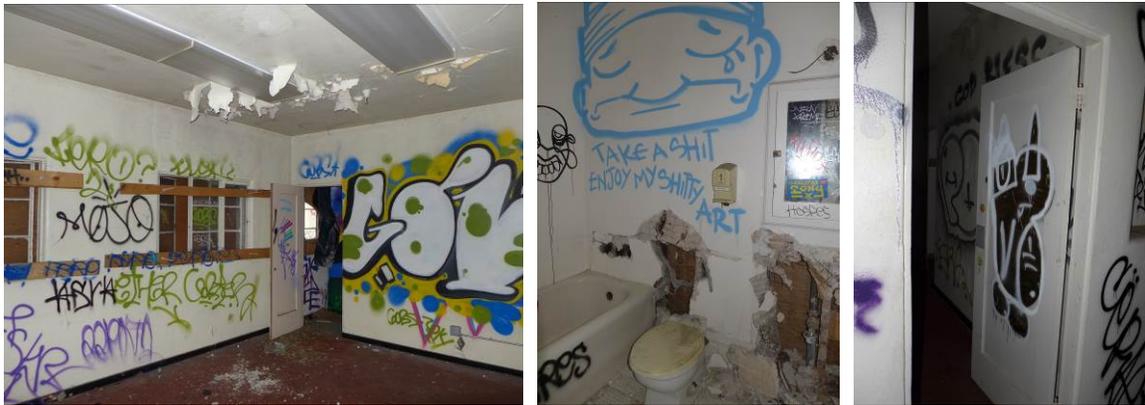
Figures 45, 46 and 47: Typical room in “third wing” (left), typical restroom in “third wing” (middle) and panel door “third wing” (right), 2016.

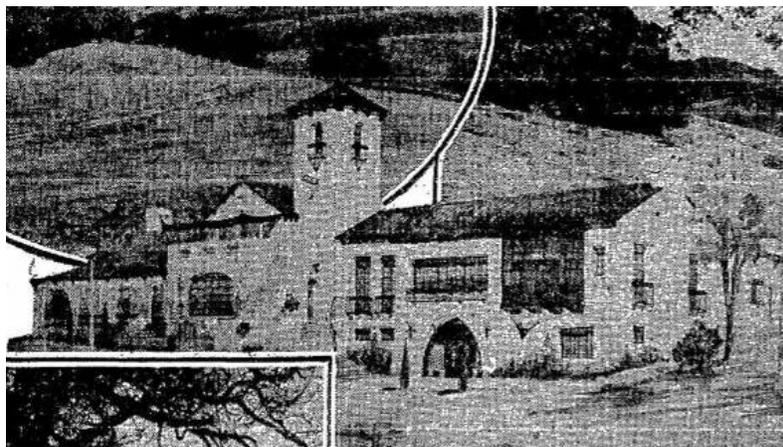
Figure 48: Rendering of proposed clubhouse in 1926 *Oakland Tribune* article.¹⁵

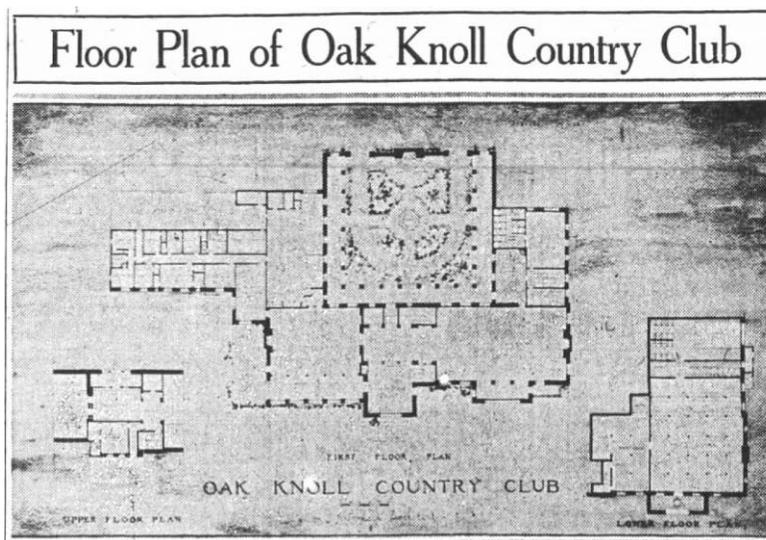
Figure 51: Floor plan of the Oak Knoll Country Club.⁶¹

The basement and “third wing” spaces are original to the building and formerly housed ancillary functions of the structure. The basement provided a locker room and lounge area for the men and the “third wing” provided private areas for club members according to plans in a newspaper article.⁵⁹ The basement lacks the original configuration and many of the original finishes were removed as part of remodels during the Navy's occupation. However, direct access to the exterior, where the golf course once was located, remains. This direct link to the former course area was important as club members accessed the links from the basement level of the clubhouse. The basement has been extensively modified and the importance of outdoor access is diminished by the loss of the golf course. However, the basement space would be considered *contributing* to the building as a whole.

While the “third wing” lacks the ornamentation and detailing found in the more public spaces, alterations to the arrangement of the rooms appear minimal and much of the historic fabric (wood baseboard and plaster walls) remains intact. Therefore, the “third wing” would be considered *contributing* to the building as a whole.

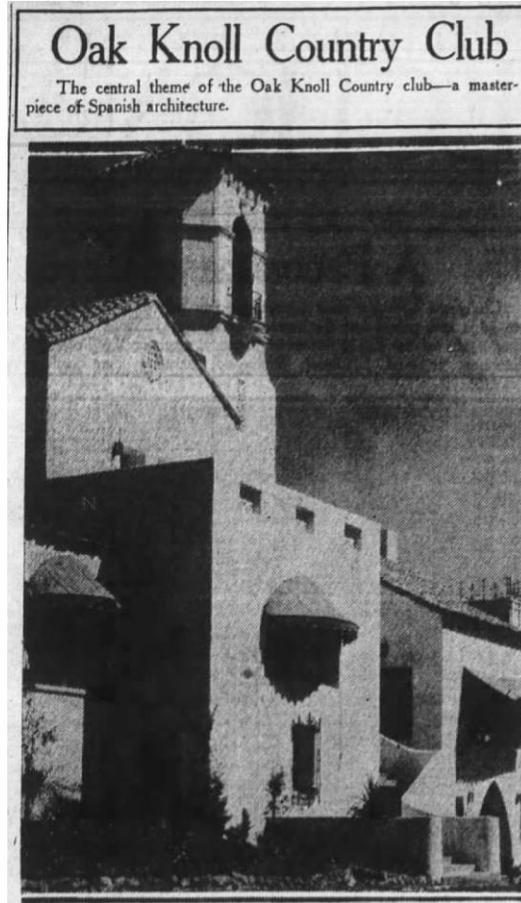
Figure 52: Entry from the golf course to the main level, via stairs.⁶⁴

Setting. Setting is the physical environment of the property and concerns the relationship between the building and its surroundings. Since the building is situated on a knoll, actually built into the hillside, it is important for the site of the building’s relocation to echo this aspect of its setting. The building currently sits among groups of eucalyptus and oak trees. A parking area extends behind the clubhouse to the east off the courtyard side of the building. The golf course and naval hospital setting have been lost. Historically, access to the building occurred either through the open courtyard on the main level or from the golf course through the basement entry facing the greens. People mainly accessed the building from the courtyard side, after they parked their car, so the courtyard side of the structure is the primary entry side of the building. Also, an exterior stair from the golf course accessed a secondary entry on the main level.

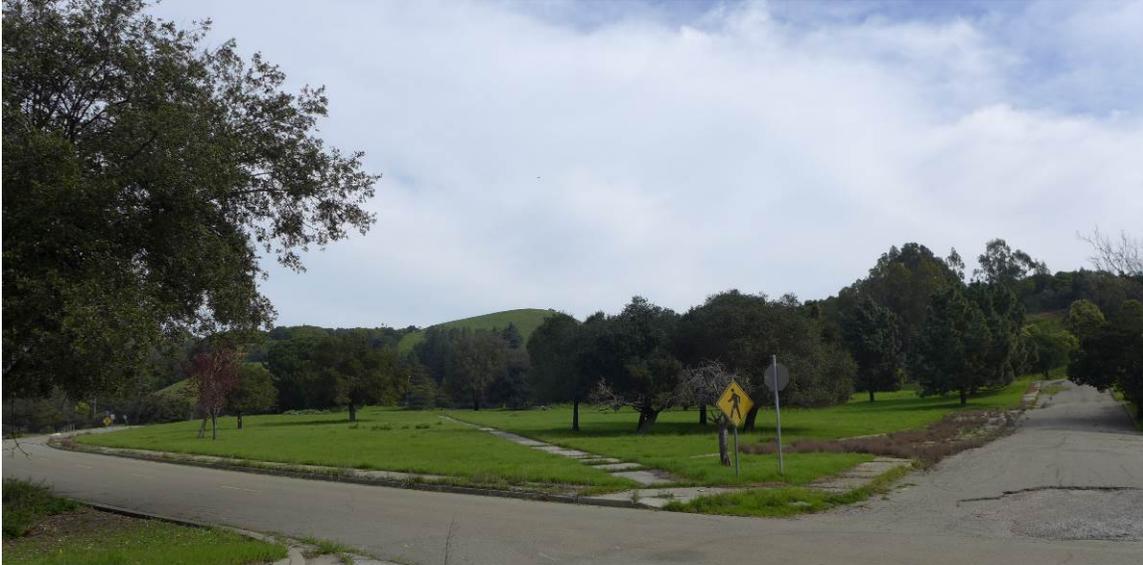
Figure 53: Viewed from entry road, Alexander Street to the right, 2016.

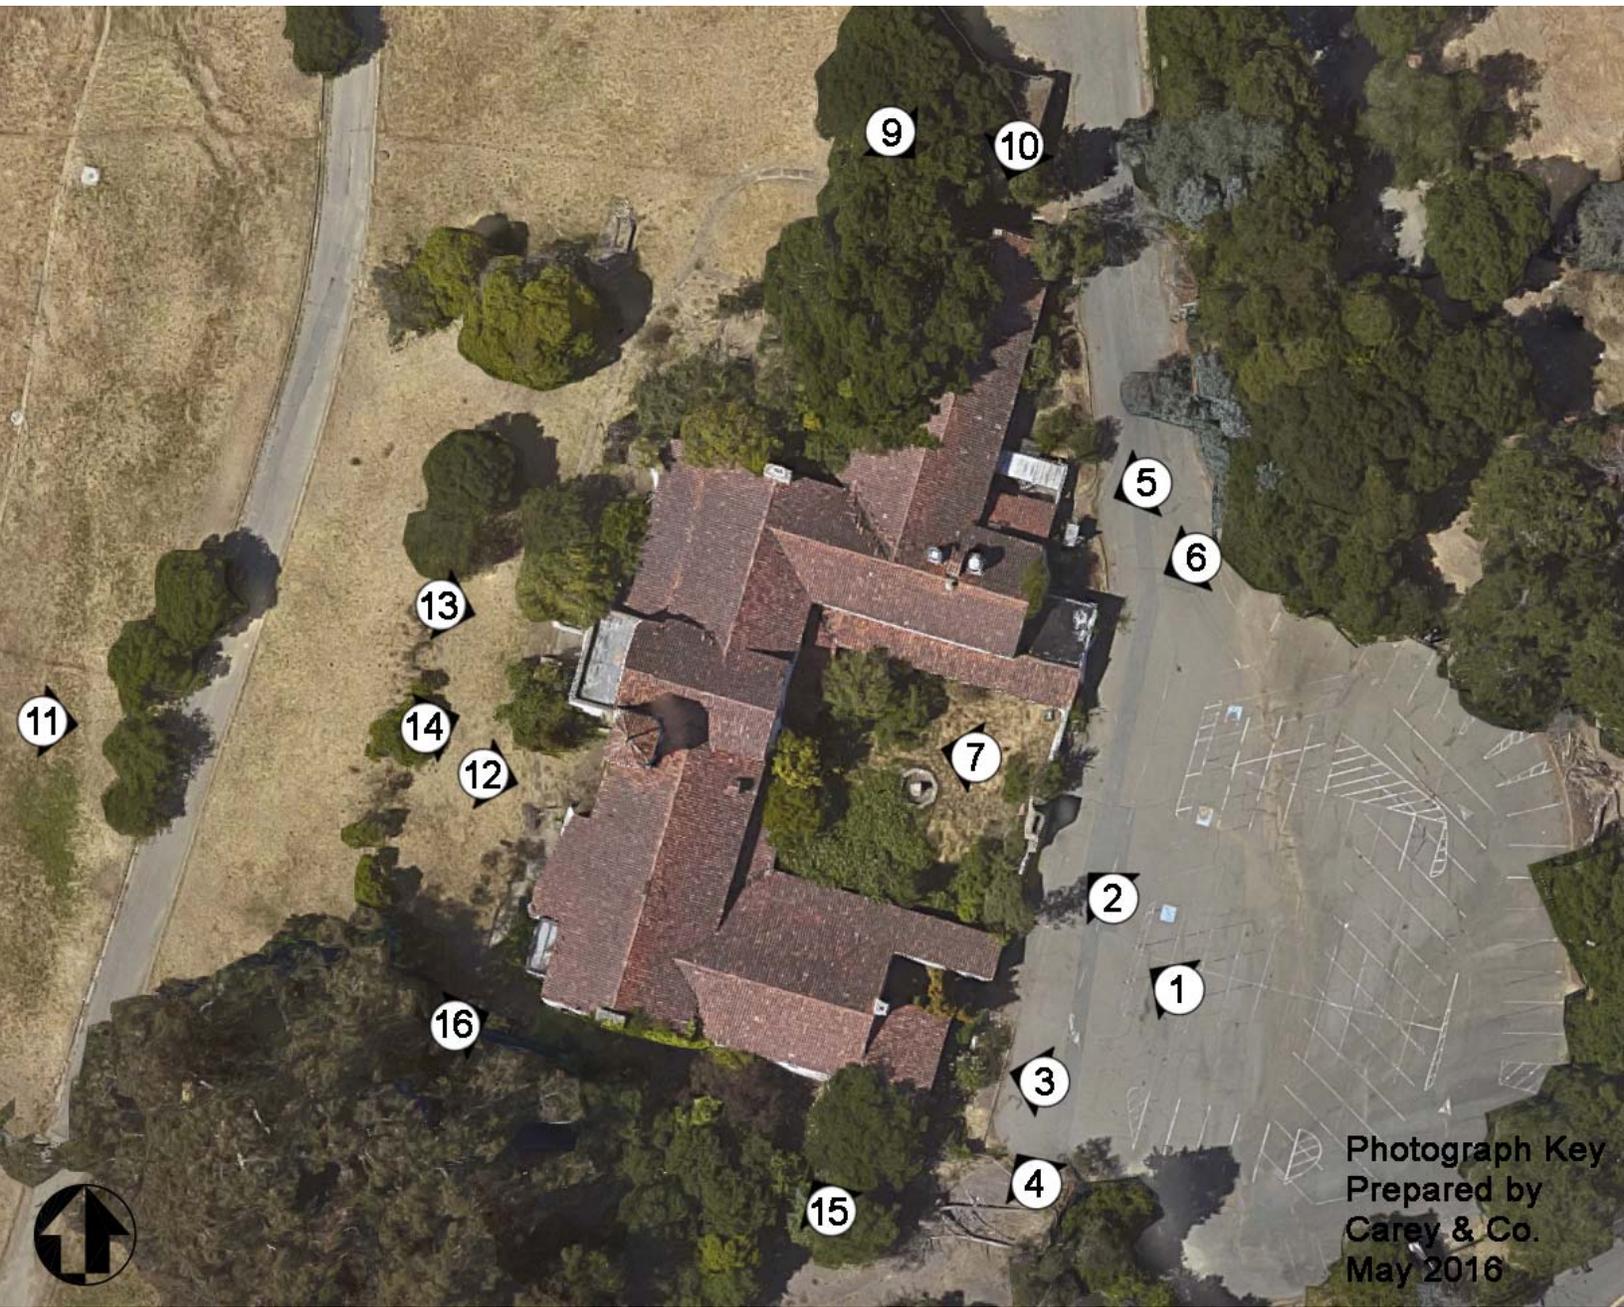
Photograph Key
Prepared by
Carey & Co.
May 2016

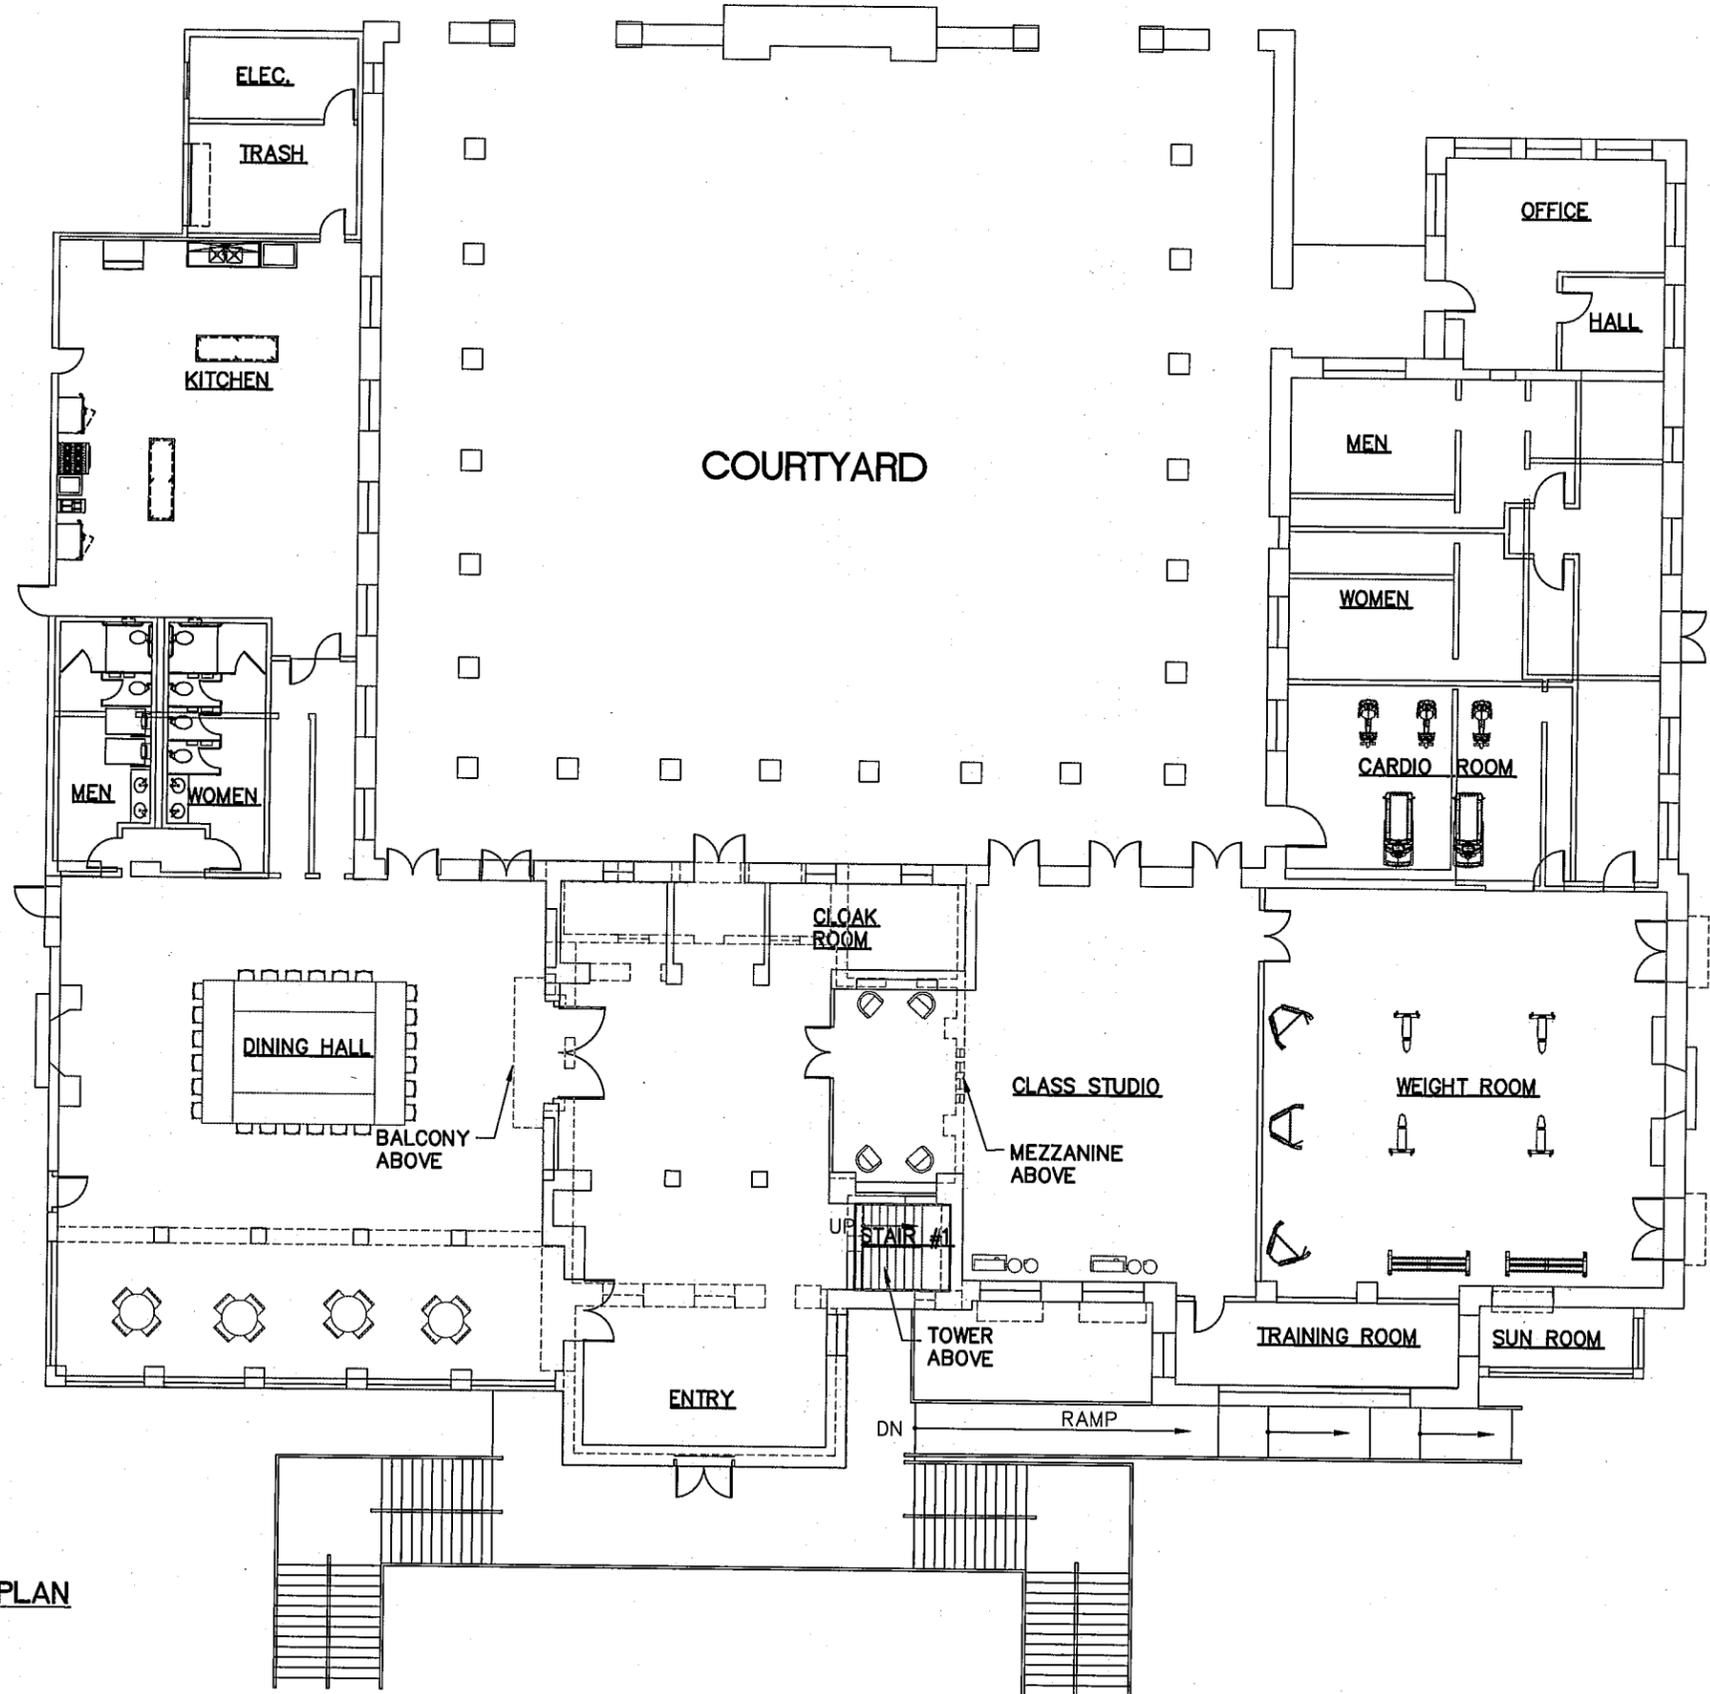
DRAWING NO.
DR-5

FLOOR PLAN
1/8" = 1'-0"

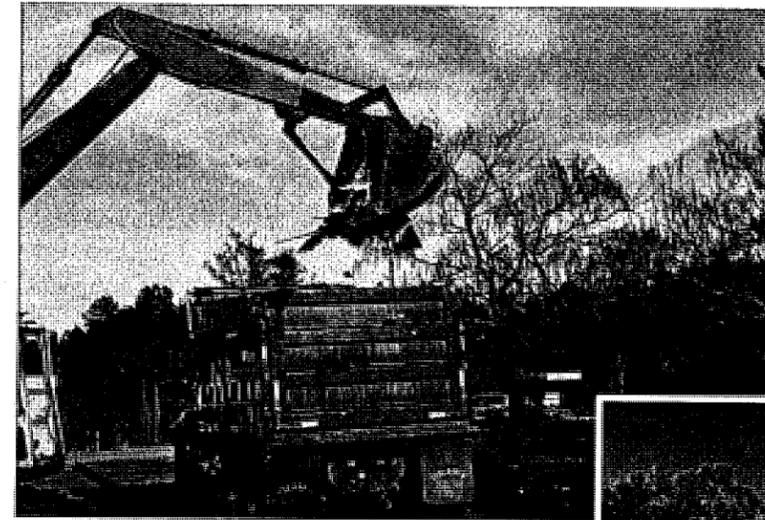
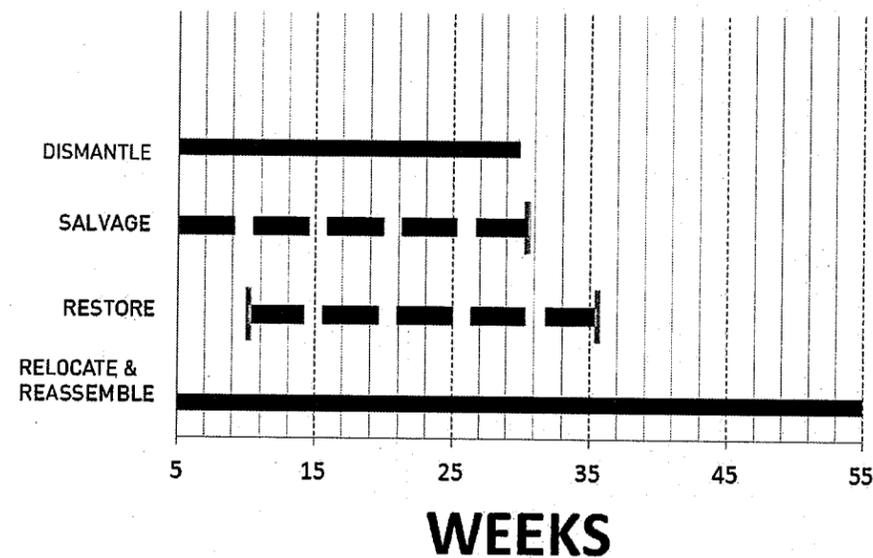
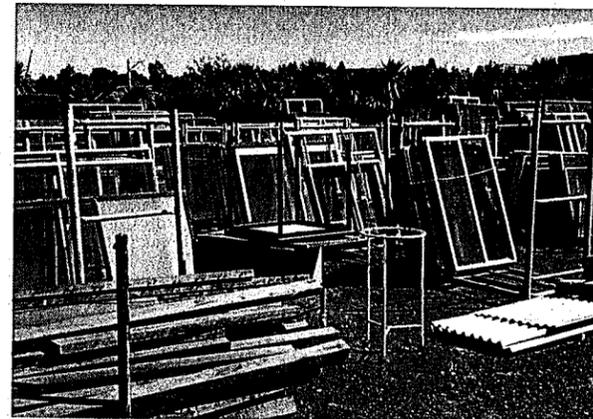
DRAWING NO.
DR-6.1

OLD SITE * DISMANTLE

NEW SITE * RELOCATE & REASSEMBLE

MOBILIZE CONSTRUCTION AND CREATE SALVAGE YARD AT NEW SITE

It is intended that the Project Schedule see the dismantlement of the existing building and reassembly process start concurrently. While the building is being dismantled, and its parts salvaged, the new building site would be prepared to allow immediate transport and reassembly of components without storage thereof. It is important that existing components be moved and reassembled in one effort to avoid storage and the risk of damage to components.

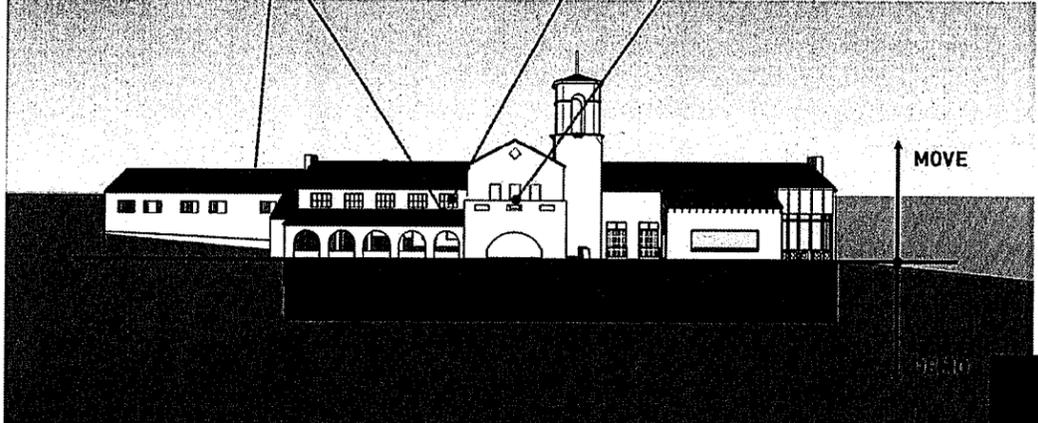
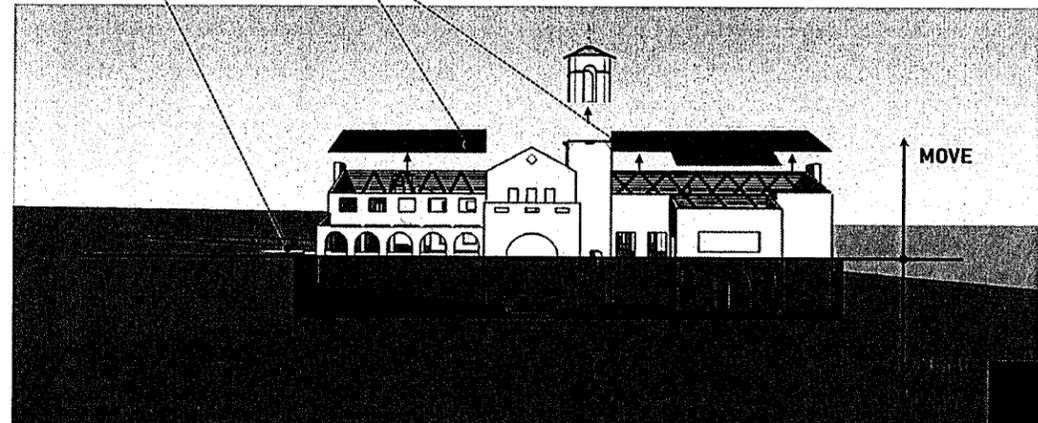
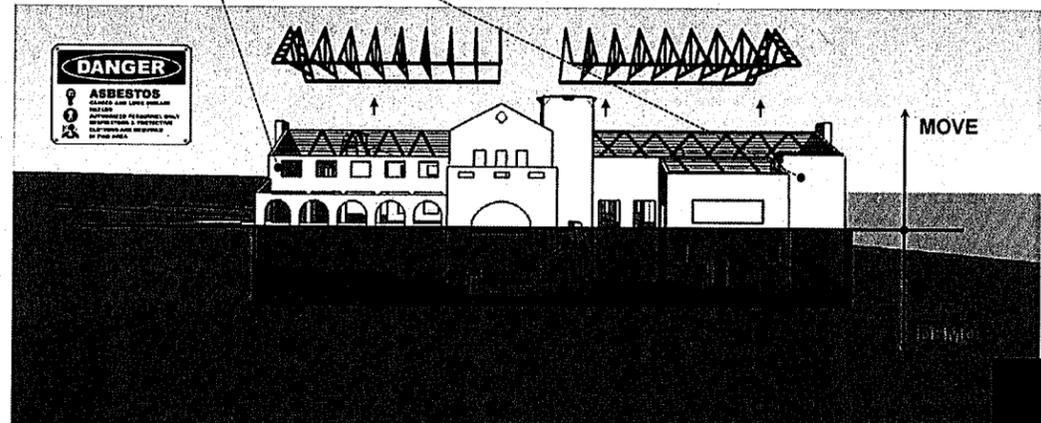
2 SALVAGE ROOF TILE, WINDOWS, AND DOORS

3 DEMO SIDE WING, ROOF SHEATHING REMOVE SALVAGE AND MOVE TOWER

4 DEMO INTERIOR SYSTEMS/SALVAGE PARTS

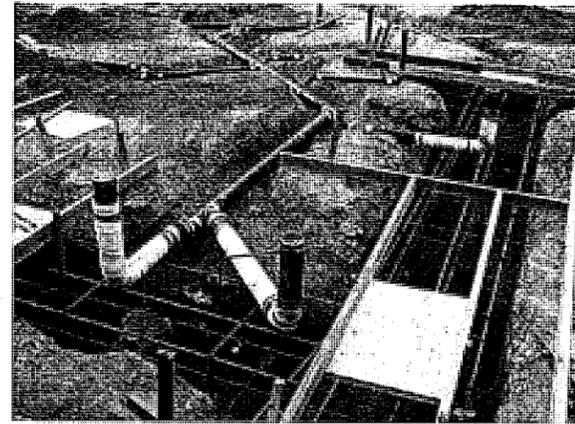
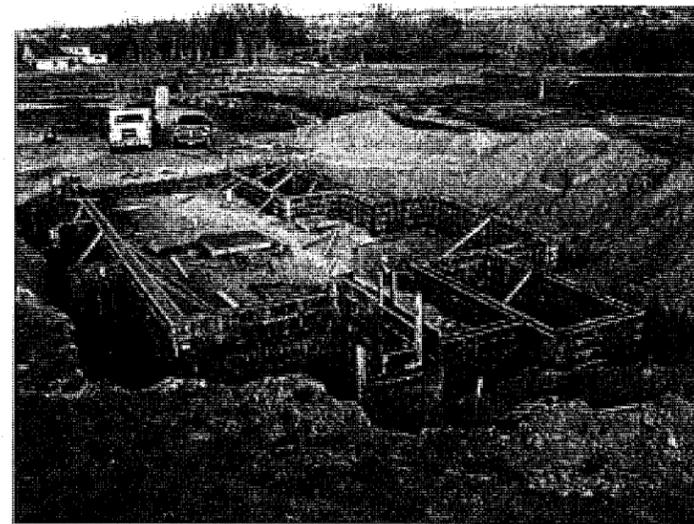
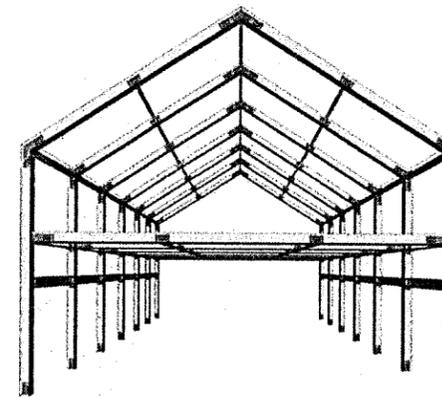
DR-6.3

UNDER-SLAB UTILITIES/ UNDERGROUND UTILITIES

FOUNDATION AND SLAB CONSTRUCTION

BUILD STEEL SKELETON / ASSEMBLE COMPONENTS

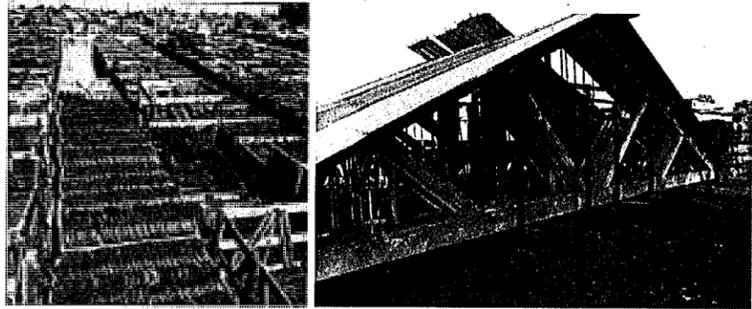
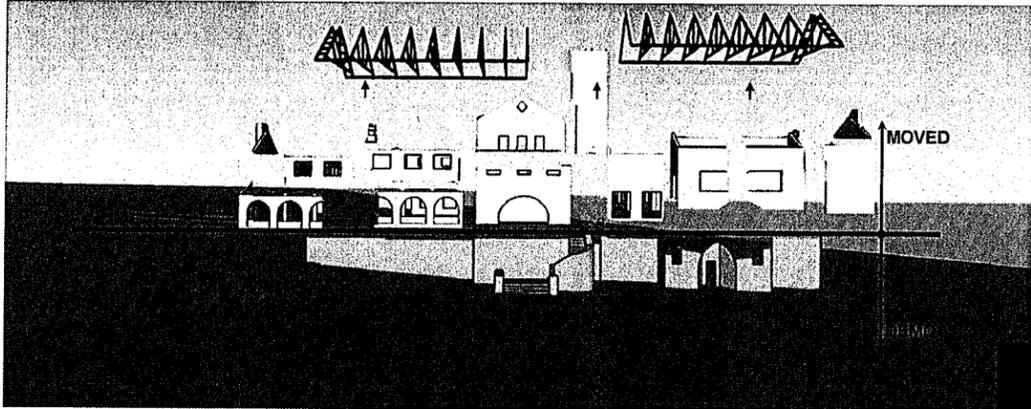
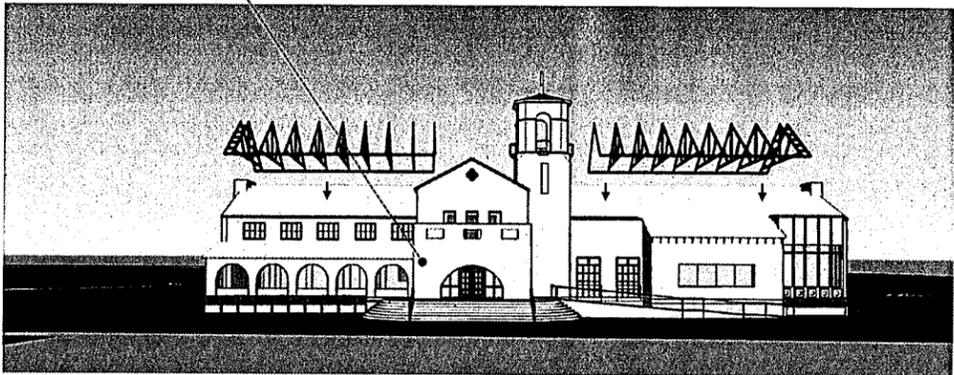
DR-6.4

END
OF
DISMANTLEMENT

6 COMPONENTS DISMANTLED AND MOVED

REASSEMBLY OF WALLS CONTINUES / REINSTALL ROOF TRUSSES

REASSEMBLE SALVAGED COMPONENTS AND PARTS, SUCH AS ROOF TILE, WINDOWS AND DOORS

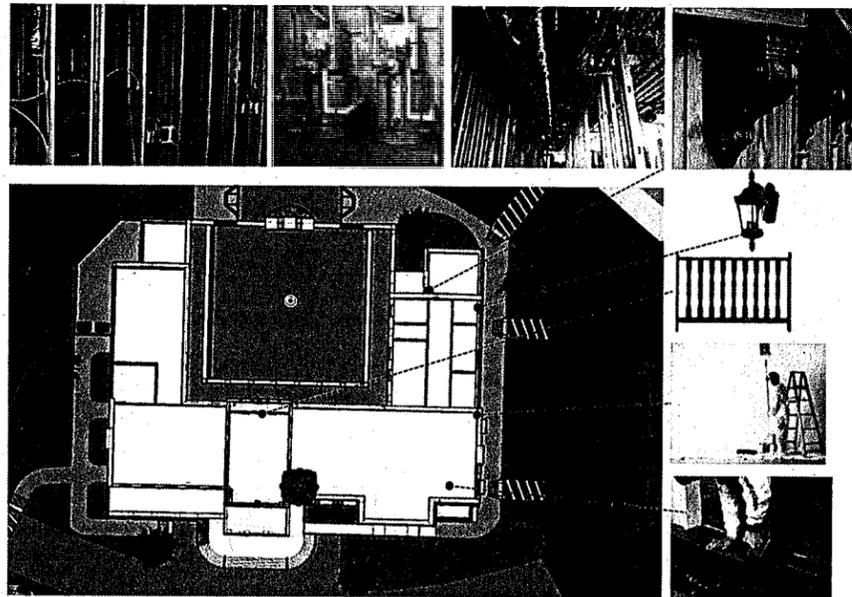
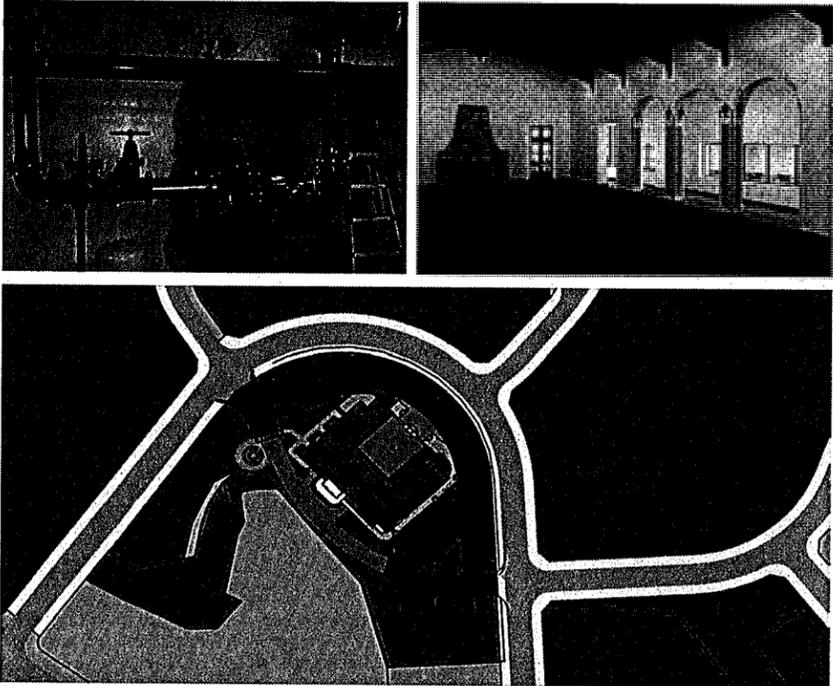
DRAWING NO.
DR-6.5

REINSTALL SALVAGED INTERIOR COMPONENTS / MEP SYSTEMS INSTALLATION

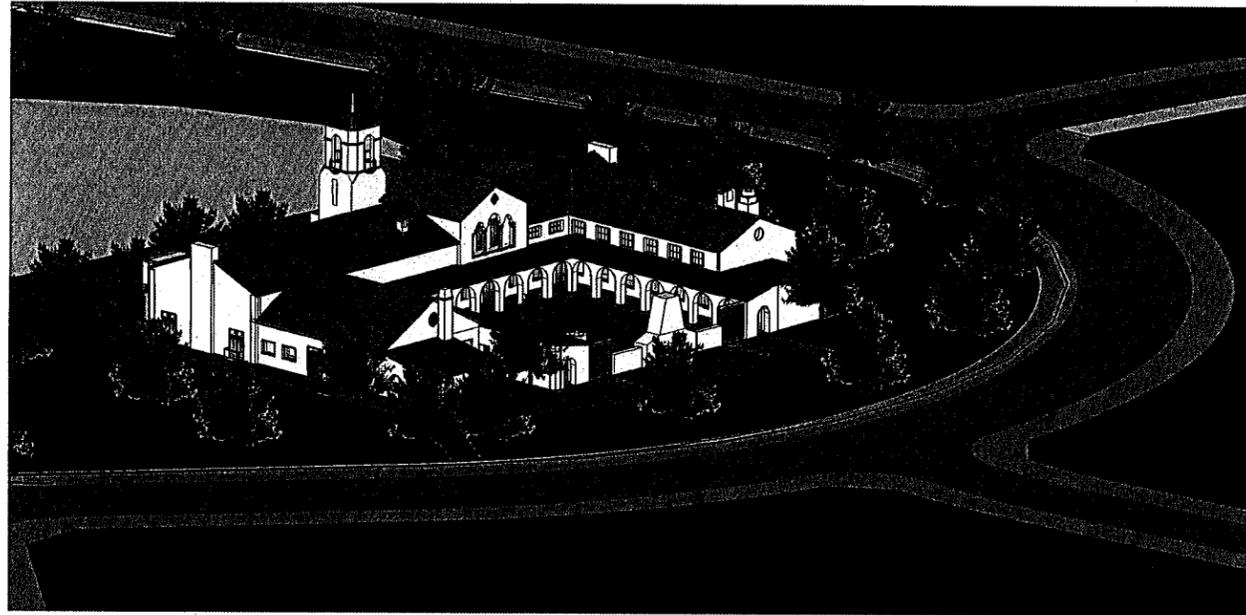
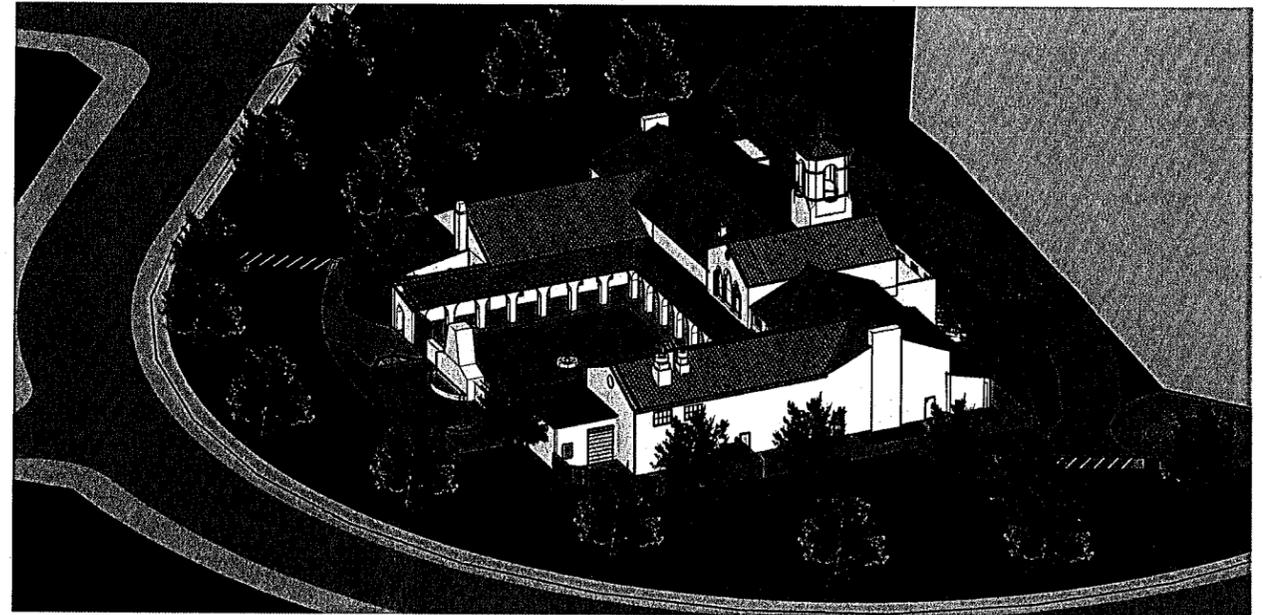
DRAWING NO.
DR-7

LOOKING WEST PERSPECTIVE- NEW SITE

LOOKING SOUTH PERSPECTIVE- NEW SITE
