Landmarks Preservation Advisory Board

STAFF REPORT

Case File Number ER15-004

Project Name and Location:	Oak Knoll Mixed Use Community Plan Project The project is located on the former Oak Knoll Naval Medical Center Property at 8750 Mountain Boulevard and is bounded by Keller Avenue and Mountain Boulevard. APNs: 043A-4675-003-21, 043A-4712-001 (portion), 043A-4675-003-19, 043A-4675-003-16, 043A4678-003-17 {roadway easement}, 043A-4675-003- 30 (roadway easement) 048-6865-002-01, and 043A-4675-74-01.
Proposal:	Conduct an informational briefing on the current status of the Project and its updated proposal to salvage and relocate the historic Club Knoll building as a community center for the Project, rather than demolition of the building as had been previously proposed.
Applicant:	Oak Knoll Venture Acquisitions, LLC (previously SunCal Oak Knoll, LLC), c/o Sam Veltri
Phone Number:	Sam Veltri, at (949)705-8786
Owners:	Oak Knoll Venture Acquisitions, LLC and the City of Oakland

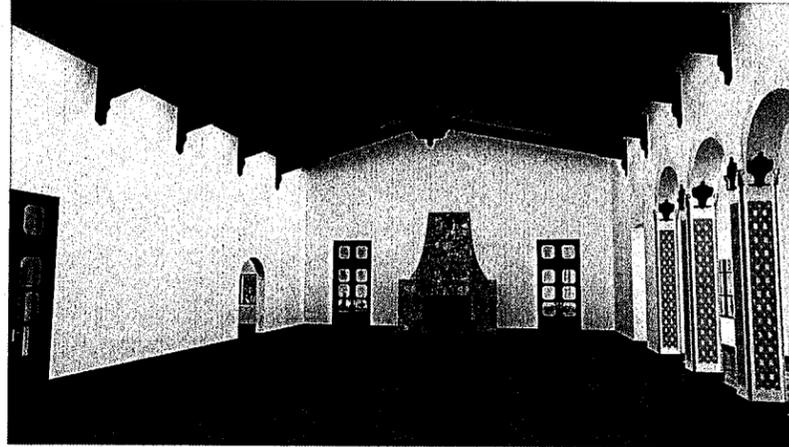
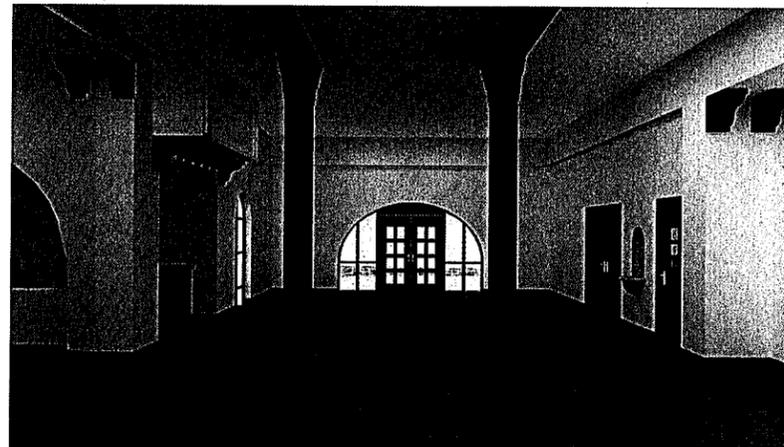
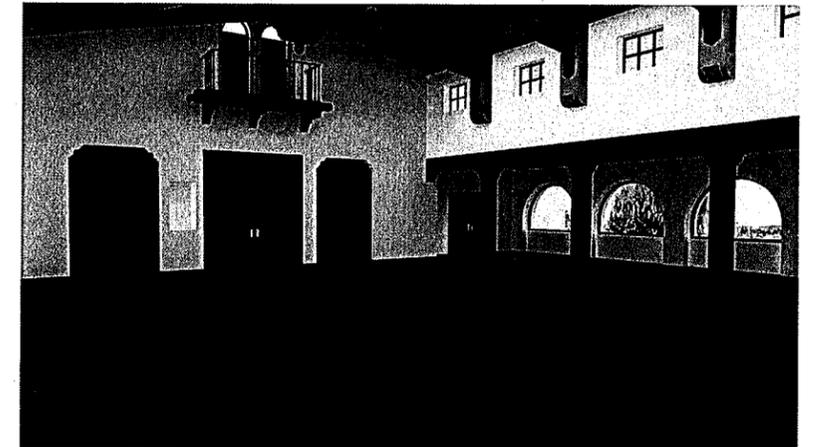
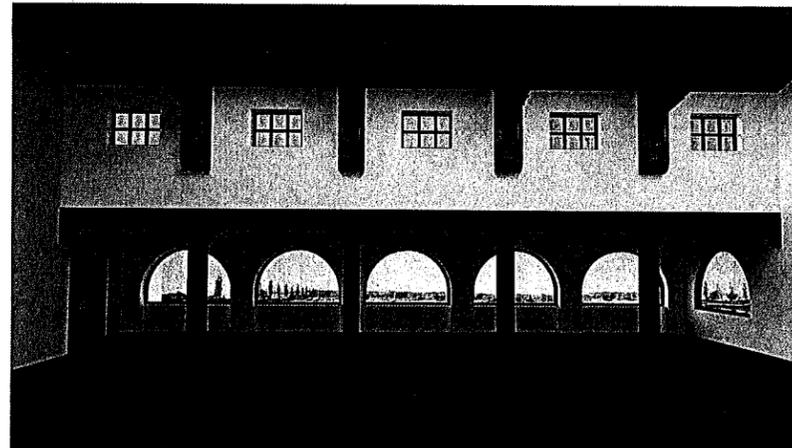
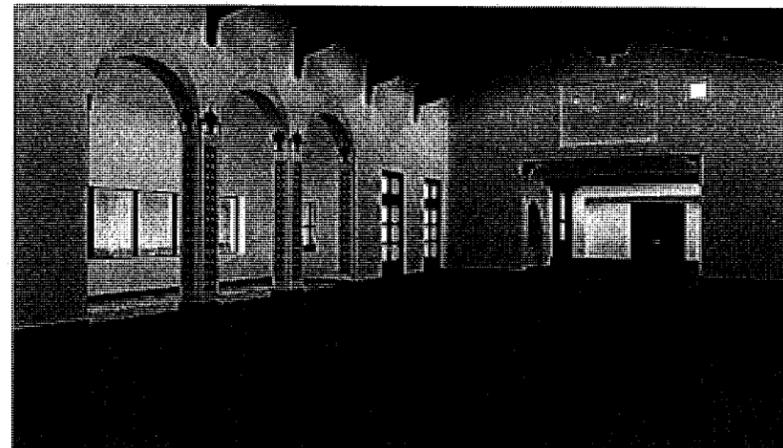
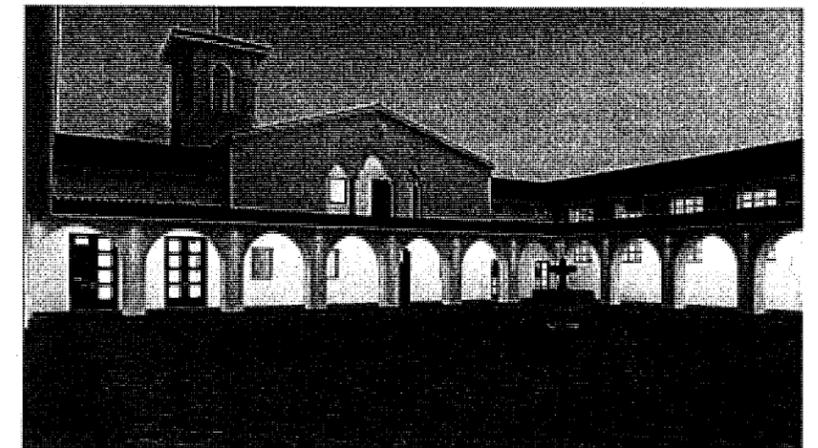
NOTE:
 INTERIOR VIEWS REFLECT UNDERSTANDING OF
 ORIGINAL DESIGN, NOT FUTURE BUILDING USE.

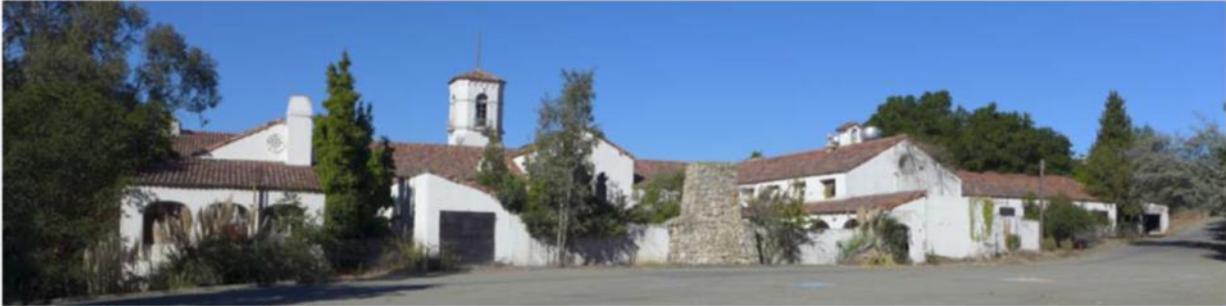
Figure 1. East elevation, 2013.

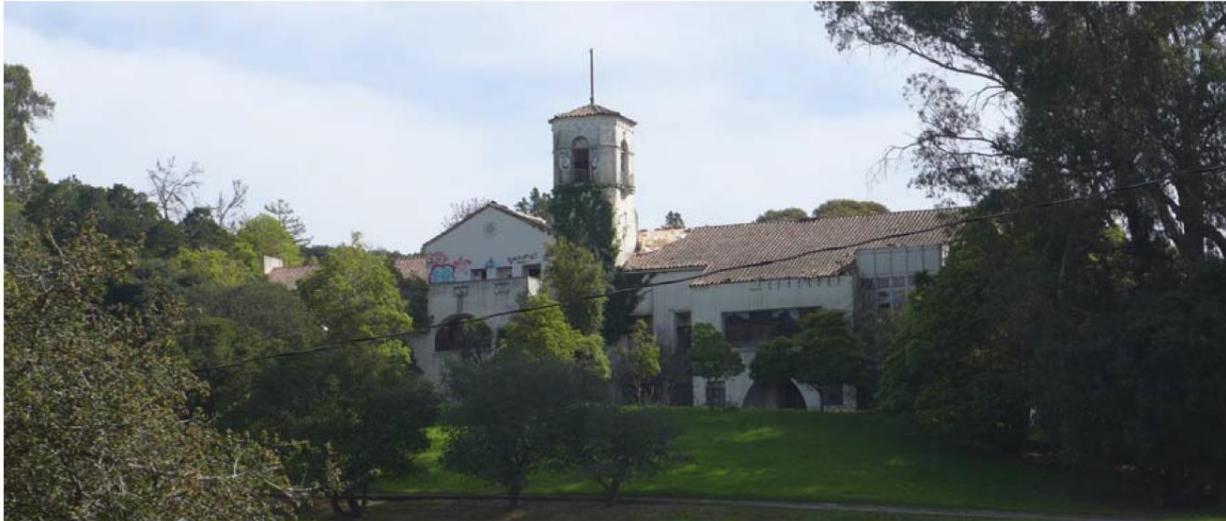
Figure 2. West elevation viewed from former golf course, 2016.

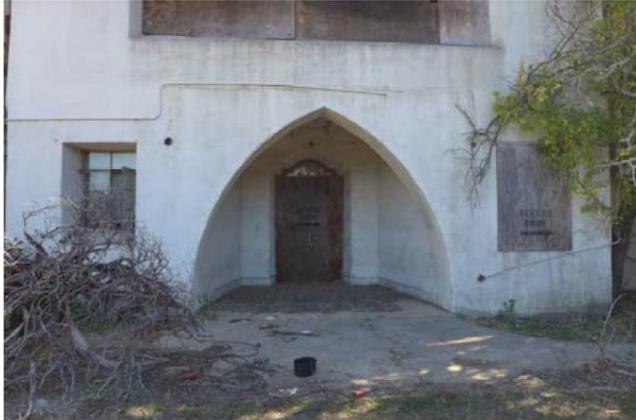
Figure 3: Ground floor entry, 2013.

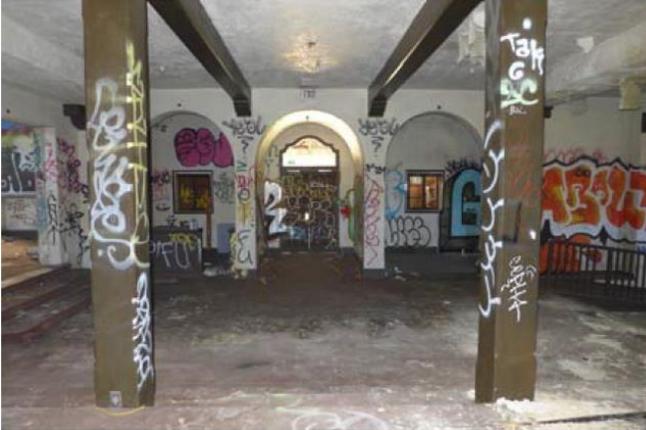
Figure 6: Looking toward entry door from lobby, 2013.

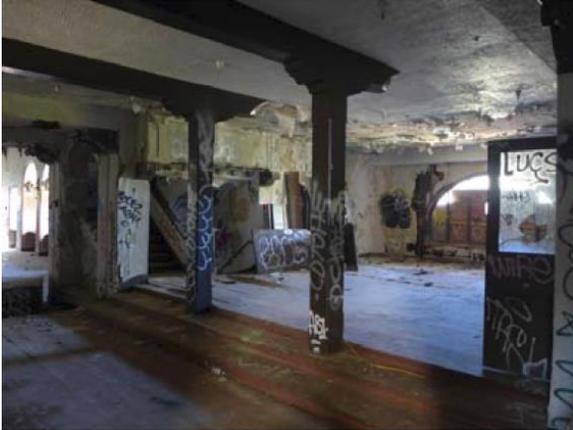
Figure 7: Post and beams, 2013.

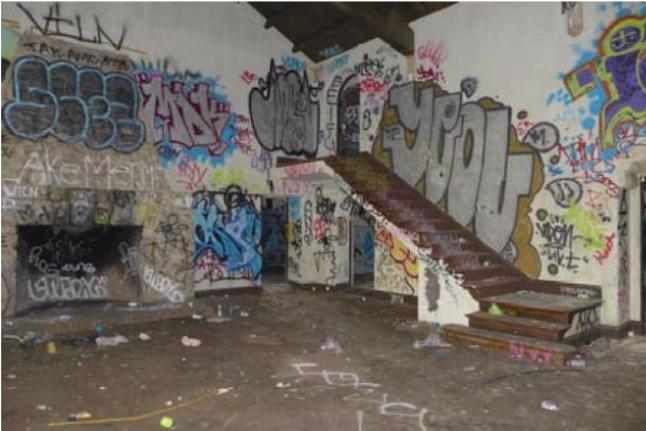
Figure 8: Fireplace and stairway in dining room, 2013.

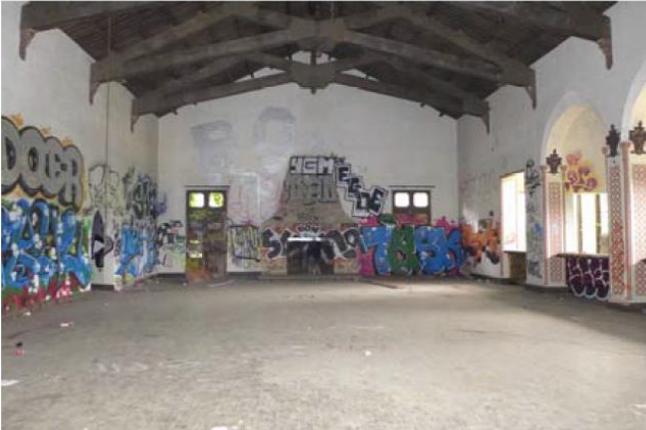
Figure 10: Fireplace centered on end wall in lounge, 2015.

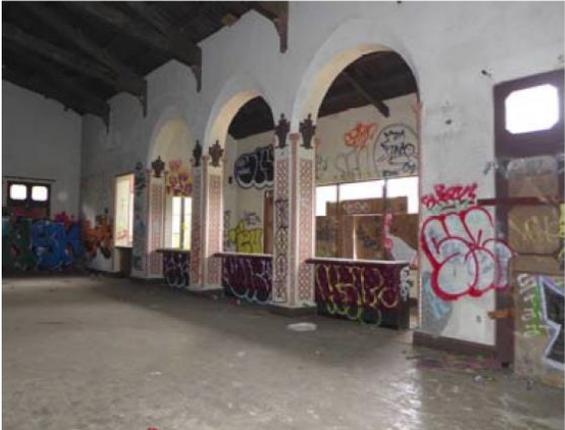
Figure 11: Arches in lounge, 2015.

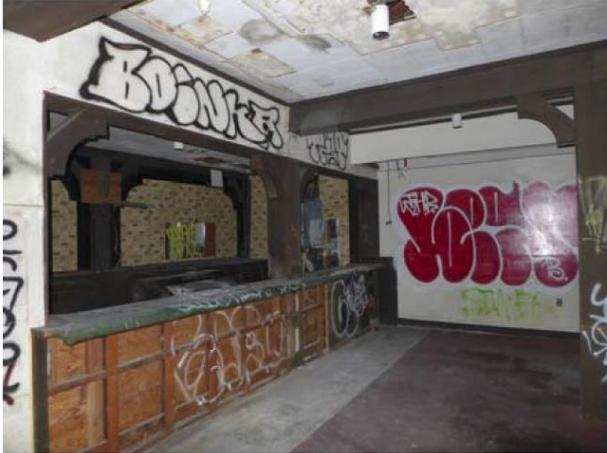
Figure 12: Basement bar, 2016.

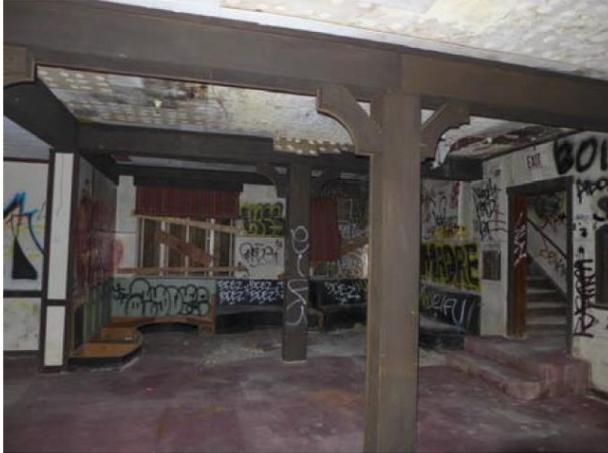
Figure 13: Basement – column and beam detail, 2016.

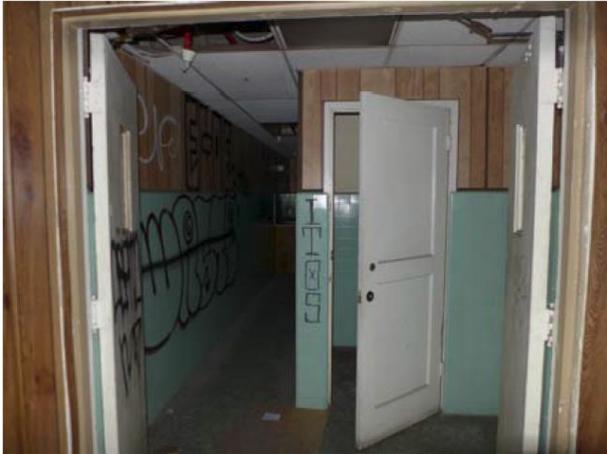
Figures 14, 15 and 16: Restroom with panel door (left), wood cabinet (middle) and door and transom (right), 2016.

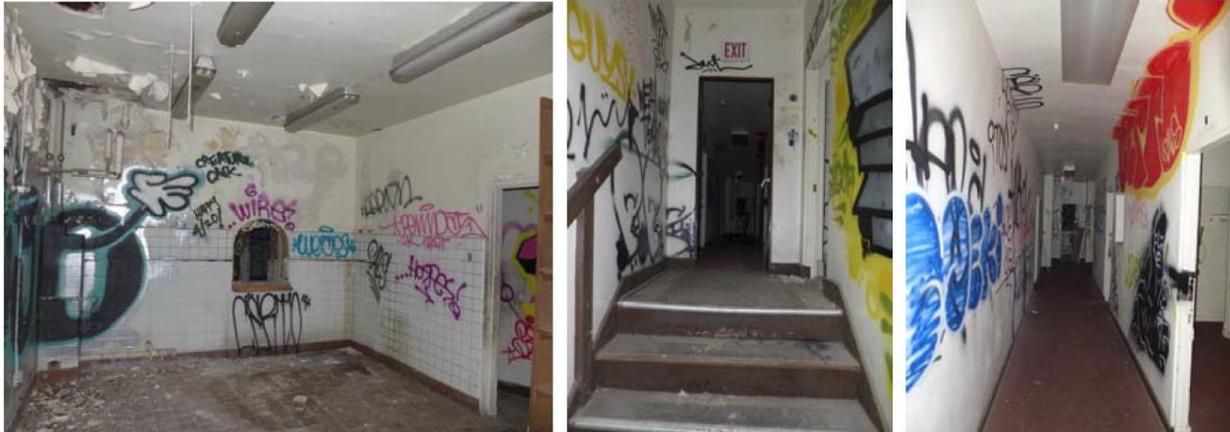
Figures 17, 18 and 19: Secondary kitchen area in the “third wing” (left), stair in hall of “third wing” (middle) and hall of “third wing”, 2016.

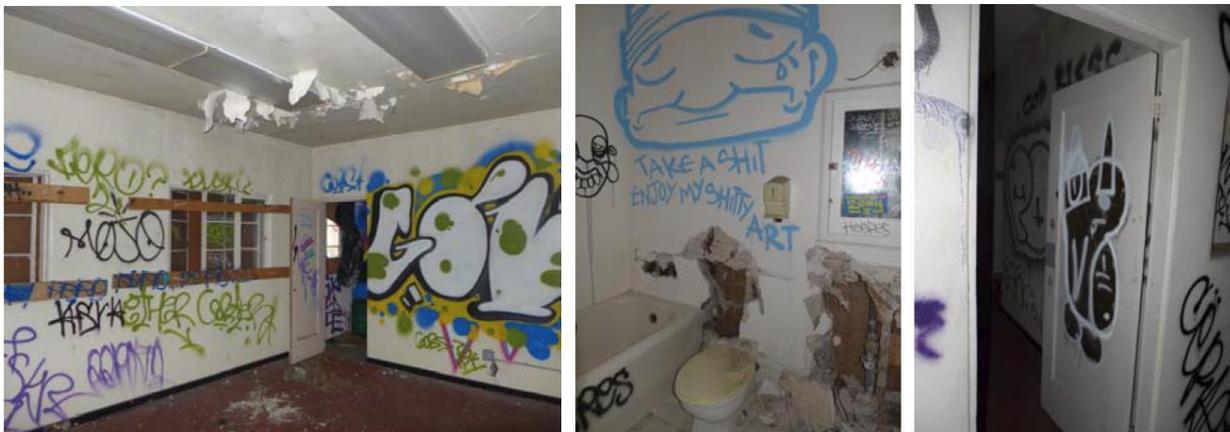
Figures 20, 21 and 22: Typical room in “third wing” (left), typical restroom in “third wing” (middle) and panel door “third wing” (right), 2016.

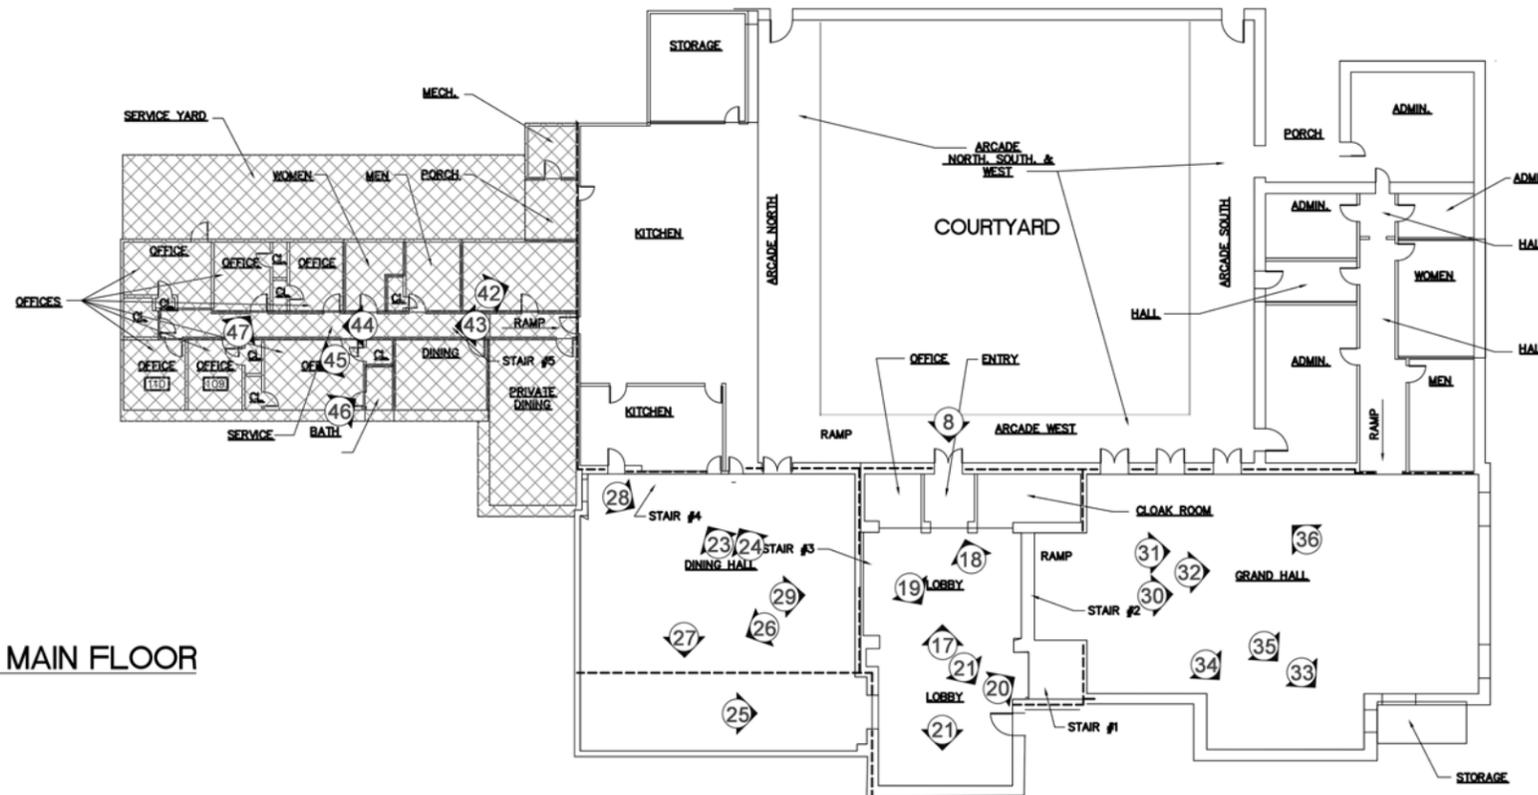
FLOOR PLAN- MAIN FLOOR

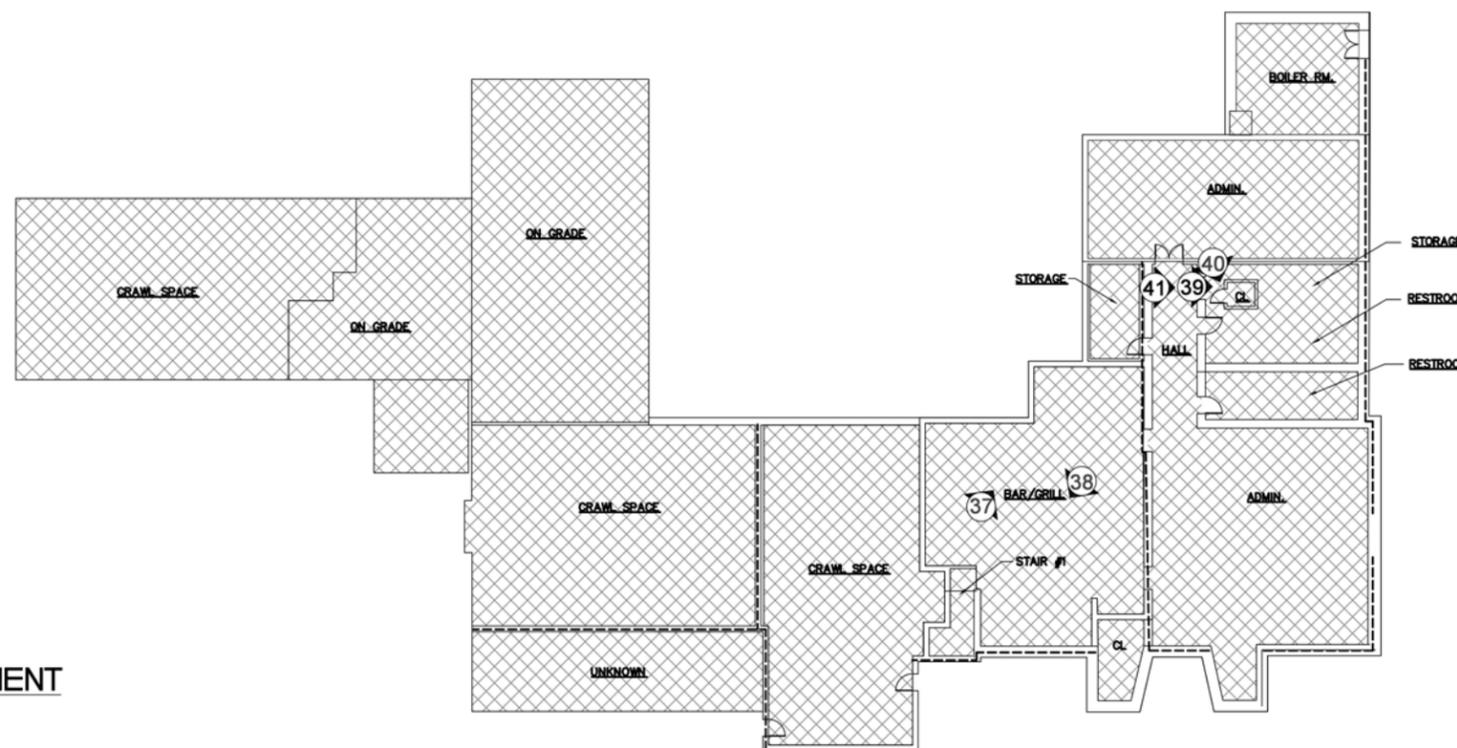
FLOOR PLAN- BASEMENT
