PHASE I ENVIRONMENTAL SITE ASSESSMENT AND HAZARDOUS BUILDING MATERIALS ASSESSMENT

JULY 2009

5835 Foothill Boulevard
Oakland, California

For:
City of Oakland
Oakland, California

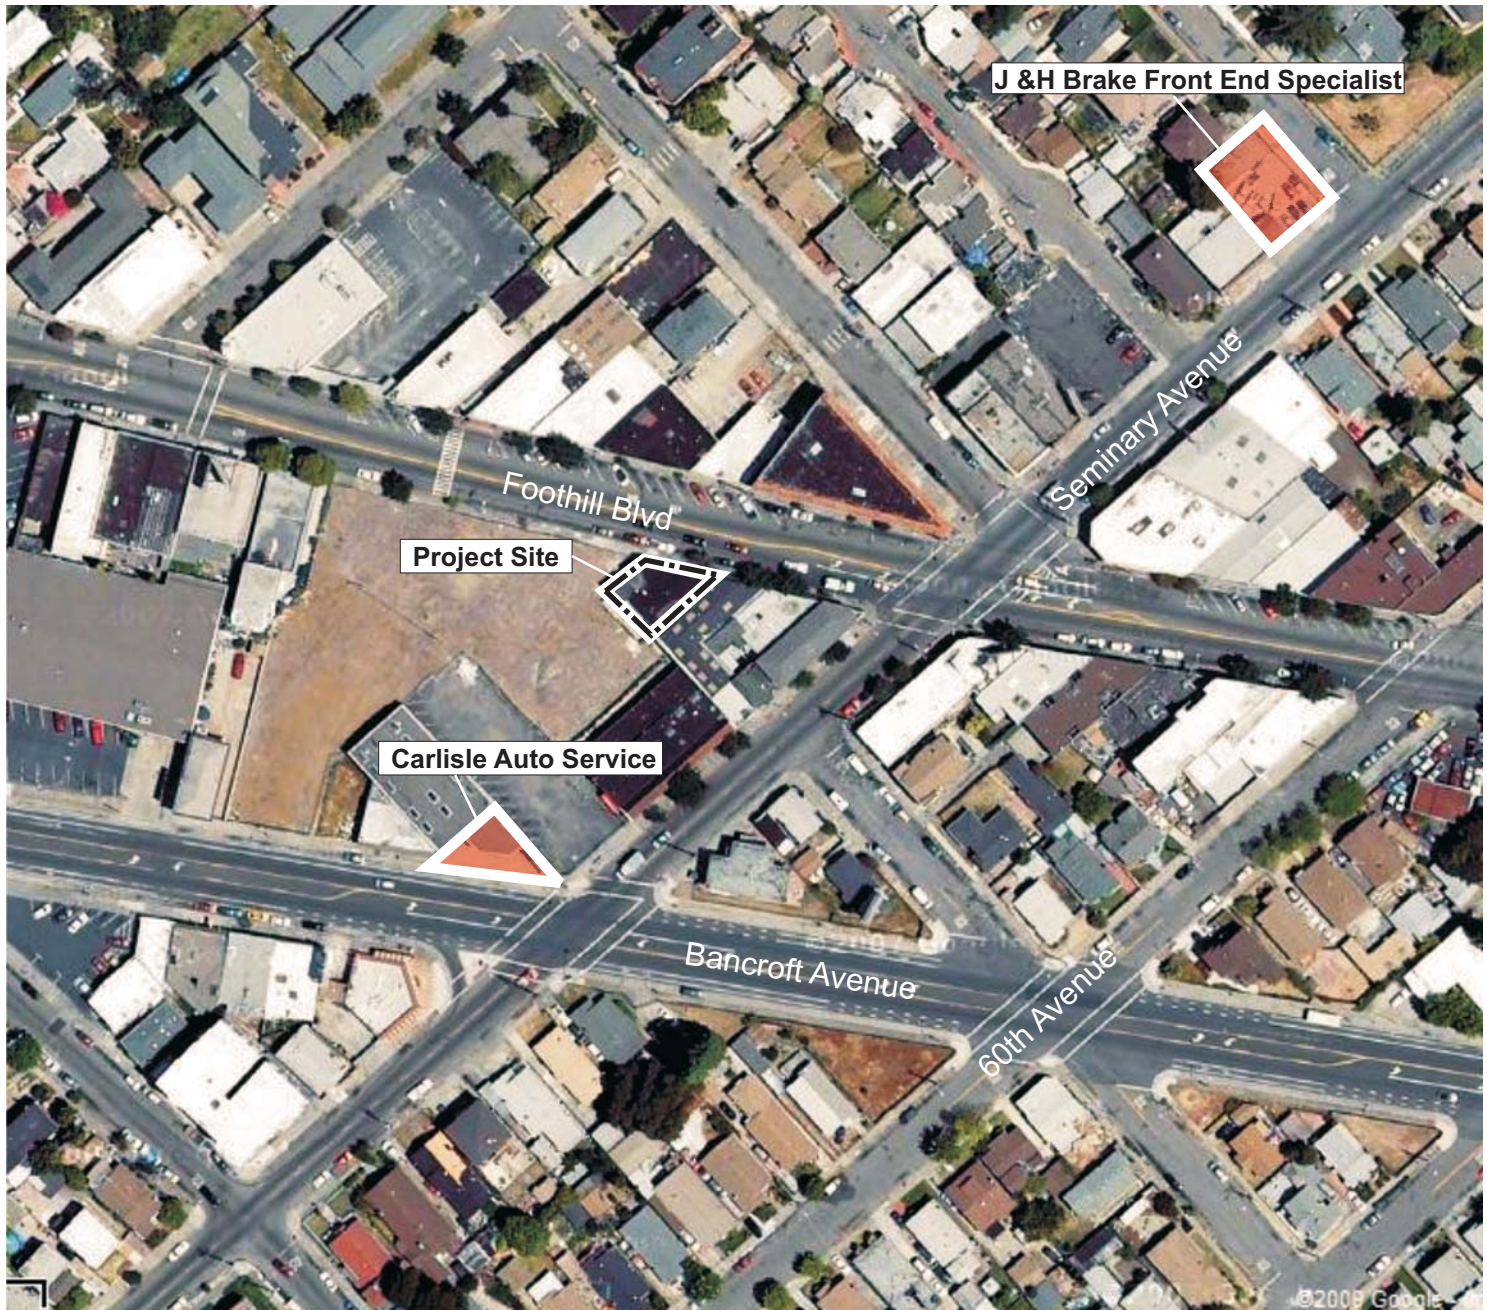
Figure 2

Historical land uses at the Project site were identified to assess potential sources of hazardous materials that could have affected the underlying soils and groundwater. In addition, the general uses of properties adjacent to the Project site and nearby land uses with apparent hazardous materials use were identified to assess potential sources of contamination that could potentially migrate beneath the Project site. Historical land uses identified in the Project vicinity that may have been associated with hazardous materials are shown in Figure 2.

HISTORICAL LAND USES ASSOCIATED WITH HAZARDOUS MATERIALS

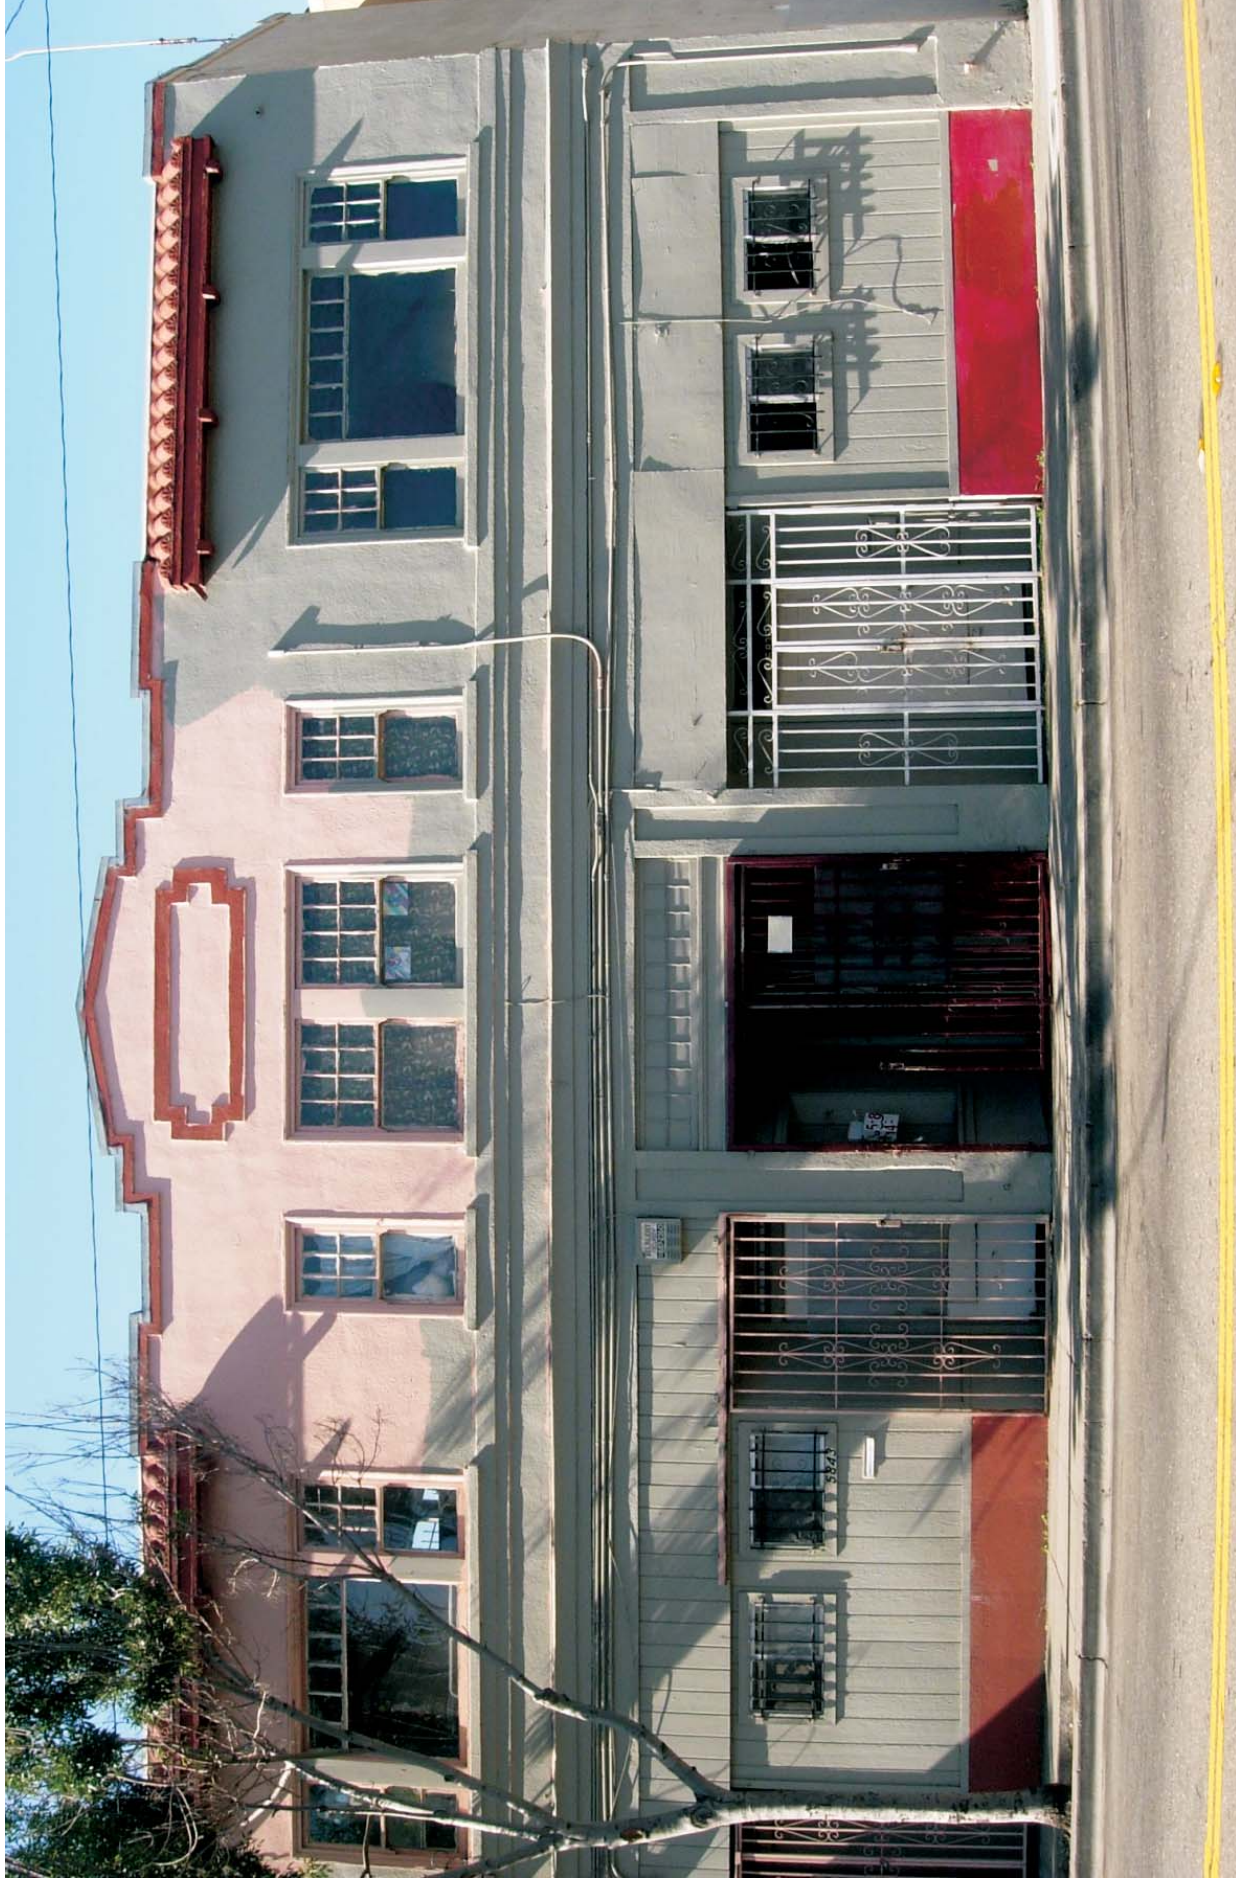
The Project site consisted of four unoccupied apartments with two units on the ground floor, two units on the second floor, and a patio behind the building (Figure 3). The apartments were generally empty except for some miscellaneous furniture. No hazardous materials storage or evidence of hazardous materials releases was observed at the Project site.

View of the Project site from the north.

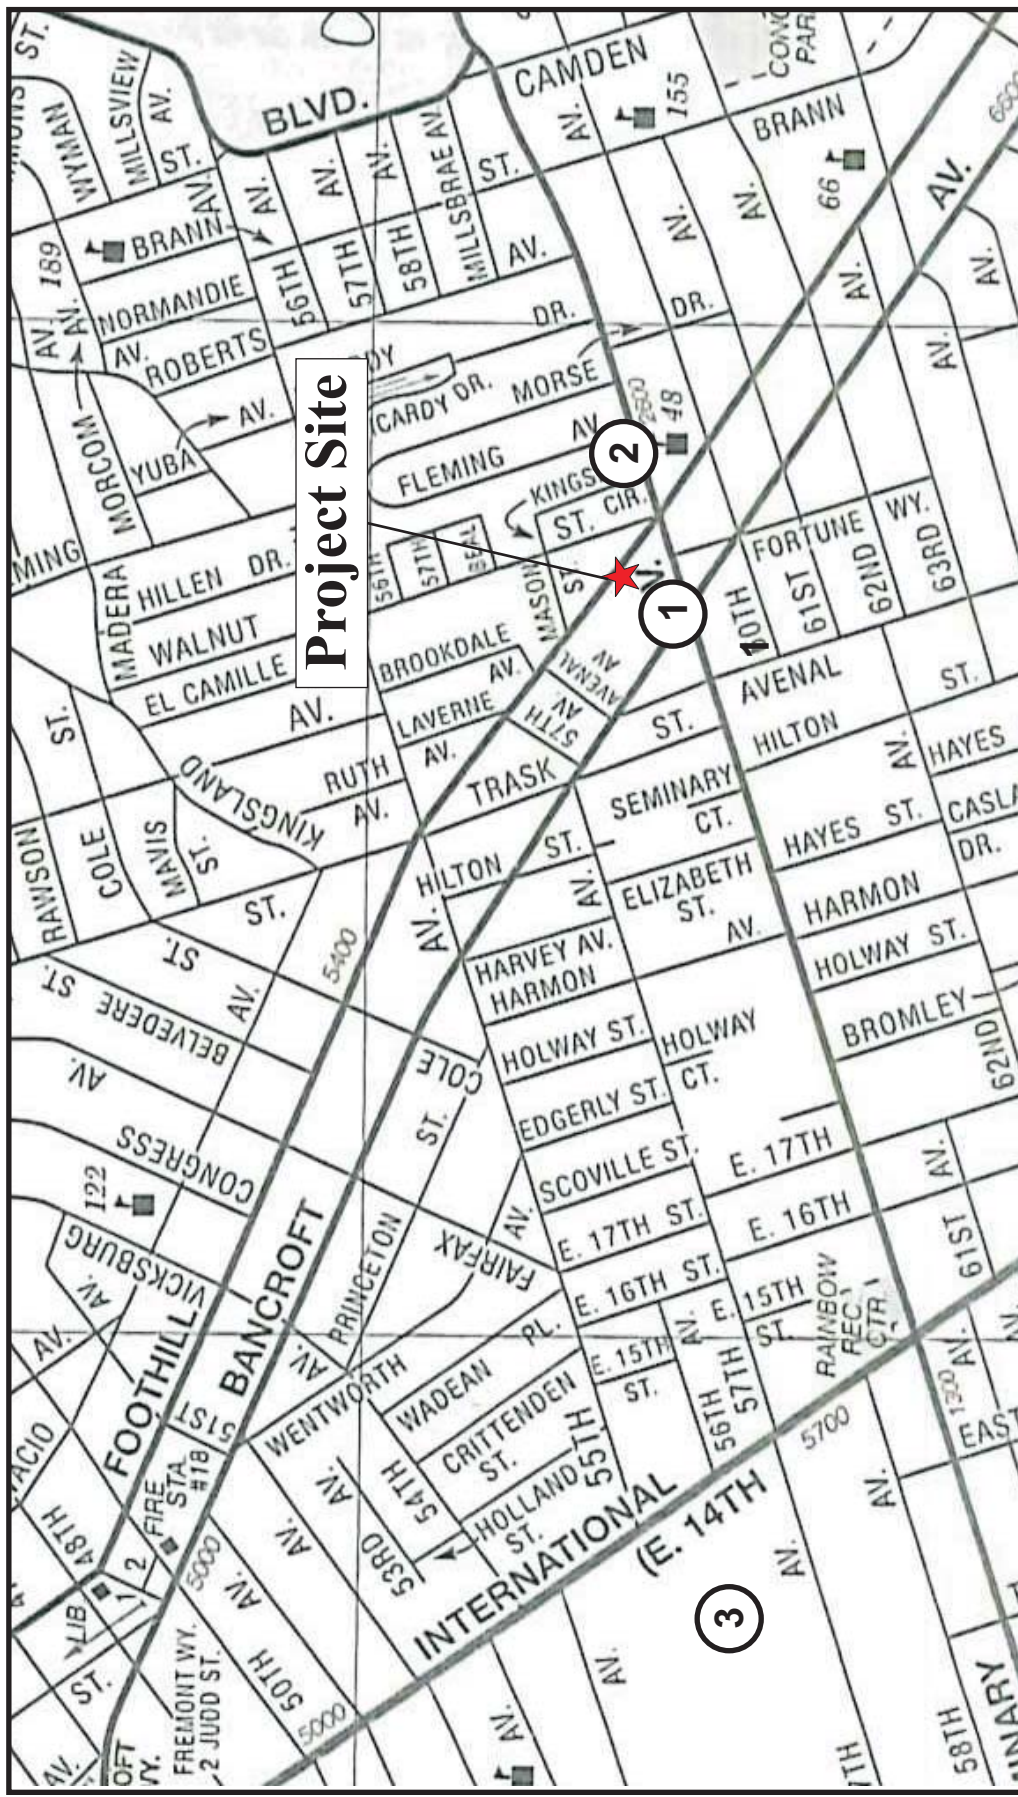
The EDR report identified three hazardous materials release sites within the minimum search distances of the Project site. A release of gasoline from a UST was reported in 1993 at Carlisle Auto Service approximately 170 feet south of the Project site (Figure 2 and Site 1 on Figure 4 and Table 3). Another release of gasoline from a UST was reported at J & H Brake Front End Specialist approximately 470 feet northeast of the Project site (Figure 2 and Site 2 on Figure 4 and Table 3). Regulatory agency oversight of remediation and monitoring has either been completed or was not necessary at the LUST sites and the cases have been closed. Based on the regulatory status of the LUST sites, contamination would not likely affect subsurface conditions beneath the Project site.

A release of polychlorinated biphenyls (“PCBs”) was reported at the General Electric Company located approximately 0.7 mile southwest of the Project site that impacted soil and groundwater (Site 3 on Figure 4 and Table 3). Groundwater remediation has been completed at the site. Based on the status of groundwater remediation, contamination from the General Electric Company would not likely affect subsurface conditions beneath the Project site.

HAZARDOUS MATERIALS SITES ON REGULATORY DATABASES Figure 4
WITHIN THE MINIMUM SEARCH DISTANCES OF THE PROJECT SITE
