Architectural Salvage Assessment

**Contributing Buildings
Oakland Army Base Historic District
Oakland, California**

**Prepared by:
Woodruff Minor
Consulting Architectural Historian**

December 7, 2006

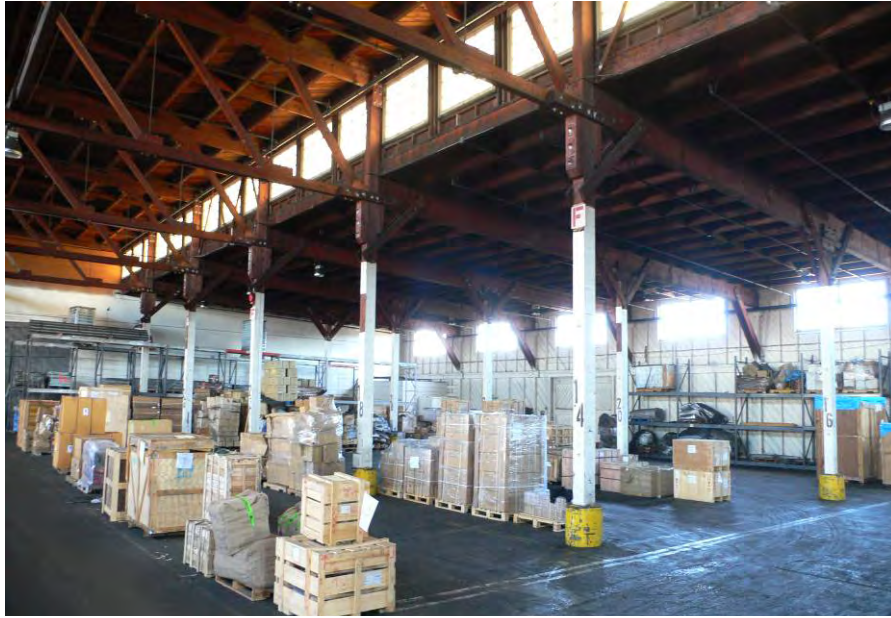
Figure 3.7. Heavy timber construction, Building 808. The “800 series” warehouses utilize grids of timber posts to support the timber girders of the side bays and timber trusses in the central monitor.

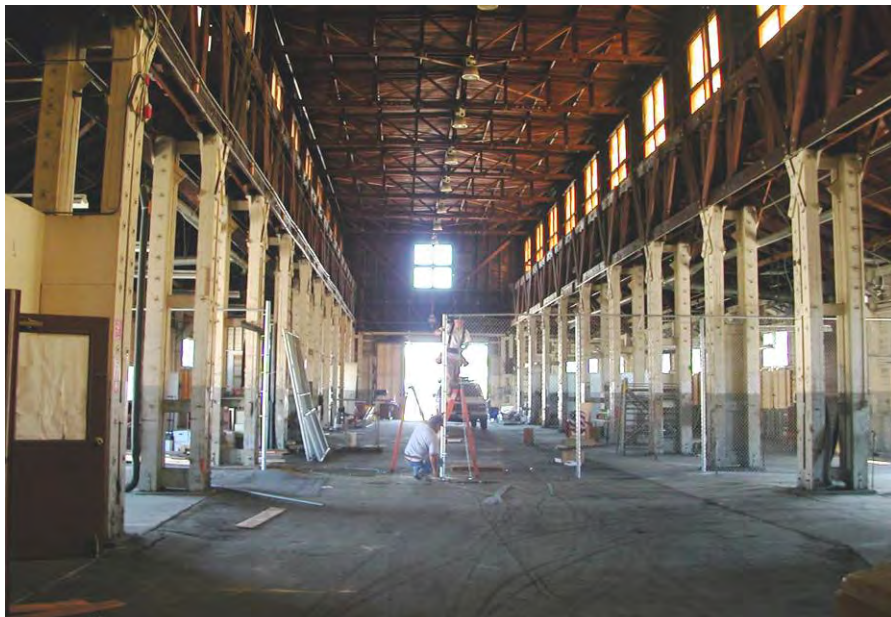
Figure 3.8. Heavy timber construction, Building 812. The double rows of bolted timber posts support longitudinal, truss-work rails for an overhead crane as well as the elevated structure of the monitor, incorporating transverse roof trusses.

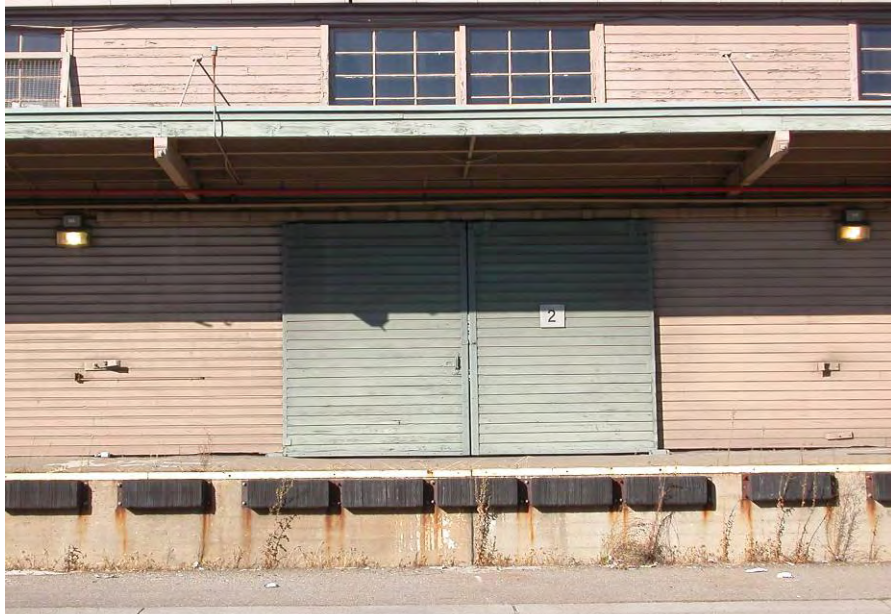
Figure 3.9. Doors on south loading dock, Building 806. Each of the “800 series” warehouses has 17 identical freight-handling bays arrayed along each side of the building. This representative view shows the exterior-mounted, sliding wood doors, clad in horizontal wood siding to match the exterior cladding of the walls. Note the fixed-pane, wood-sash windows over the canopy.

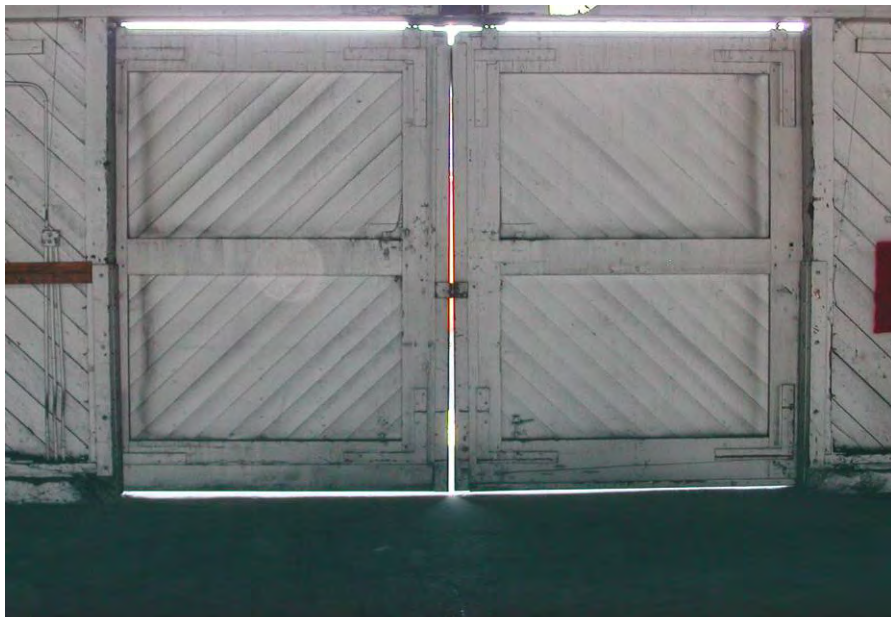
Figure 3.10. Sliding wood doors on north loading dock, Building 808. This typical view shows the diagonal sheathing of the interior side of the doors, mirroring the sheathing of the warehouse walls. Heavy wood doors suspended from metal tracks are used on all loading bays, as well as the entry bays at each end of the building.

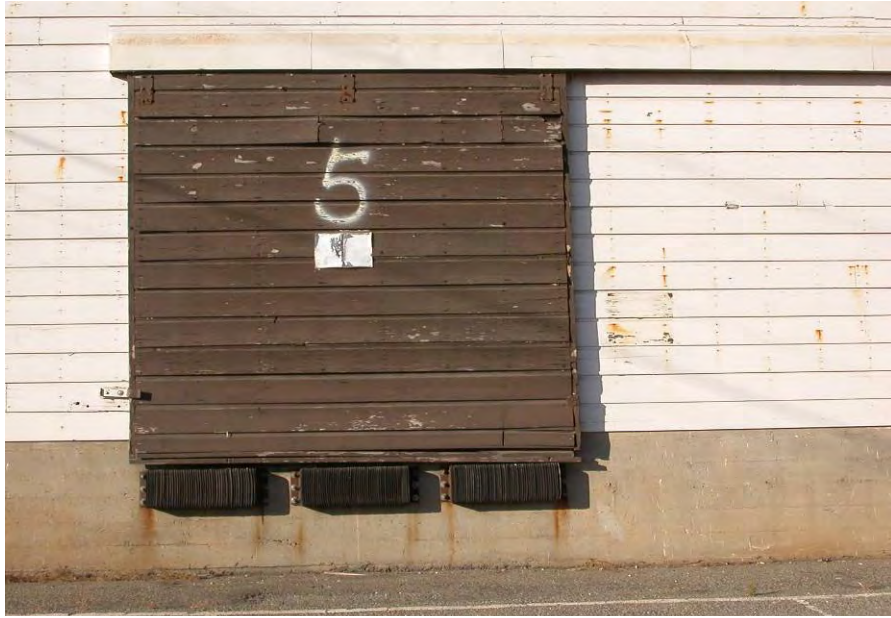
Figure 3.11. Exterior-mounted, sliding wood door on south side of Building 821. Five such doors are hung along each side of Buildings 821 and 822. Note the horizontal wood siding, which is wider than that on the “800 series” warehouses.

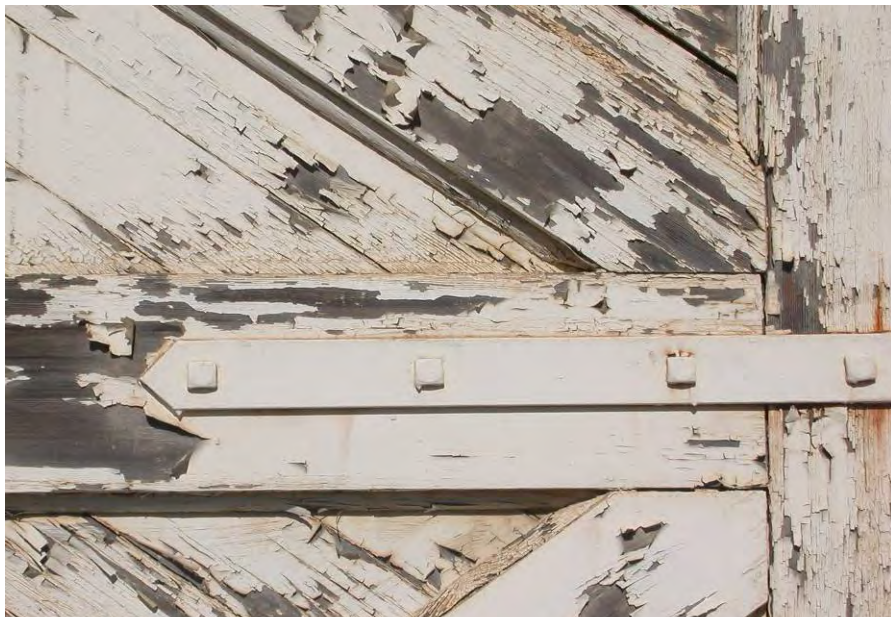
Figure 3.12. Door detail, Building 991. The two pairs of hinged wood doors on the railroad roundhouse have diagonal sheathing and bolted iron strap hinges.

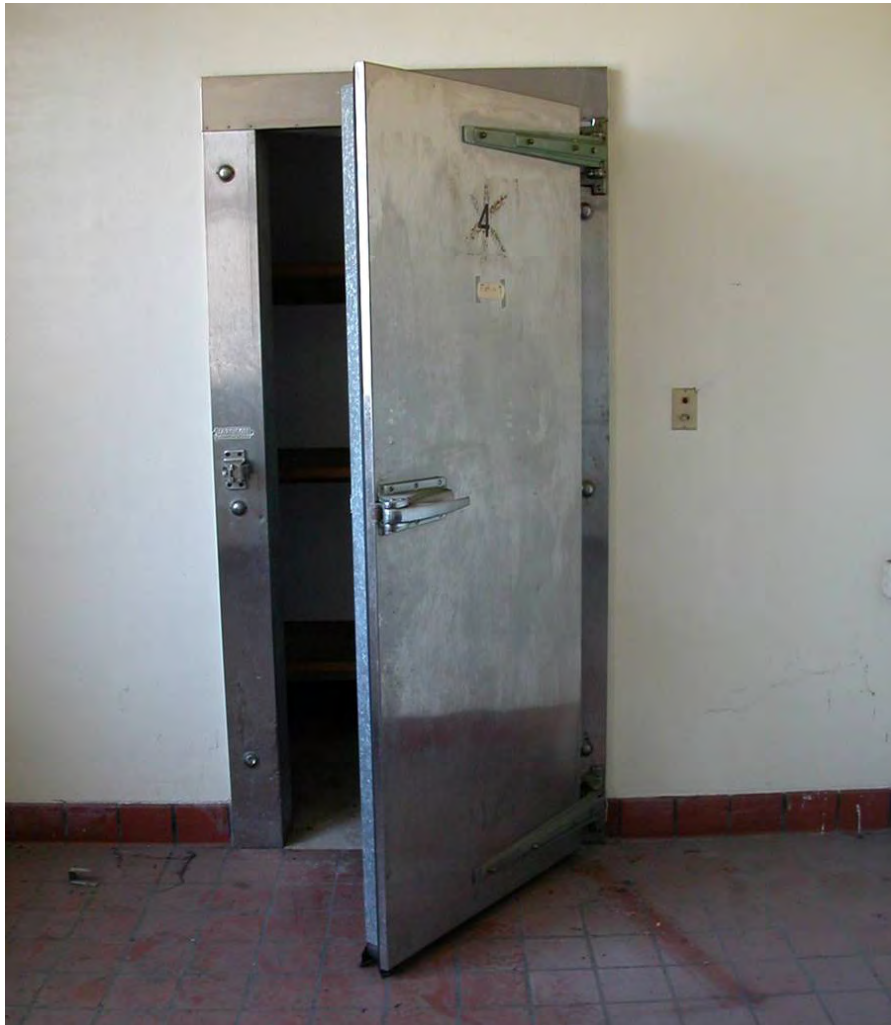
Figure 3.13. Freezer door in Cafeteria (Building 60). The interior of this building retains a number of hefty metal doors.

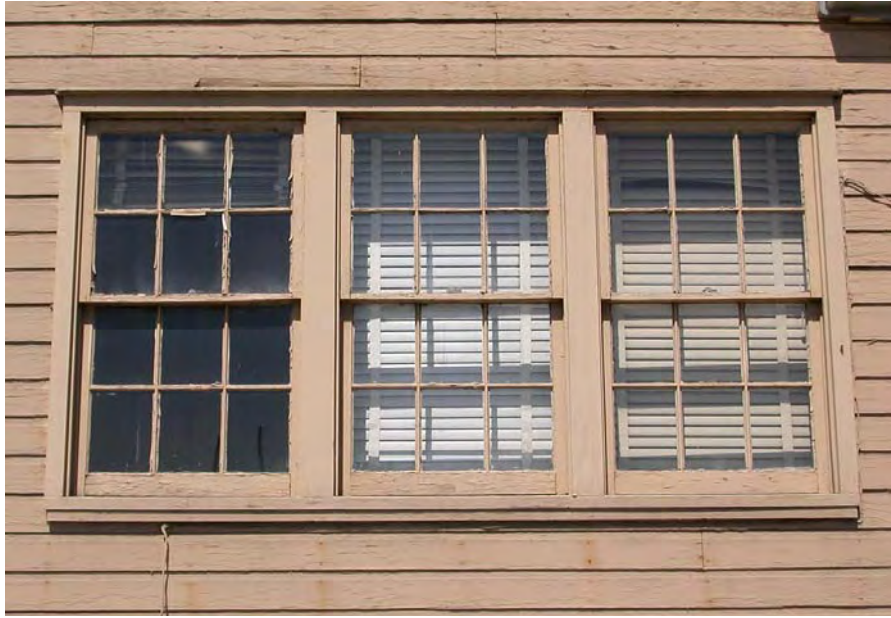
Figure 3.15. Multi-light, wood-sash windows survive in most buildings on the base, including more than 40 double-hung windows on Building 85.

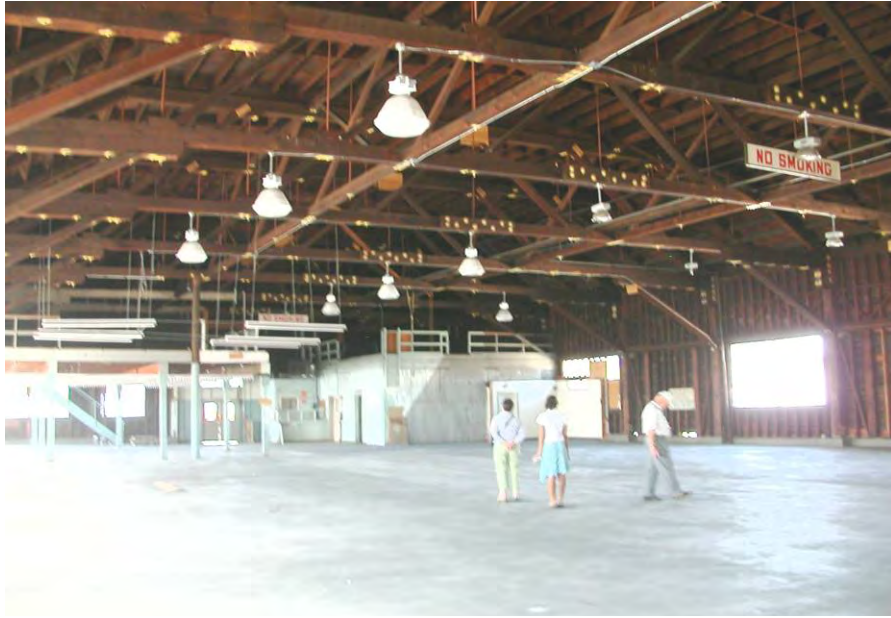
Figure 4.9. Massive timber trusses form a clear span in Building 88. This view also shows the partitioned rooms and mezzanine floors added at the south end of the building, occupying a small fraction of the interior space.

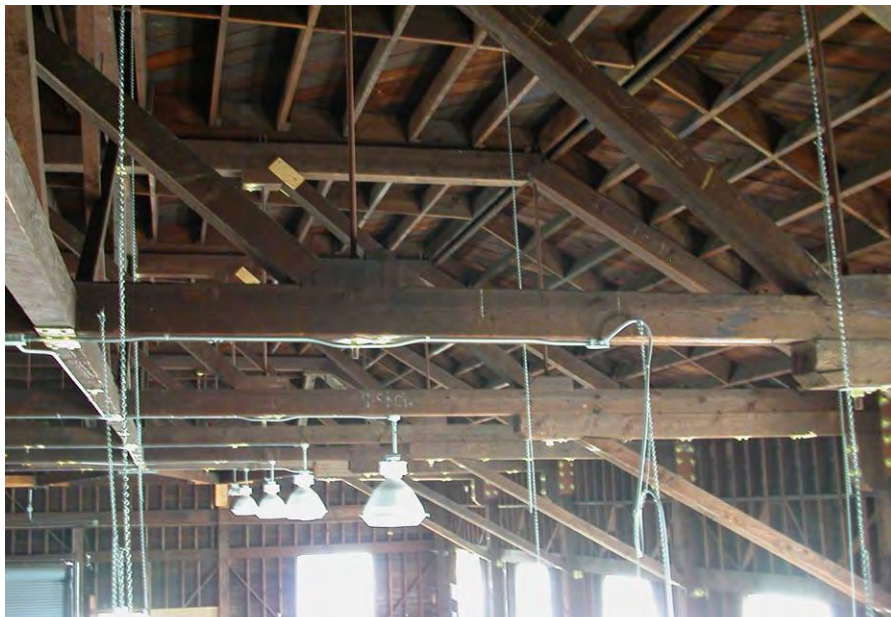
Figure 4.10. Truss detail, Building 88.

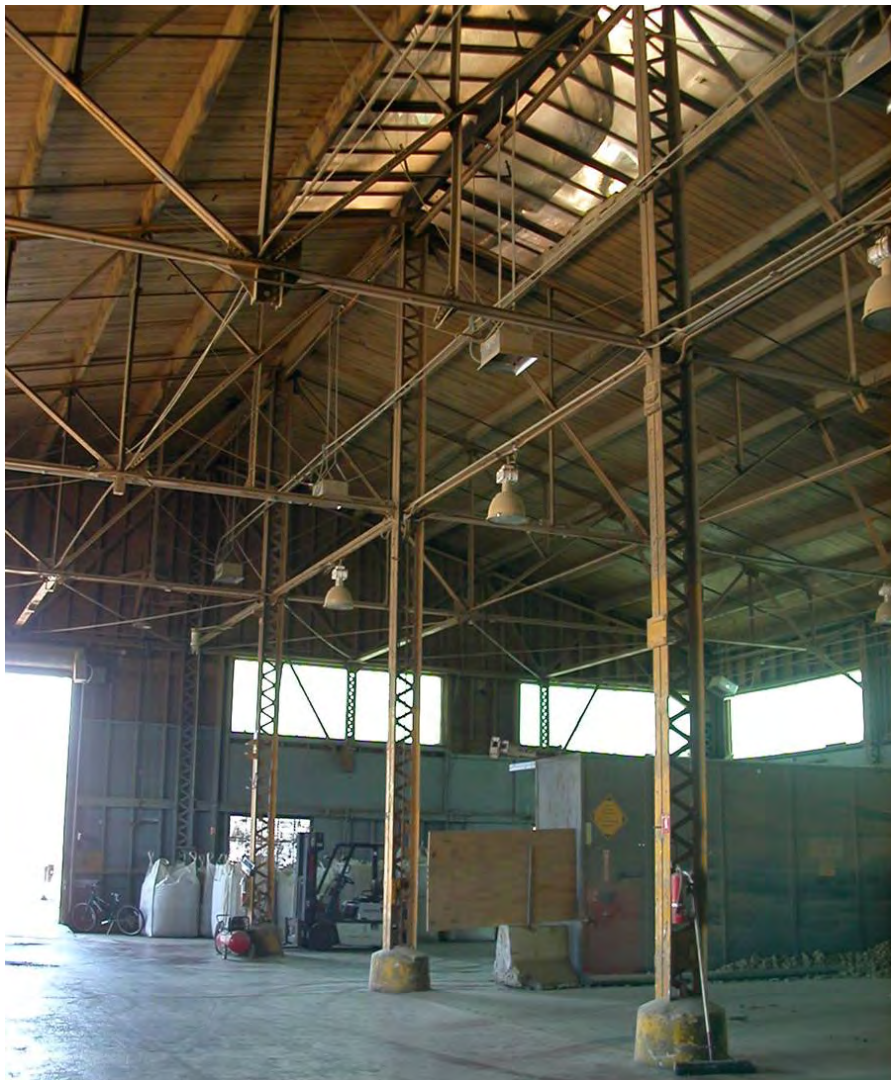
Figure 4.16. Building 99 is the only steel-frame structure in the Oakland Army Base Historic District. This view shows the trussed steel columns and spindly trusses of the one-story section at the north end of the building.

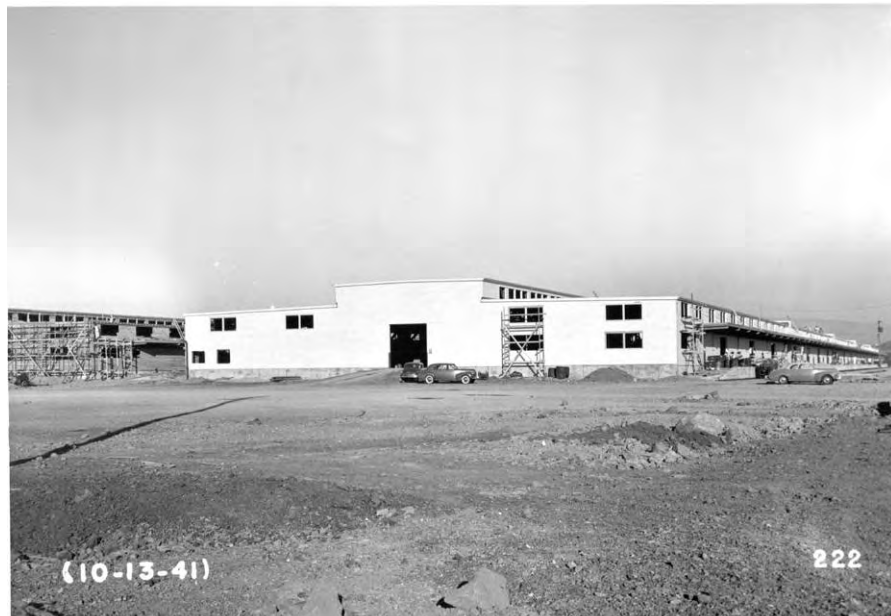
Figure 4.17. This early view, looking east, depicts one of the “800 series” warehouses (probably 802) nearing completion in October 1941. The wood siding has been painted, but windows and doors are not yet installed. Framing and sheathing is in process on the warehouse to the left. (Port of Oakland Archives.)

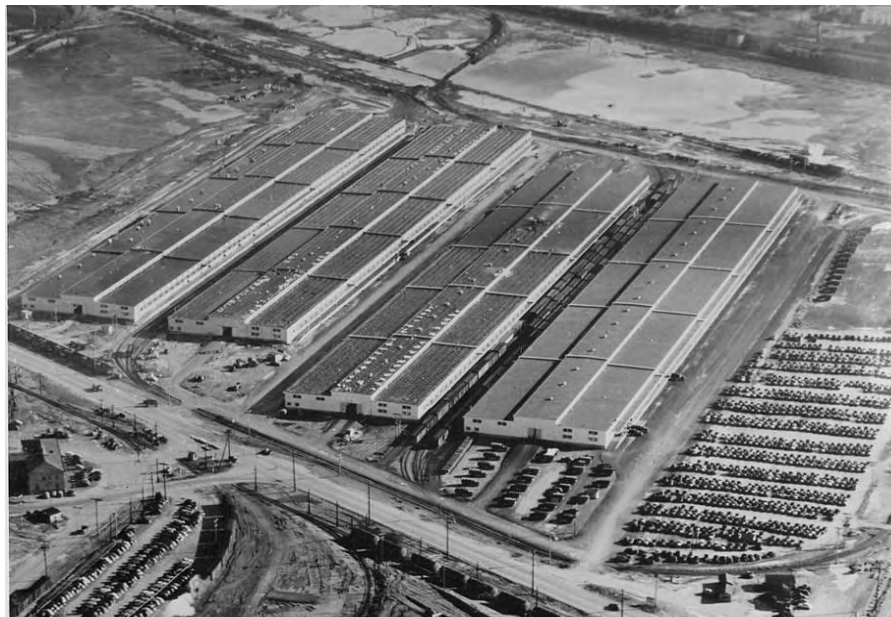
Figure 4.18. Aerial view of partially completed row of “800 series” warehouses, early 1942. The view looks east. The warehouses shown (from right to left) are Buildings 802, 803, 804, and 805, at the south end of the row. The final three warehouses (Buildings 806, 807, and 808) would be completed at the north end of the row later that year. (Oakland Army Base Archives.)

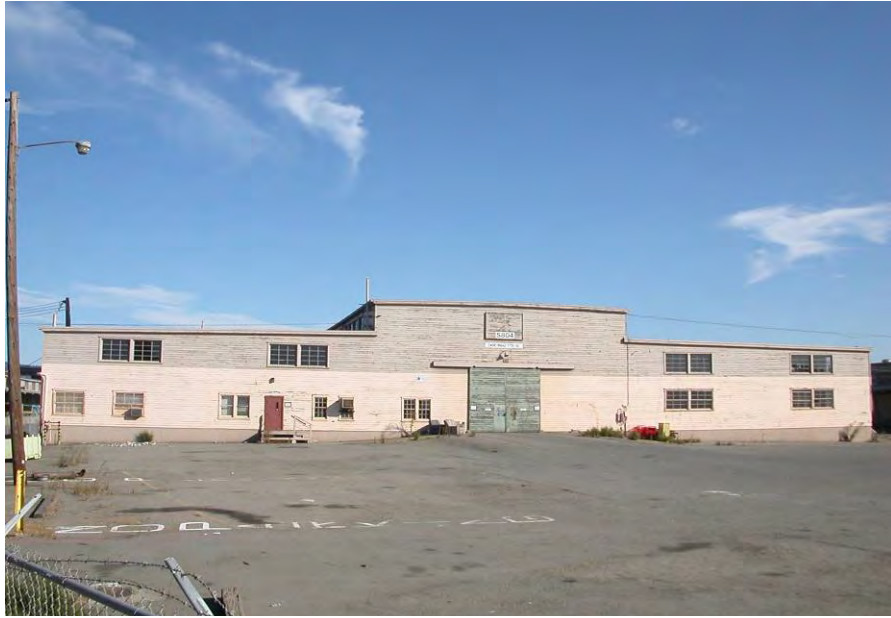
Figure 4.19. West façade, Building 804. The tripartite form of the “800 series” warehouse is clearly seen in this representative view showing the wide central monitor flanked by lower side sections. Windows provide light on two levels; sliding wood doors serve the doorway.

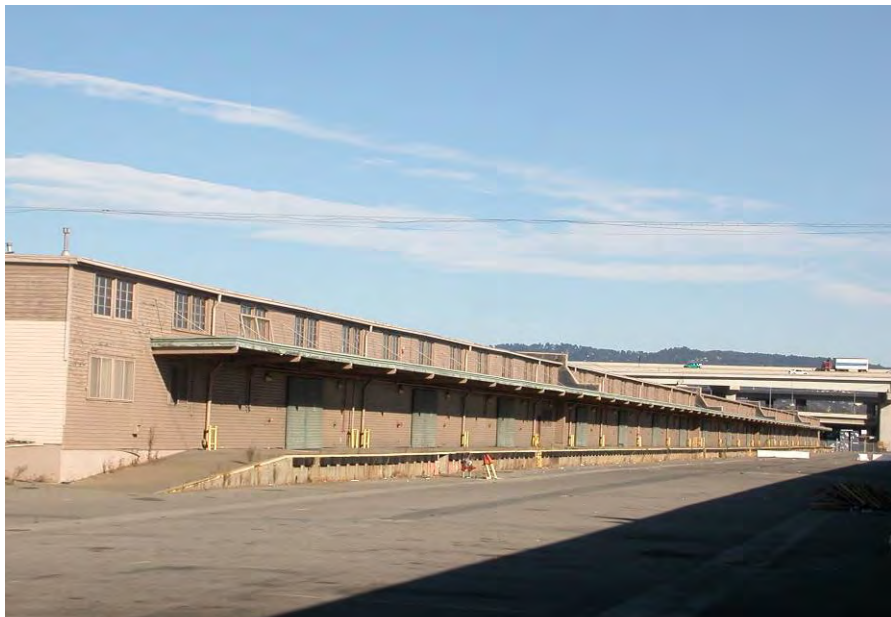
Figure 4.20. South side of Building 806. Elevated loading docks with canopies extend along both sides of the “800 series” warehouses. Each dock is served by 17 doorways, or loading bays, with sliding wood doors. Rows of paired wood-sash windows surmount the canopies.

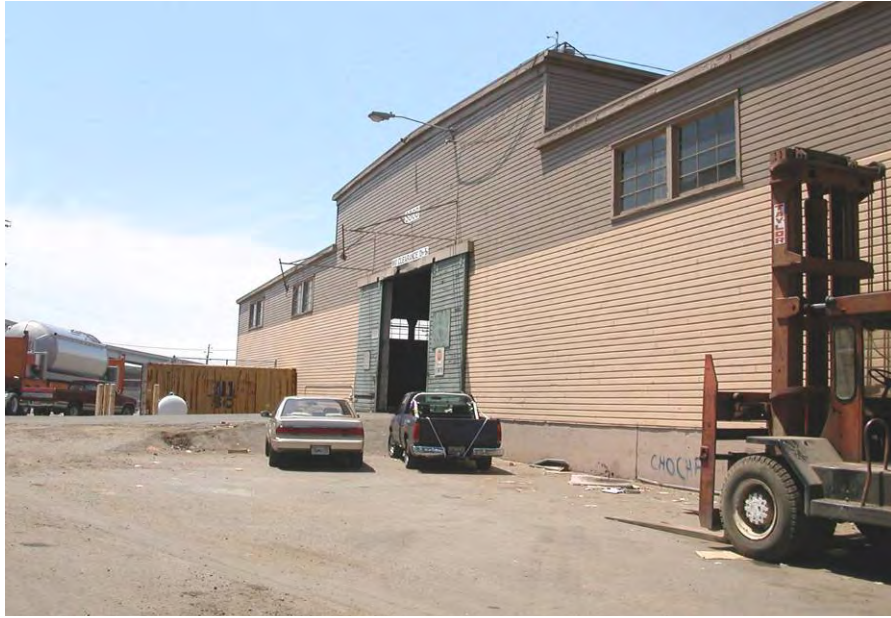
Figure 4.21. Building 808, east end. This view shows the central bay, with monitor, and flanking side bays. Note the ramped entry with sliding wood doors, as well as the wood-sash windows (limited to the upper level at this end of the building). The exterior is uniformly clad in horizontal wood siding.

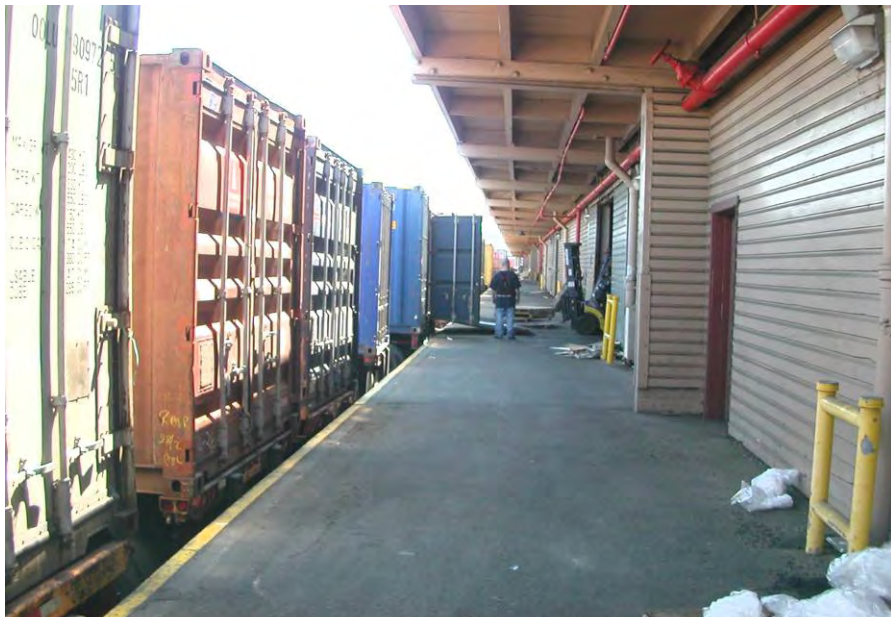
Figure 4.22. Building 808, north loading dock. This view highlights the cantilevered form of the canopy and the horizontal wood siding of the walls.

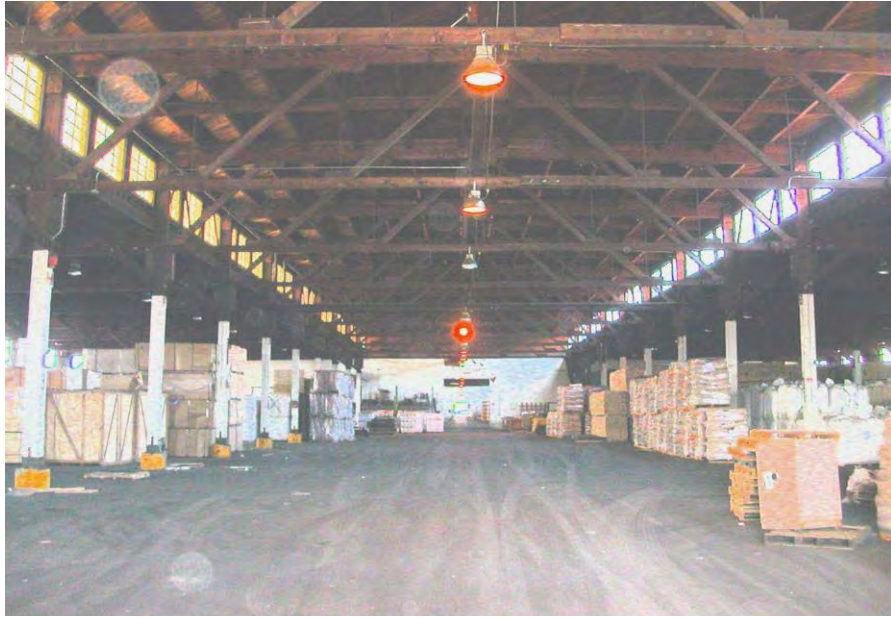
Figure 4.23. Building 808, interior view of central bay. Wood trusses on heavy timber posts support the wide, window-lined form of the monitor.

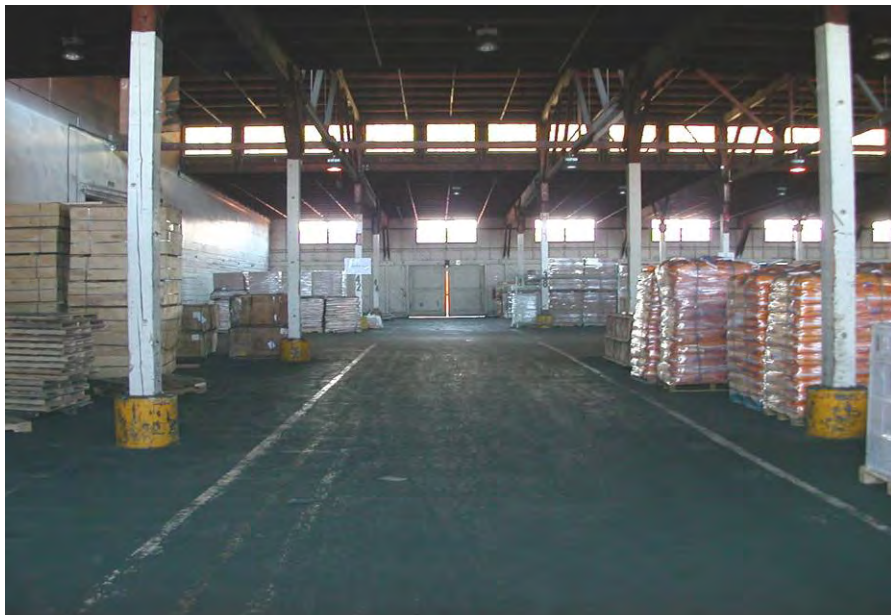
Figure 4.24. Building 808, transverse view of interior. Natural lighting is provided by the monitor windows and the lower window row over the loading bays. Note how the bay is on axis with the aisle formed by the rows of columns.

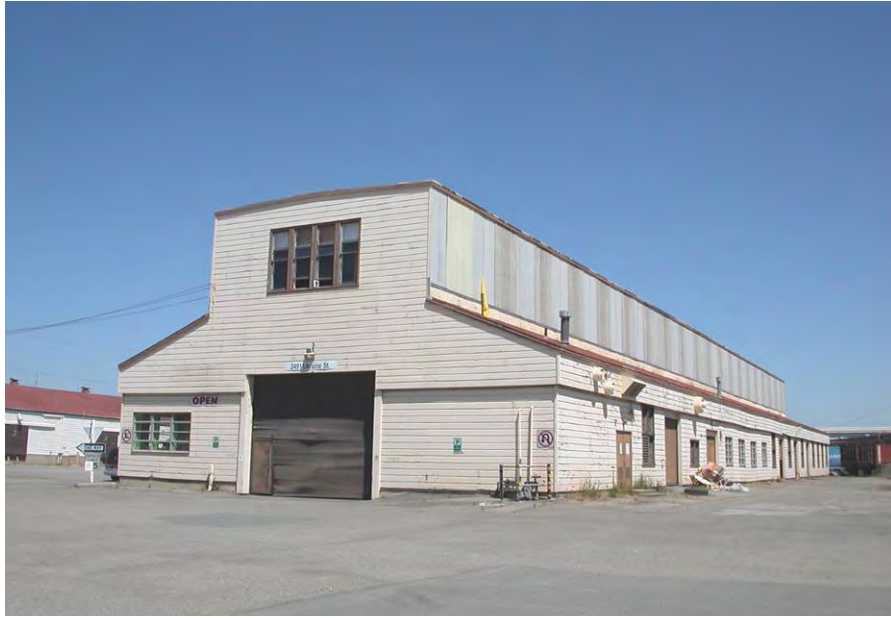
Building 812 has received a number of alterations. Alternating panels of asbestos cement (“transite”) and translucent fiberglass have been applied to the monitor. Metal roll-up doors have replaced the sliding wood doors, and most ground-floor windows now have aluminum sash. The interior appears intact apart from the addition of partitions in some side bays and the possible replacement of the original crane.

Figure 4.25. Building 812, perspective view of west end and south side. The most prominent feature of the building—a bulky monitor accommodating a rolling bridge crane—has been altered by the application of asbestos and fiberglass panels.

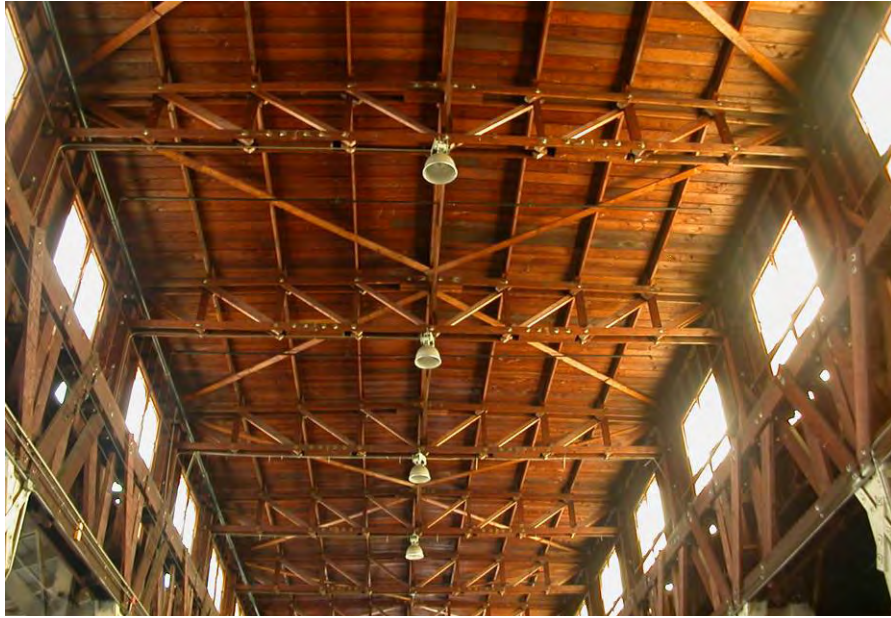
Figure 4.27. Building 812, interior view of monitor. Bolted wood trusses and purlins support the roof decking.

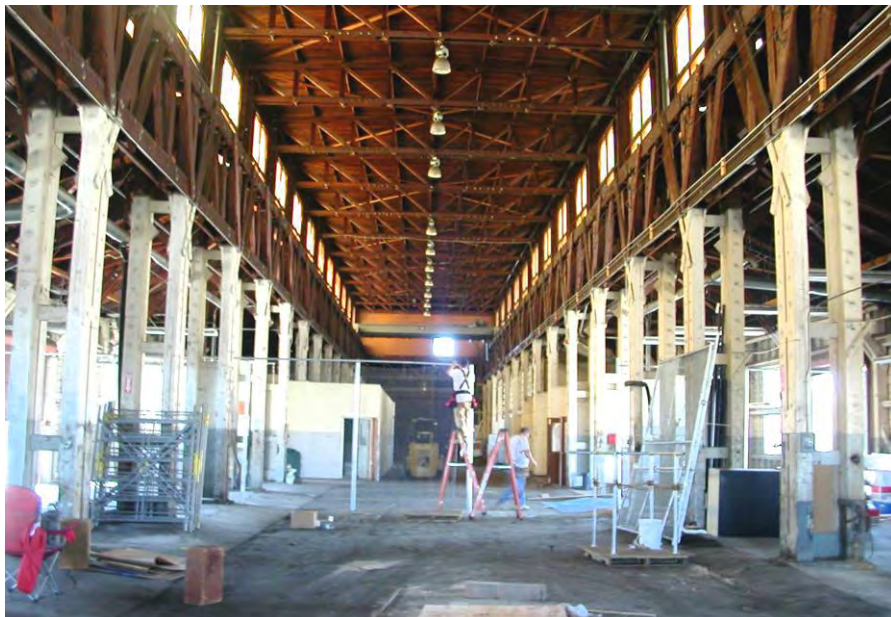
Figure 4.28. The double rows of heavy timber posts support truss-work rails serving a 5-ton rolling crane (visible in distance).

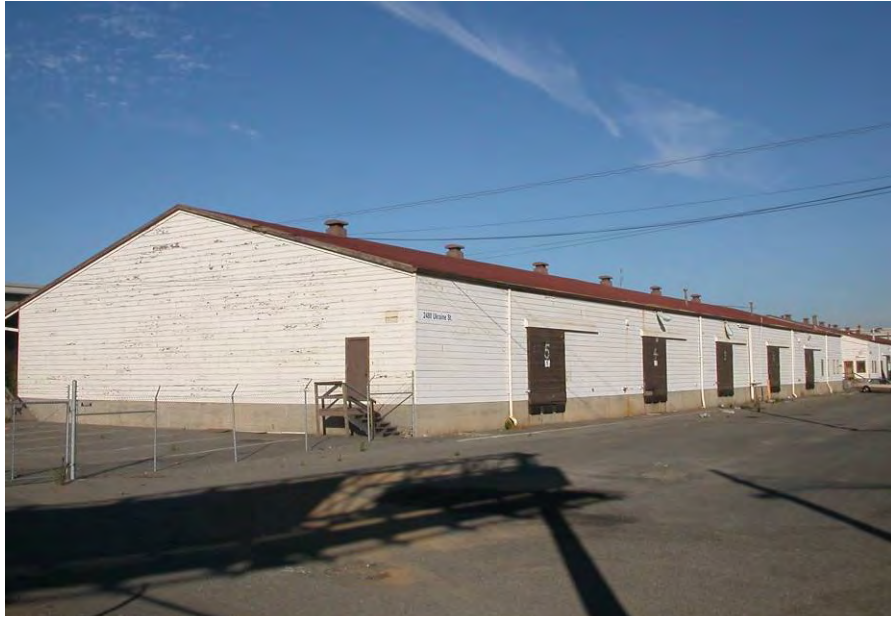
Figure 4.29. Building 821, perspective view looking east. Built in 1943, this warehouse is identical to Building 822 (partly visible, far right).

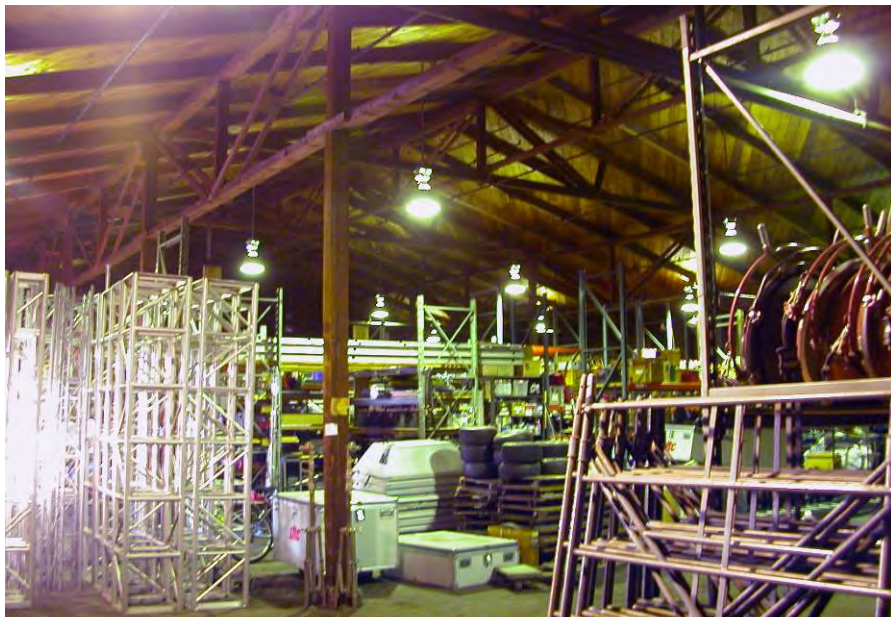
Figure 4.30. The heavy timber construction of Building 821 consists of two rows of timber posts supporting flat and gabled trusses.

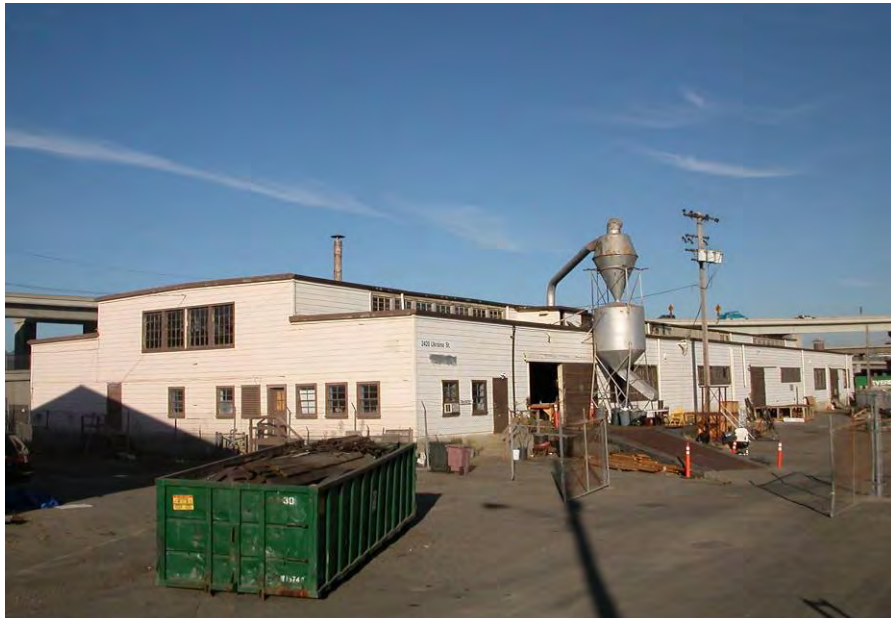
Figure 4.31. Building 823, perspective view looking east. Though quite similar to Buildings 821 and 822, this former box factory was built a year earlier, in 1942, and incorporates a monitor in its design.

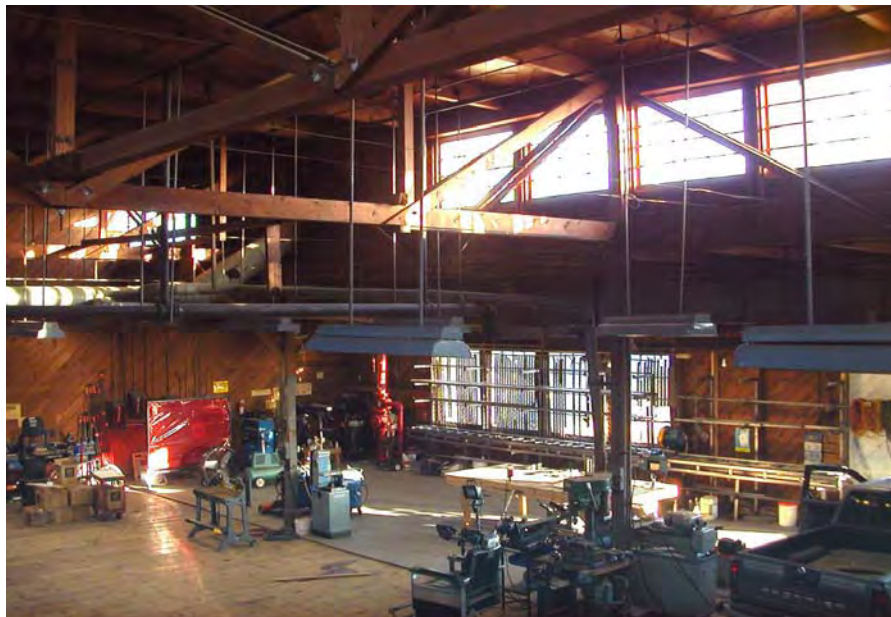
Figure 4.32. The heavy timber construction of Building 823 features large monitor trusses spanning the central bay. Note the diagonal board sheathing on the partition and sidewall.

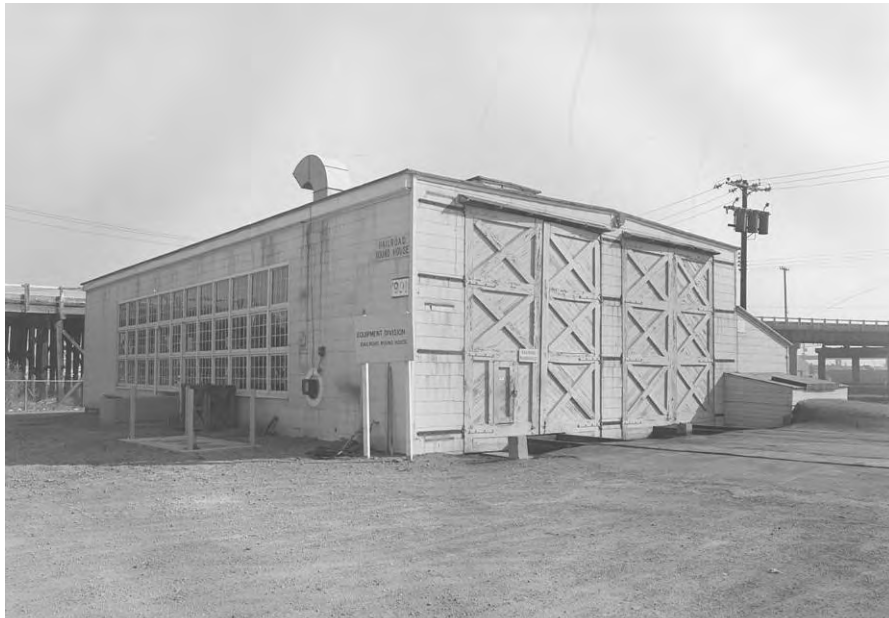
Figure 4.33. Building 991, perspective view looking east, 1976. Built in 1942 in conjunction with the Knight Rail Yard, this building served as the base's repair and maintenance facility for locomotives. It was known variously as the Engine Switch Shop, Railroad Engine Shop, and Railroad Roundhouse. Spur tracks led from the rail yard to the shop, branching to enter two service stalls served by tall hinged doors. (Oakland Army Base Archives.)

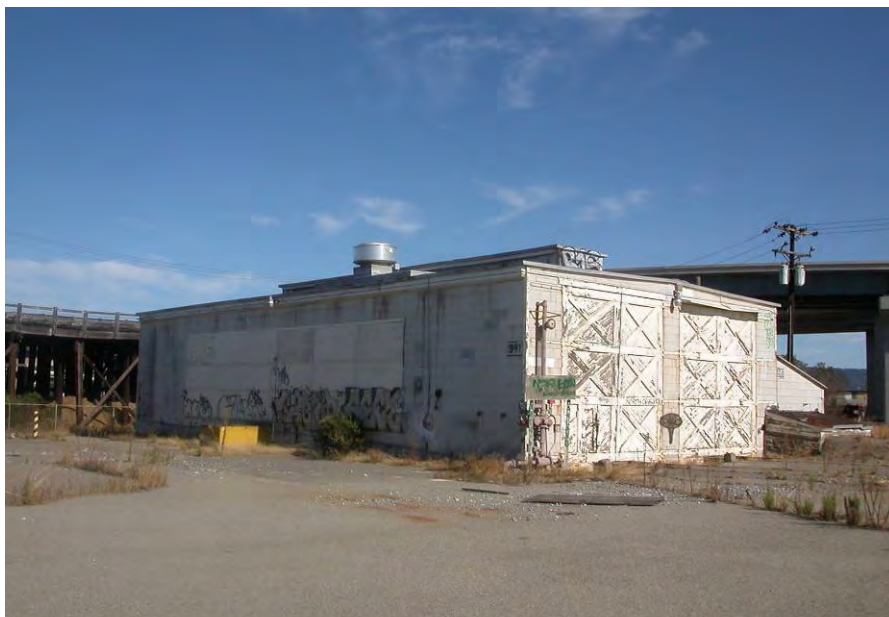
Figure 4.34. The building is largely intact. Asbestos-cement shingles have been added over the wood siding of the walls, and sheets of plywood cover the large window panels.

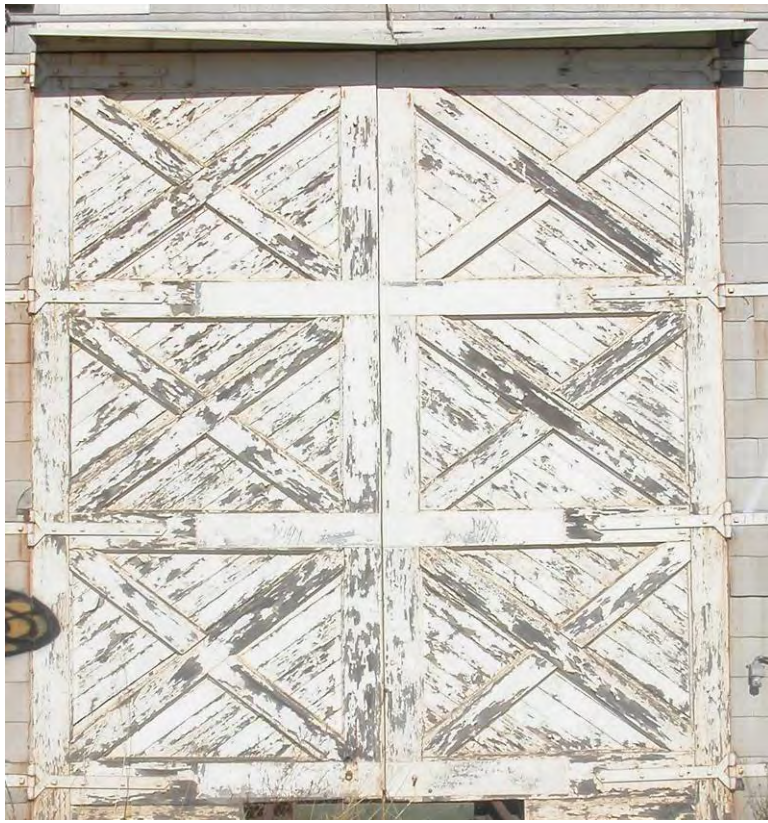
Figure 4.35. Door detail, Building 991. Each door has three cross-braced panels with diagonal sheathing.

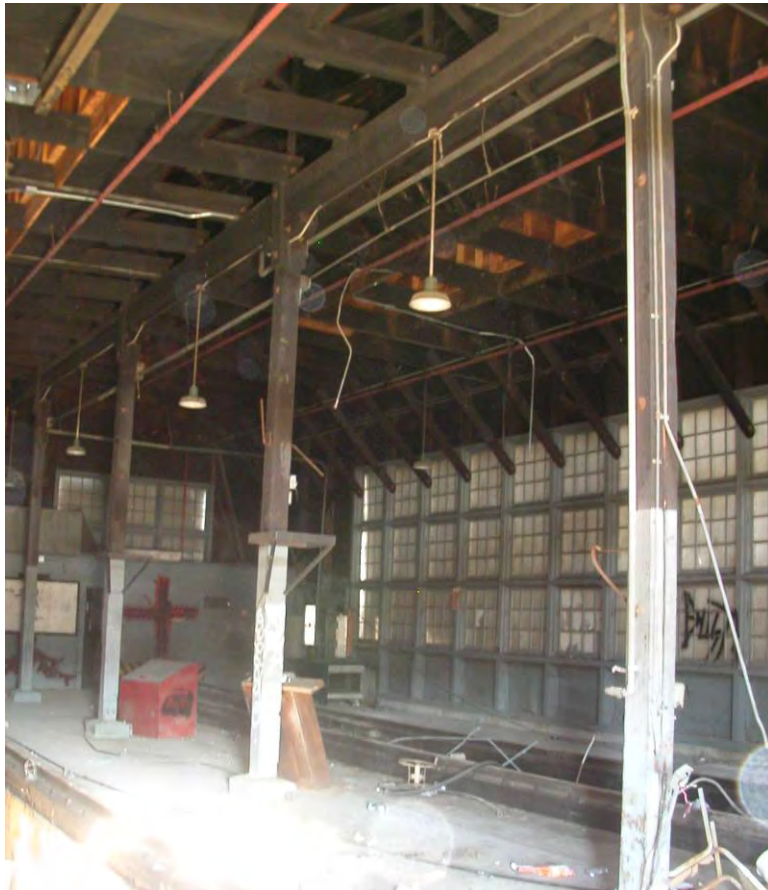
Figure 4.36. Building 991's two service bays (one equipped with a pit) are separated by a row of heavy timber posts running down the center of the floor, with several small partitioned rooms and a mezzanine at the far end. Note the intact window panels at the side and rear.
