**Subject: Preliminary Geotechnical Evaluation
Broadway & 28th Street
Oakland, California
Langan Project No.: 750631701**

This letter report presents the results of our preliminary geotechnical evaluation for the proposed development at Broadway & 28th Street in Oakland, California. Our services were performed in general accordance with our proposal dated 7 August 2015. Our preliminary conclusions and recommendations may be used for preliminary design and pricing exercises. The intent of this letter is to inform you regarding the geotechnical conditions at the site for use in your due diligence. During final design, we should perform a geotechnical investigation which will allow us to evaluate the conditions across the site and develop final geotechnical and foundation conclusions and recommendations for the project.

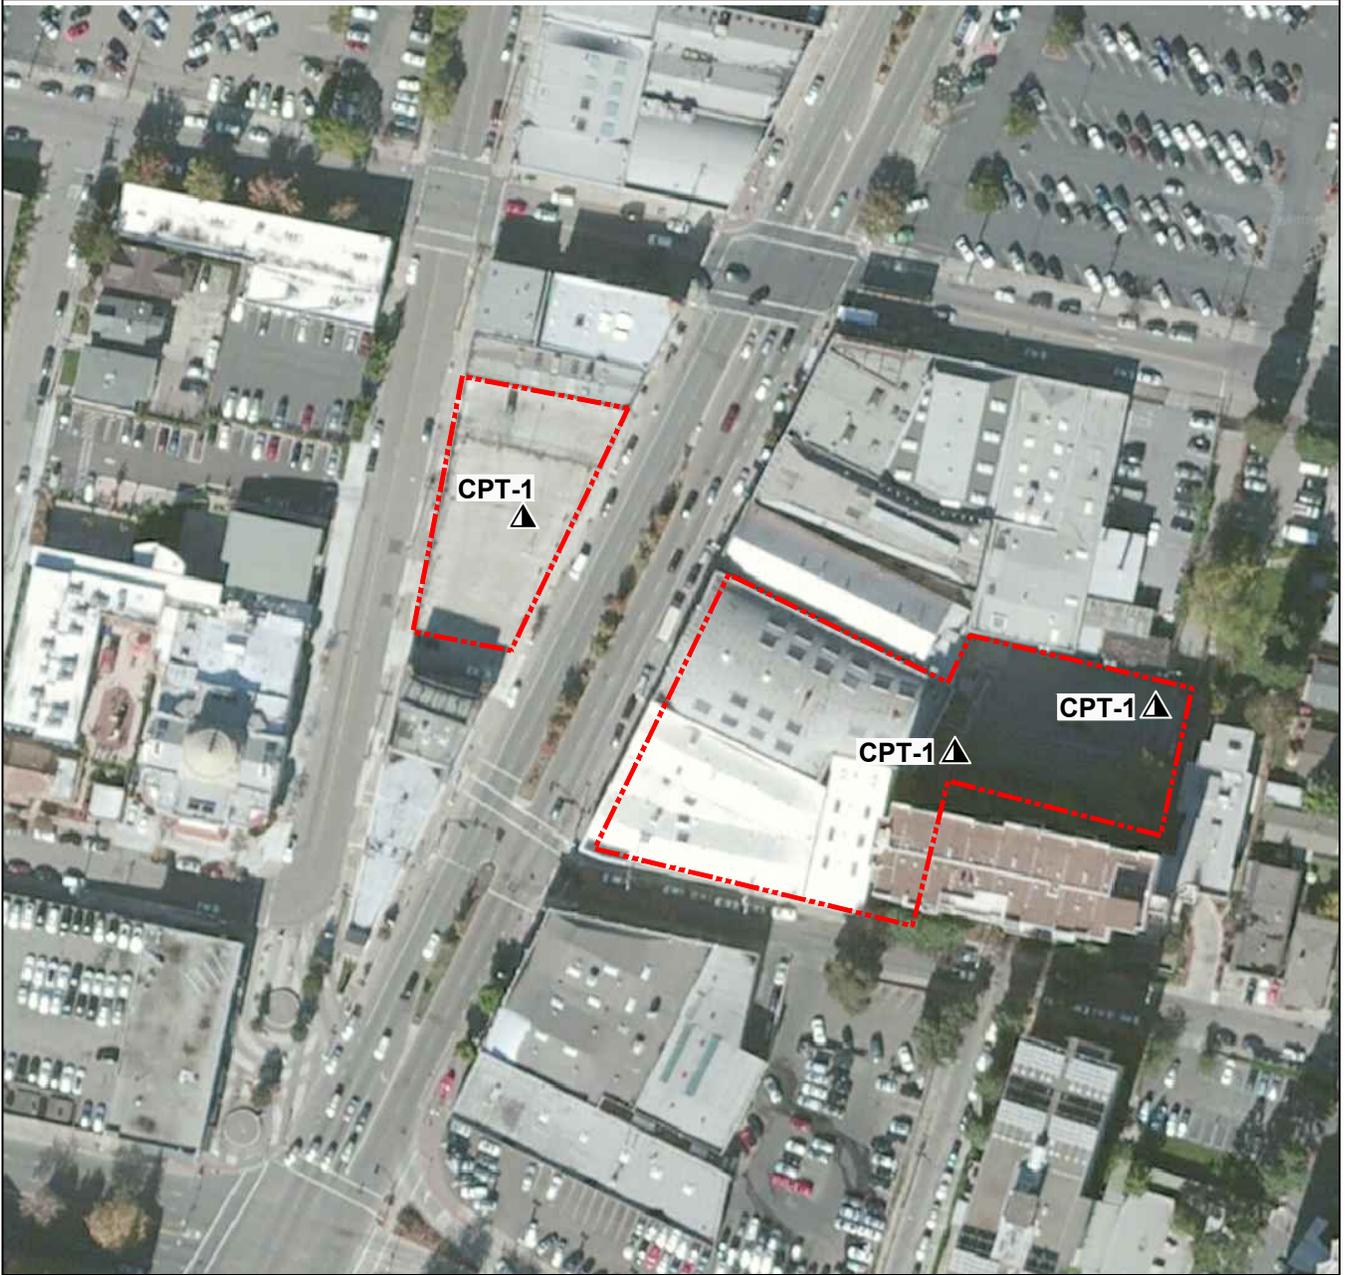
Date 09/09/15	Project No. 750631701	Figure 2
---------------	-----------------------	----------

- CPT-1** ▲ Approximate location of cone penetration test by Langan Treadwell Rollo, August 2015
- - - - -** Site Boundary

SITE PLAN

The western development area is at 2855 Broadway and is bound by Broadway on the east, a one story building on the north, Webster Street to the west, and a one story building on the south. This parcel is currently an asphalt paved parking lot used as a Hyundai car lot. The approximate location of the proposed development areas are shown on the attached Site Plan, Figure 2.

To evaluate the subsurface in some portions of the site, we performed three cone penetration tests (CPTs) for this preliminary investigation. The approximate locations of the CPTs are shown on the Site Plan, Figure 2. Prior to performing our field investigation, we obtained a soil boring permit from the Water Resources Wells Section of the Alameda County Department of Public Works Agency (ACDPWA), notified Underground Service Alert (USA), and retained a private underground utility locating service to check that locations of exploratory points were clear of existing utilities.
